## Report on Asbestos Containing Materials in the Workplace

**Address of Building:** 12 King Street,  
CABOOLTURE, QLD 4510

**Date of Inspection:** 18/02/2026

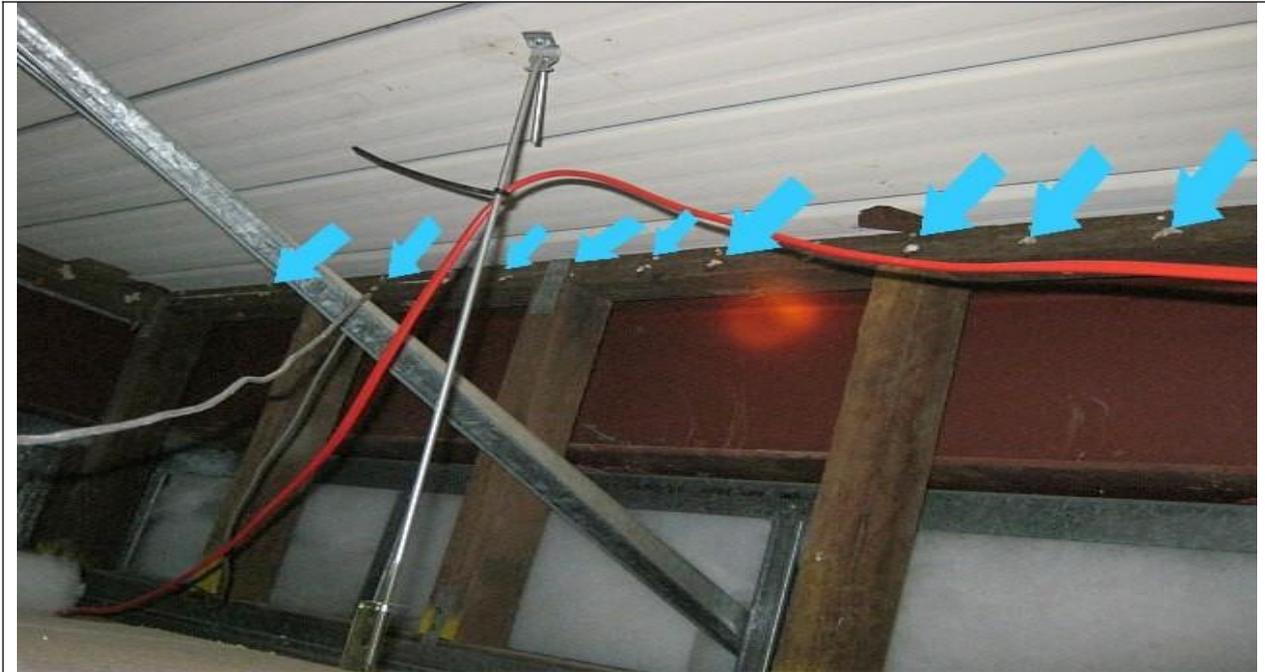
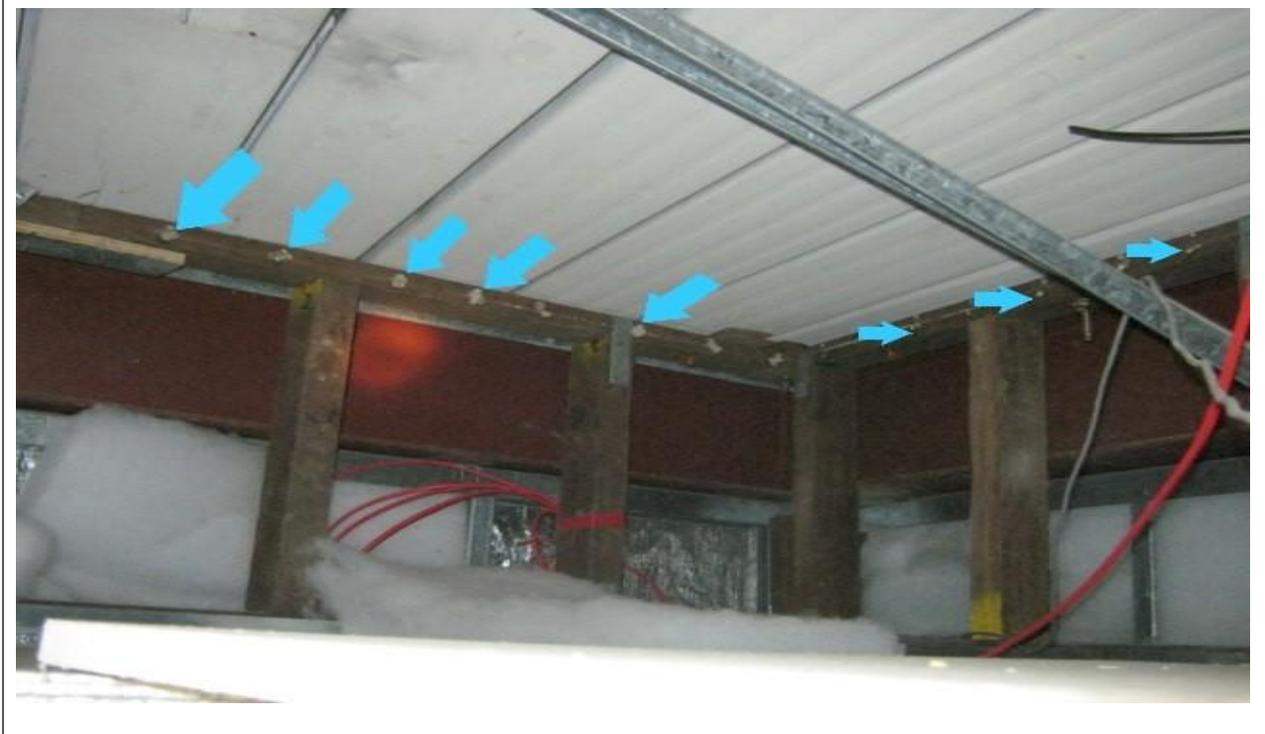
<b>Building Name</b>	<b>12 King Street, Caboolture</b>		<b>Inspector:</b>	<b>Paul Douglas</b>	PHOTO	Building	PHOTO	Building
<b>Test Date:</b>	2011	<b>18/02/26</b>	<b>Building Photo</b>	01

Lvl	Location	Location ID or Room designation	Component	Surface Treatment	Material Extent	Material unit	Form	ID status	State	Condition	Exposure Frequency	Likelihood of Disturbance	Advise	Action	Action Date	Photo No:	Sample No:	Comment
GF	Ceiling space	North offices	Linings	R	<.1	sqm	A/C products	PT	B	F	R	VL	X	R		1	NA	Remove at tenancy change
