## Report on Asbestos Containing Materials in the Workplace

**Address of Building:** 12 King Street,  
CABOOLTURE, QLD 4510

**Date of Inspection:** 04/09/2020

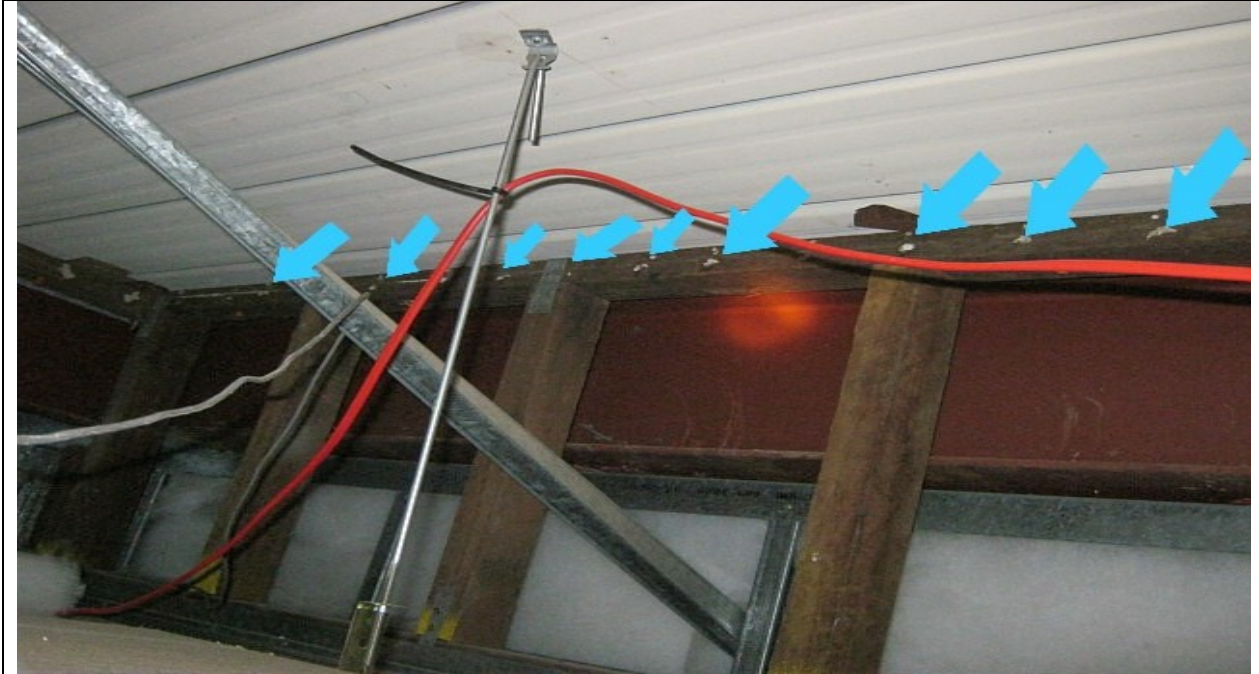
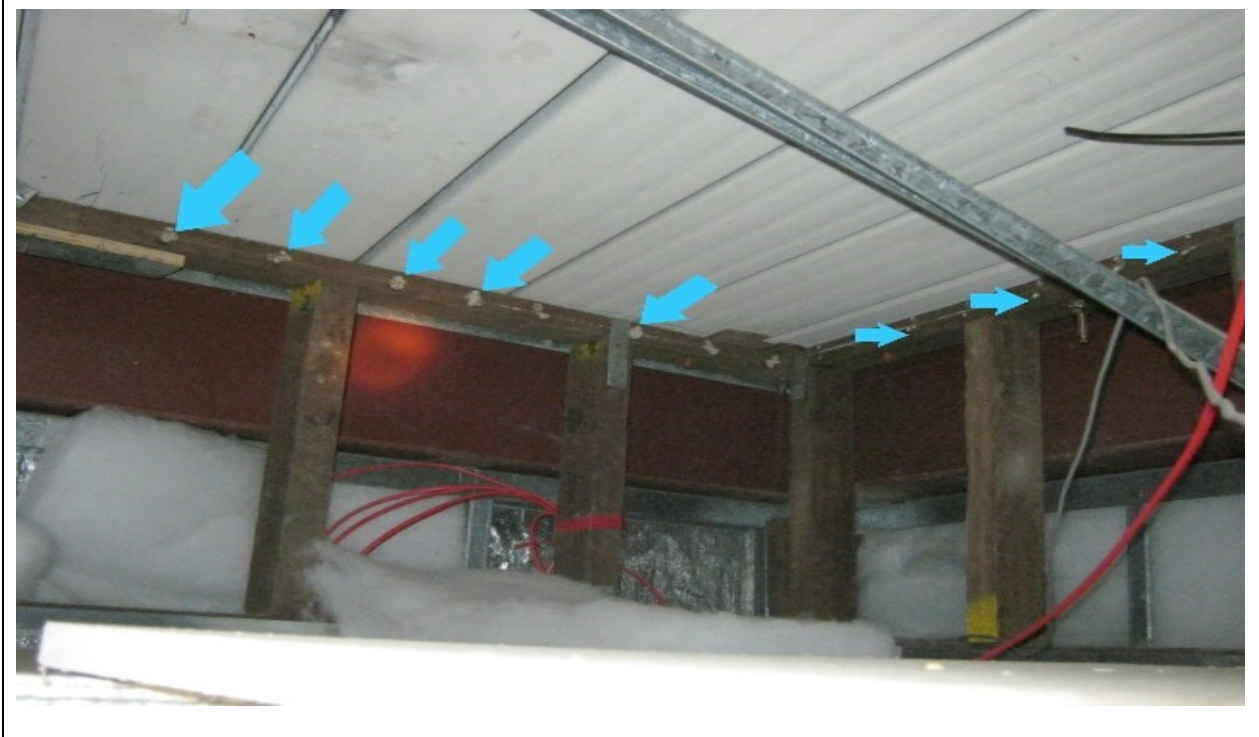
Lvl	Location	Location ID or Room designation	Component	Surface Treatment	Material Extent	Material unit	Form	ID status	State	Condition	Exposure Frequency	Likelihood of Disturbance	Advise	Action	Action Date	Photo No:	Sample No:	Comment
GF	Ceiling space	North offices	Linings	R	<.1	sm	A/C products	PT	B	F	R	VL	X	R		1	NA	Remove at tennancy change
