Report on Asbestos Containing Materials in the Workplace

Site name: 143 St Vincents Road, Virginia Qld 4014

Date of Inspection: 05/05/2022.

Executive Overview – Site:
4014

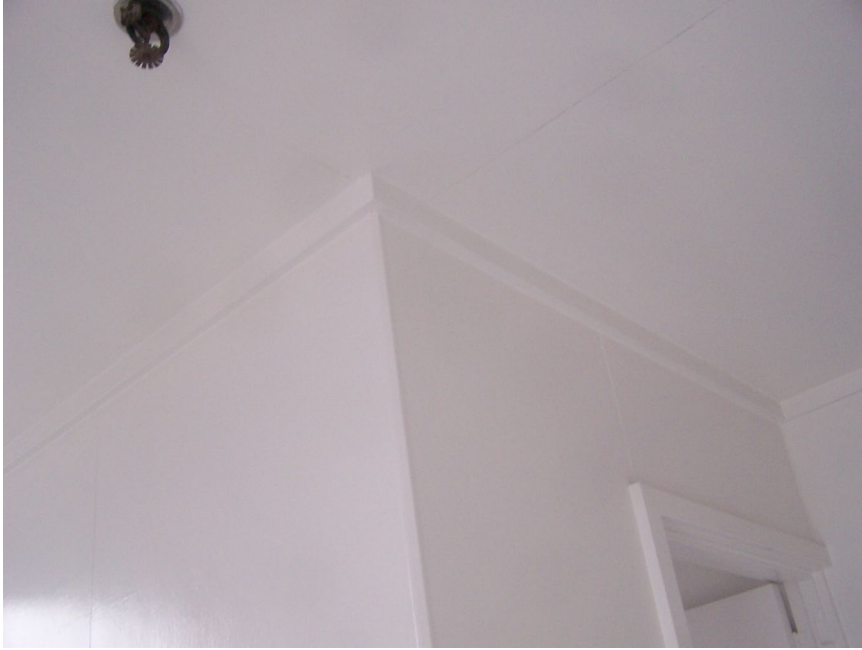
Photo No: 27

Toilets – Wall & Ceiling Lining

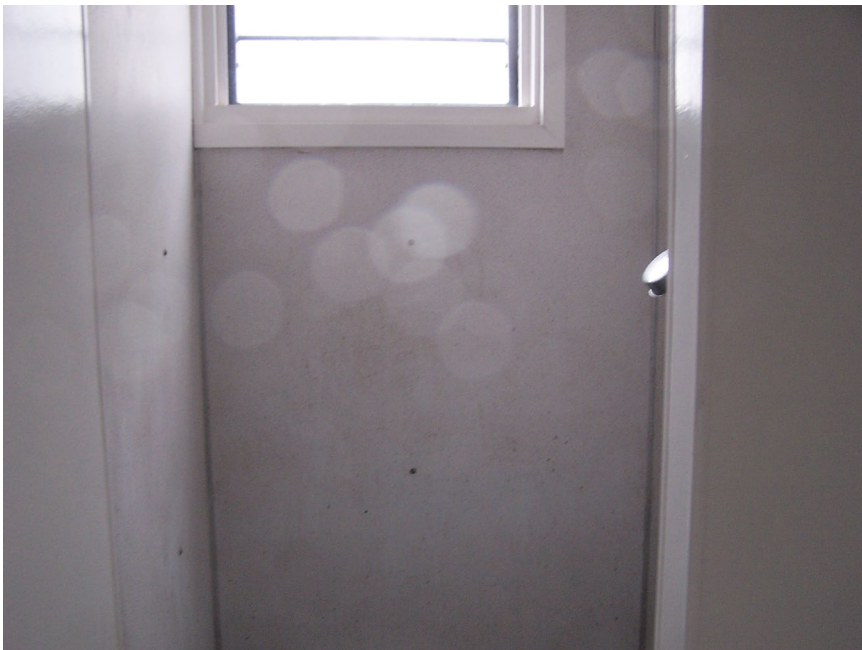
Photo No: 28

Toilets – Shower Recess

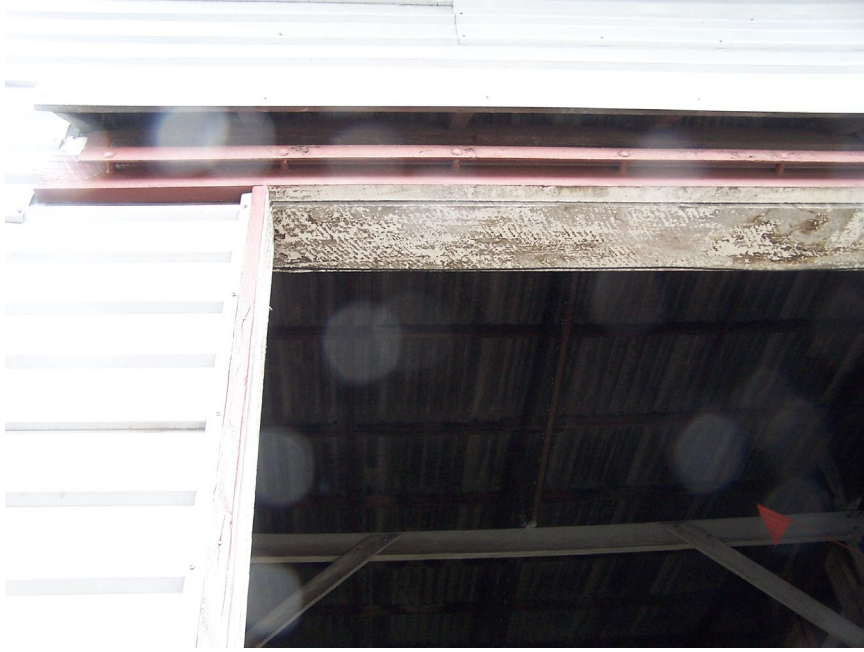
Photo No: 22

Asbestos Containing Materials Register											No Asbestos Detected		Areas with no Access				
Building Name: 143 St Vincents Rd, Virginia - Shed 1				Inspector: Paul Douglas													
Test Date: 06/05/22		Reinspect		05/05/27		Building Photo											
Lvl	Location	Component	Surface Treatment	Material Extent	Material Unit	Form	Type	State	Condition	Activity Frequency	Likelihood of Disturbance	Advise	Action	Action Date	Photo No:	Sample No:	Comment
	Toilets	Wall & Ceiling Lining	P	48	SM	A/C Sheet	P	B	G	R	R	X			27		
	Toilets	Shower Recess	P	6	sm	Tilux	P	B	G	R	R	X			28		
	Roof	Roofing	RS	600	sm	Super Six	P	B	F	R	R	X	E	ASAP	22		Recommend replace

Roof – Roofing

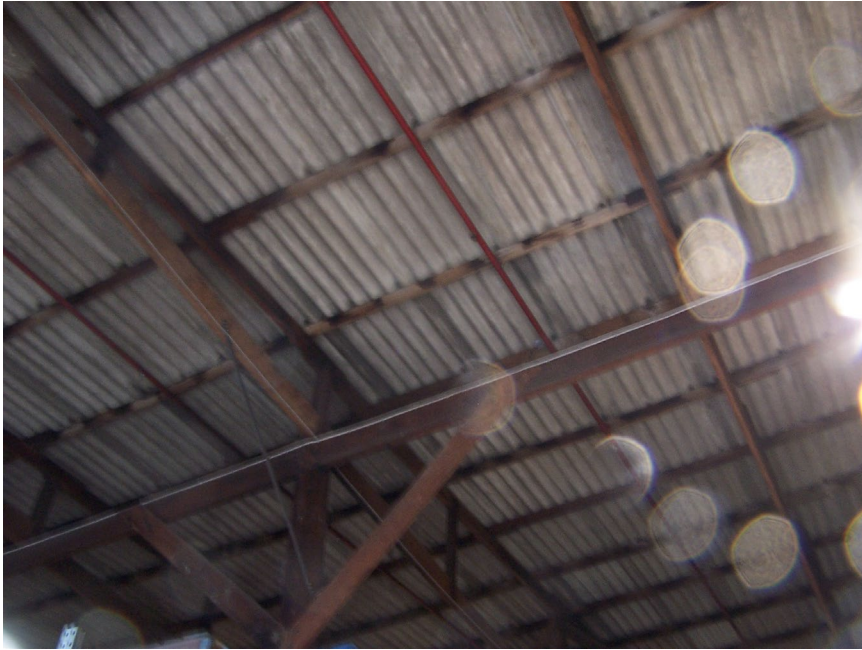
Photo No: 30

Roof – Roofing

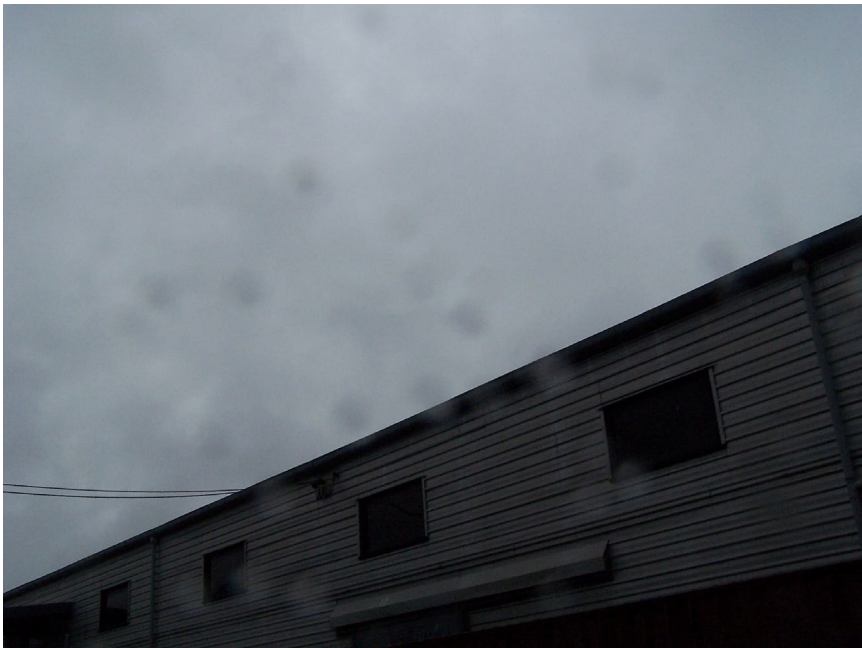
Photo No: 29

Roof – Gutter

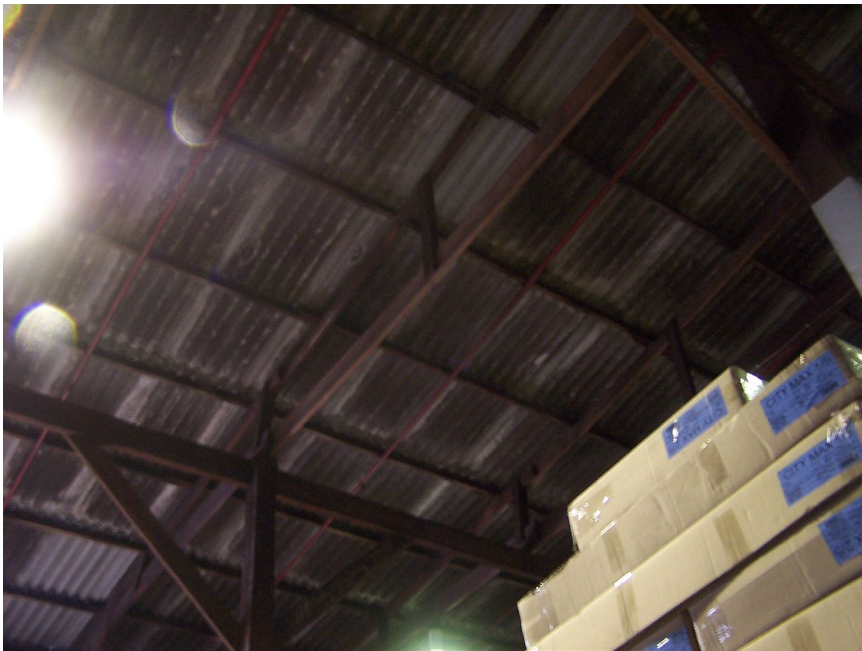
Photo No: 34

Roof – Roofing

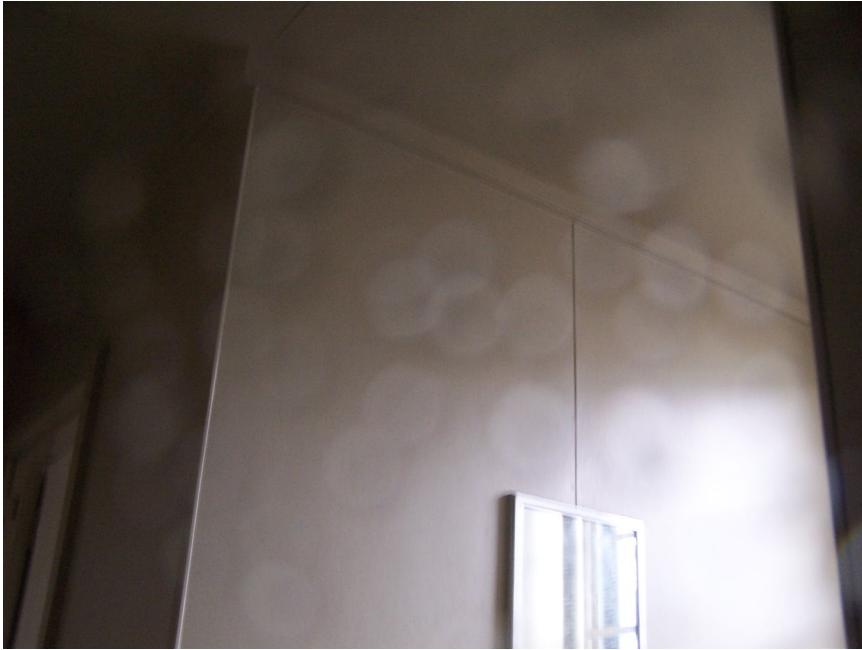
Photo No: 36

Toilets – Wall & Ceiling Lining

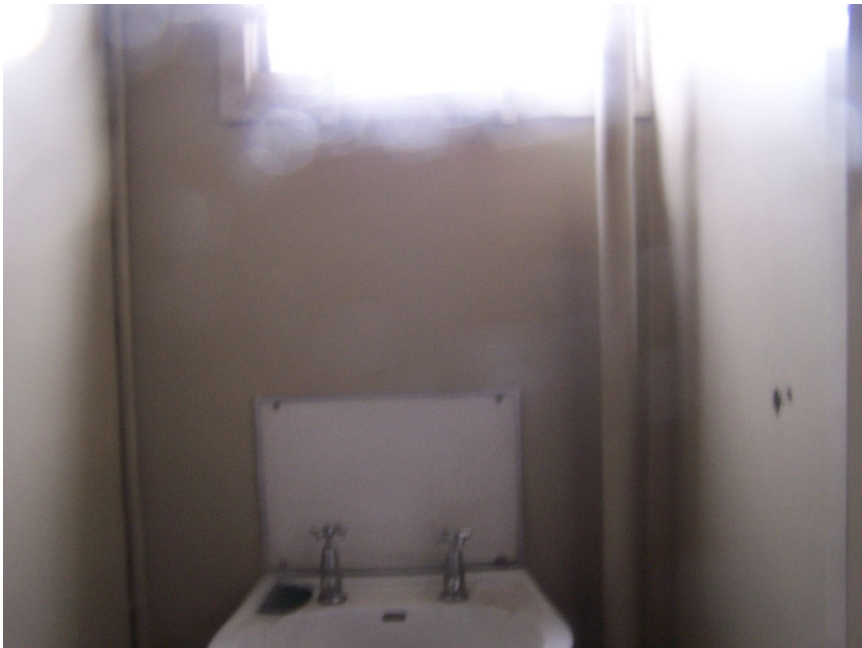
Photo No: 38

Toilets – Basic Splashback

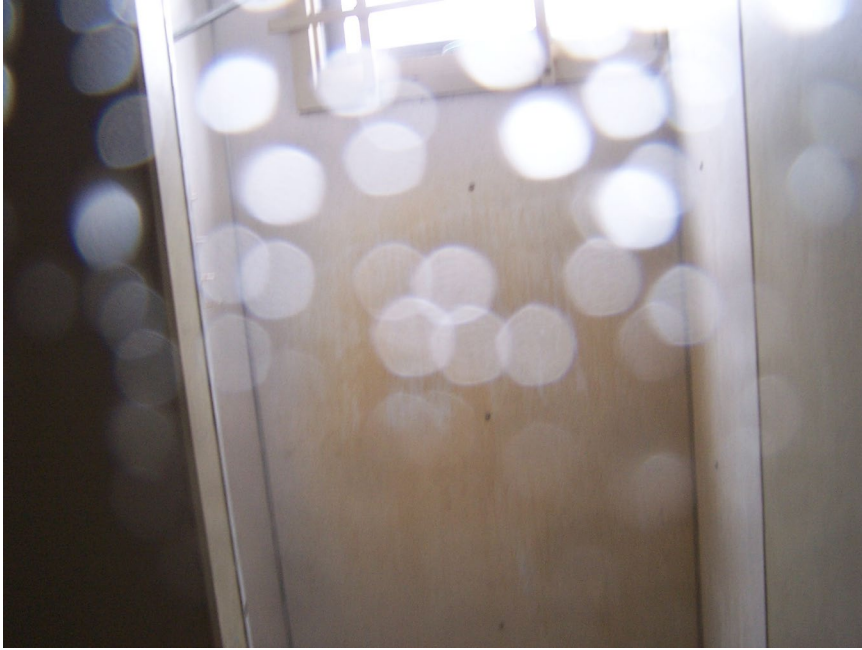
Photo No: 37

Toilets – Shower Lining

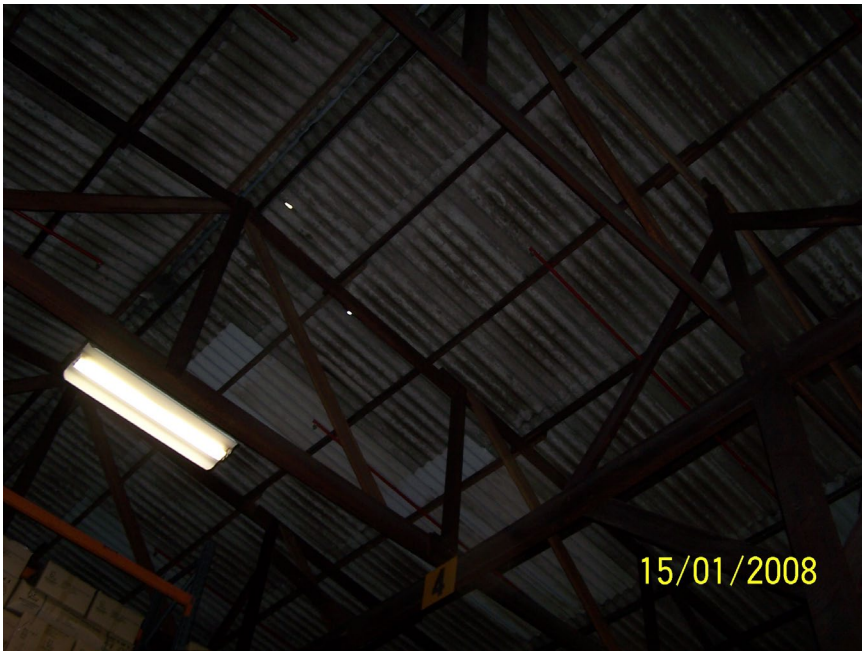
Photo No: 187

Roof – Roofing

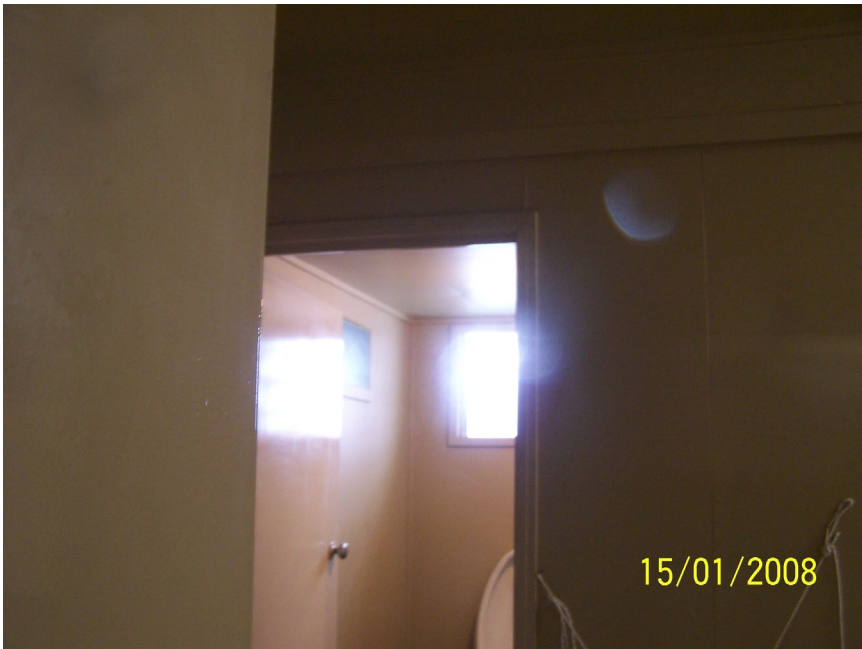
Photo No: 39

Asbestos Containing Materials Register											No Asbestos Detected		Areas with no Access				
Building Name: 143 St Vincents Rd, Virginia - Shed 4				Inspector: Paul Douglas													
Test Date: 06/05/22		Reinspect 05/05/27		Building Photo													
Lvl	Location	Component	Surface Treatment	Material Extent	Material Unit	Form	Type	State	Condition	Activity Frequency	Likelihood of Disturbance	Advise	Action	Action Date	Photo No:	Sample No:	Comment
	Roof	Roofing	RS	600		Super Six	P	B	F	R	R	X	E	24	187		Consider reroof
	Toilets Gents	Wall & Ceiling Lining	P	48		A/C Sheet	P	B	F	R	R	X			39

Toilets Gents – Walls & Ceiling Lining

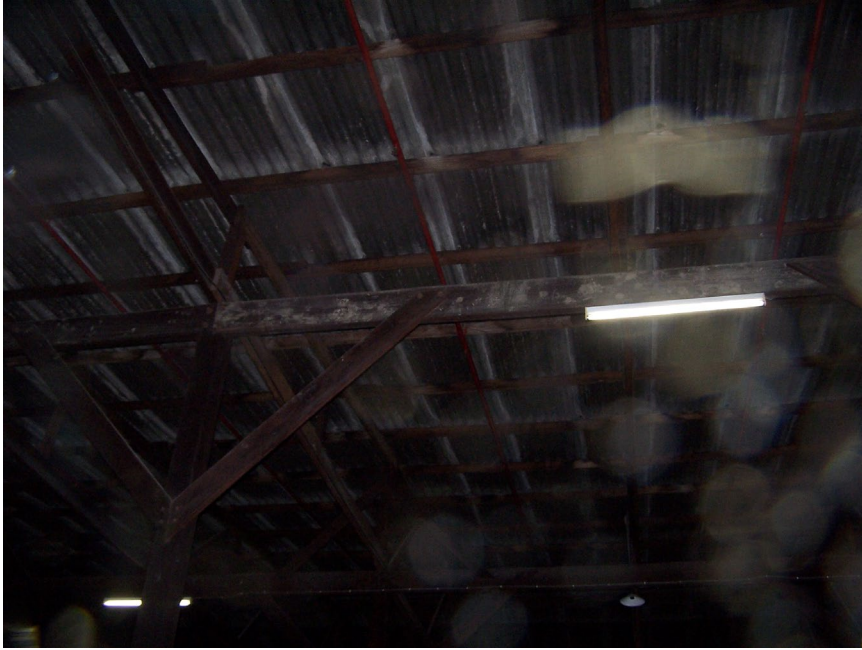
Photo No: 43

Roof – Roofing

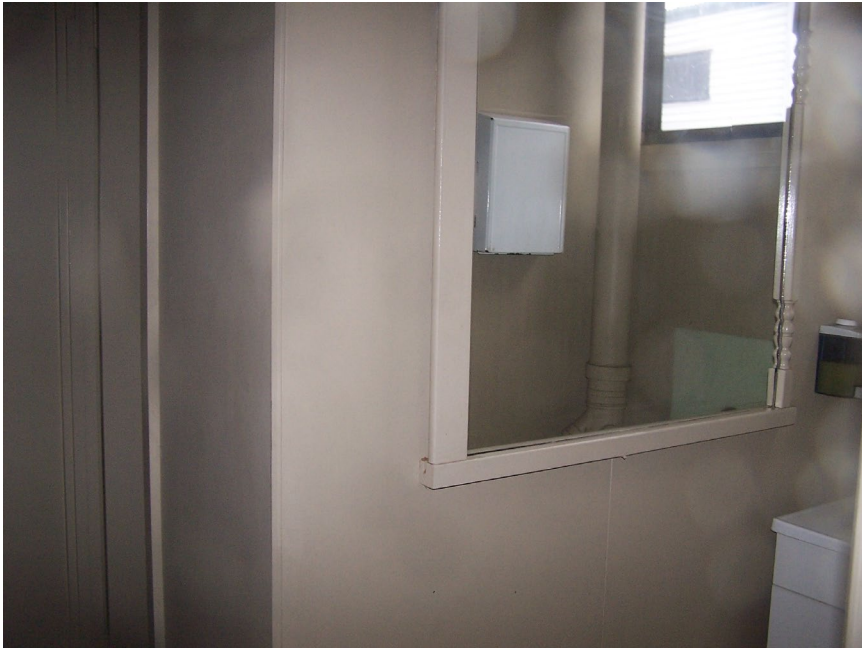
Photo No: 39

Toilets – Walls & Ceiling Lining

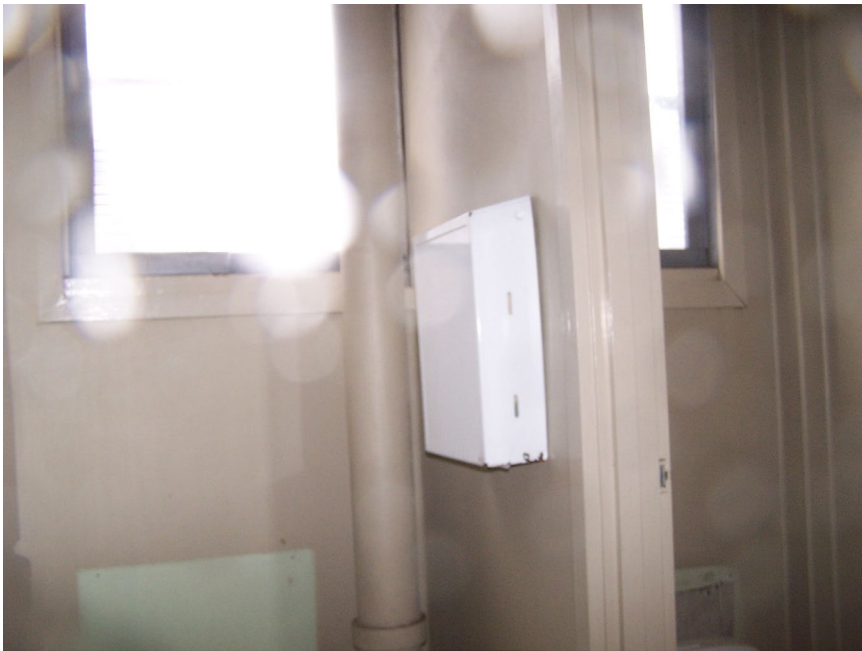
Photo No: 40

Toilets – Vent Stack

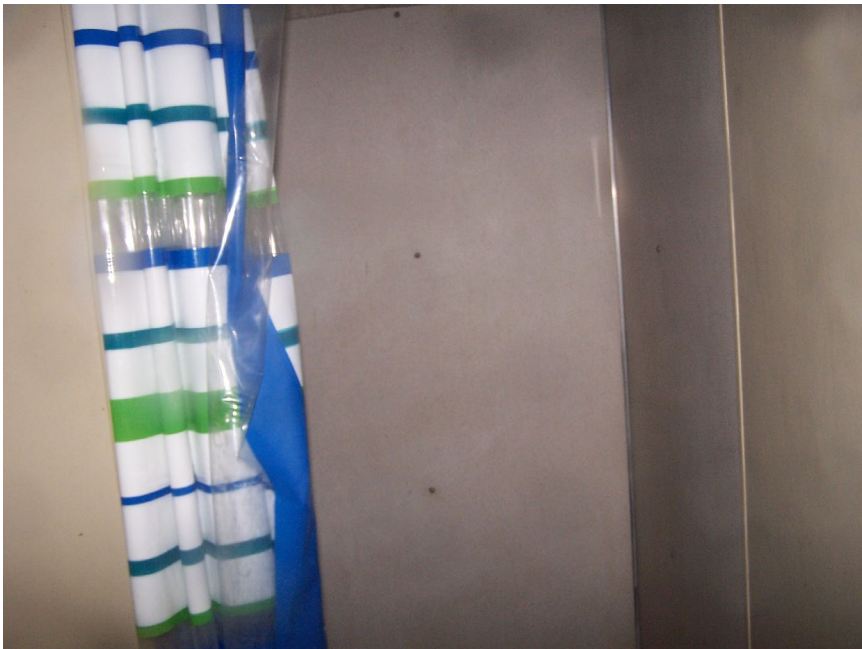
Photo No: 41

Toilets – Shower Recess

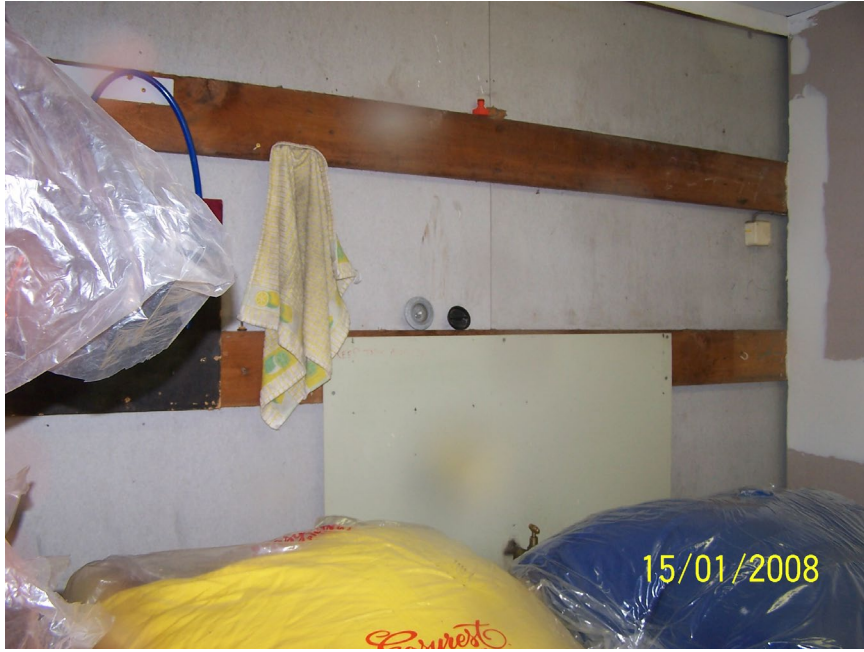
Photo No: 196

Store Room – Wall Lining

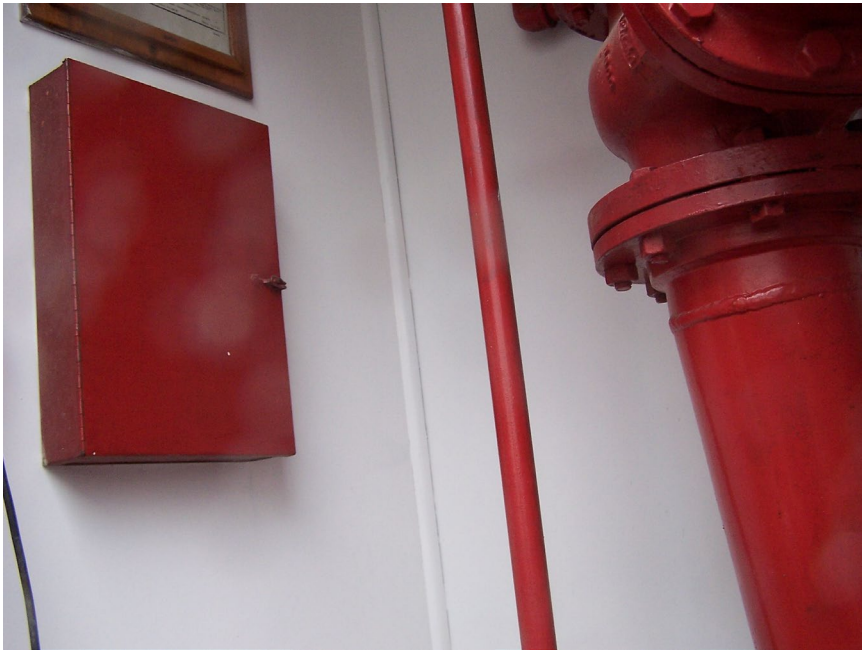
Photo No: 44

Fire Booster Cabinet – Lining

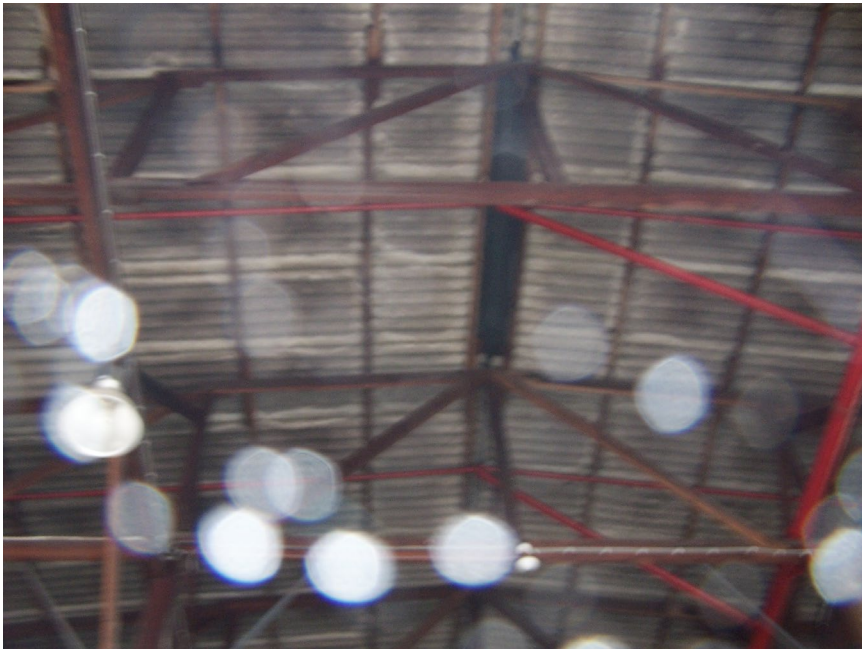
Photo No: 45

Roof – Roofing

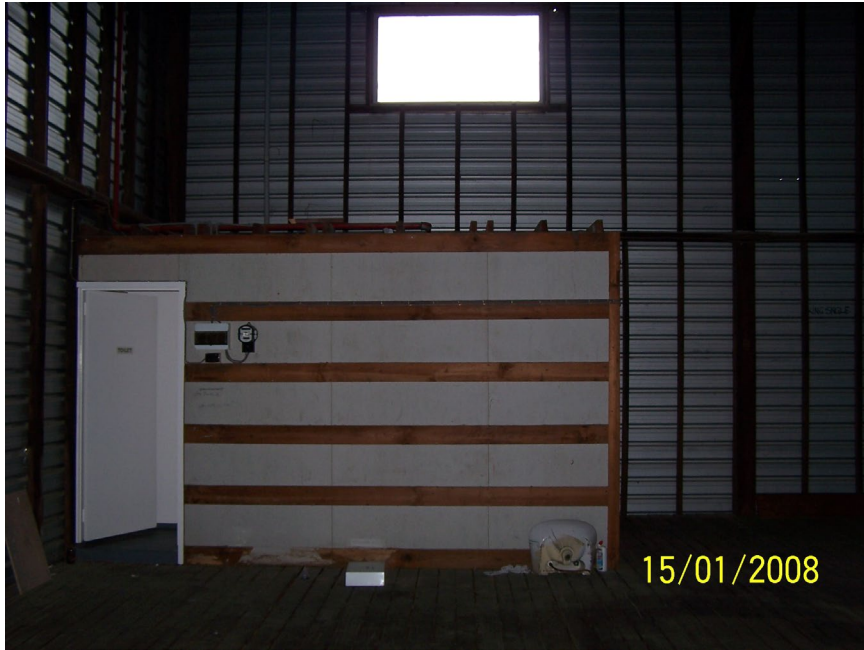
Photo No: 200

Toilets – Cladding

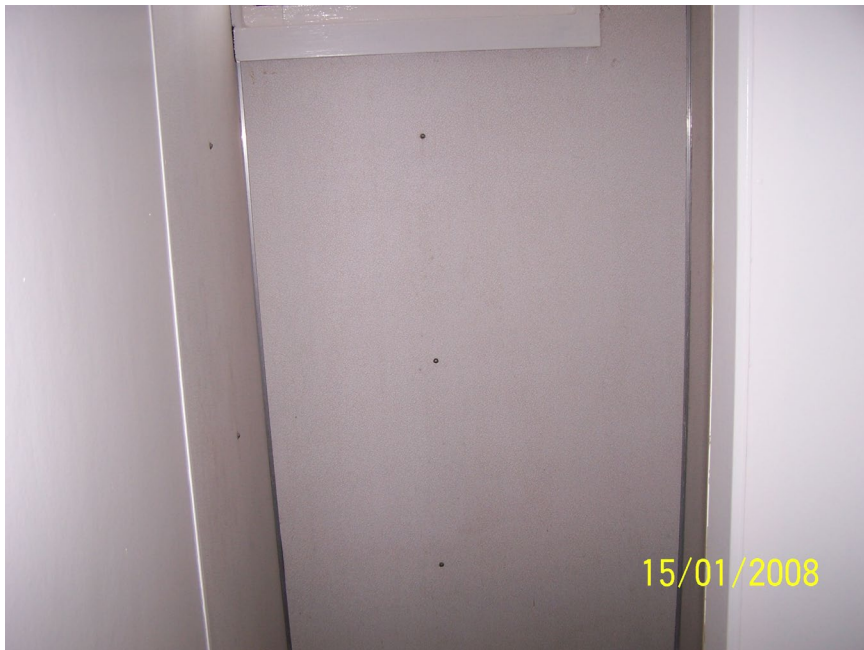
Photo No: 201

Toilets – Shower Recess

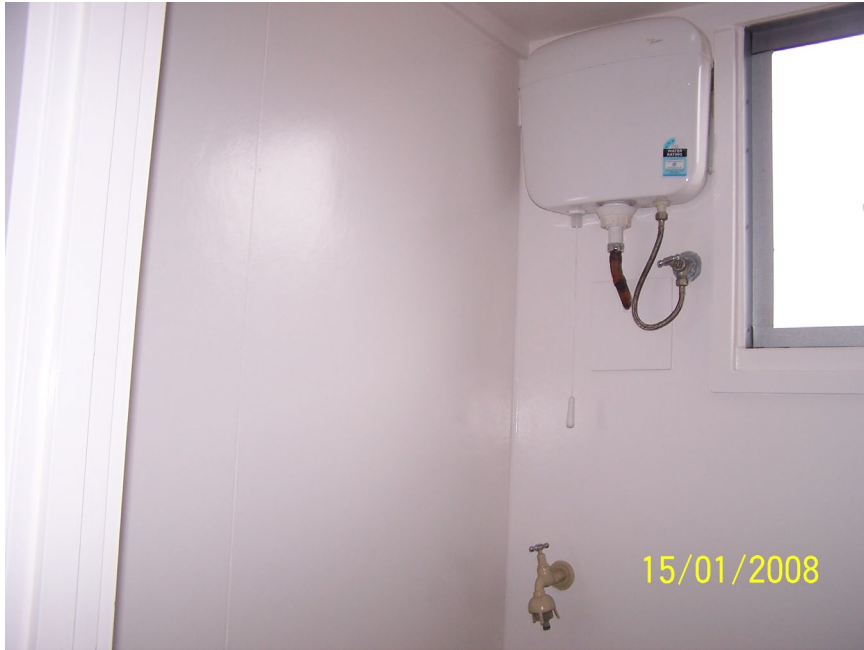
Photo No: 202

Toilets – Wall & Ceiling Lining

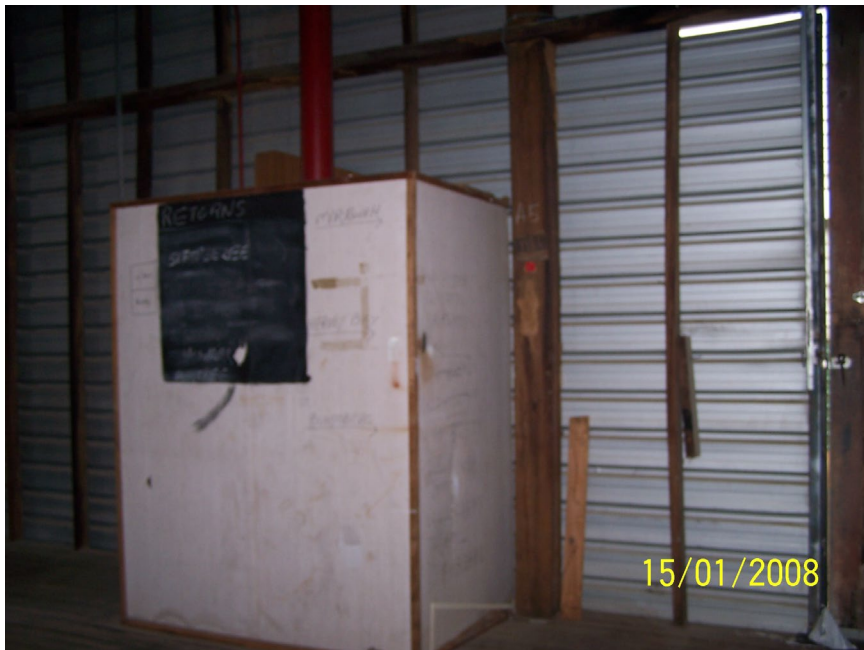
Photo No: 203

Asbestos Containing Materials Register											No Asbestos Detected			Areas with no Access			
Building Name: 143 St Vincents Rd, Virginia - Shed 6				Inspector: Paul Douglas													
Test Date: 06/05/22		Reinspect 05/05/27		Building Photo													
Lvl	Location	Component	Surface Treatment	Material Extent	Material Unit	Form	Type	State	Condition	Activity Frequency	Likelihood of Disturbance	Advise	Action	Action Date	Photo No:	Sample No:	Comment
	Fire Booster Cabinet	Lining	P	8		A/C Sheet	P	B	F	R	R	X			44		
	Roof	Roofing	RS	600		Super Six	P	B	F	R	R	X	E	24	45		Consider reroof
	Toilets	Cladding	P	24		A/C Sheet	P	B	F	R	R	X			200		
	Toilets	Shower Recess Walls & Ceiling	P	6		Tilux	P	B	G	R	R	X			201		
	Toilets	Lining	P	48		A/C Sheet	P	B	G	R	R	X			202		
	Fire Booster Cabinet	Cladding	P	8		A/C Sheet	P	B	F	R	R	X			203

Fire Booster Cabinet – Cladding

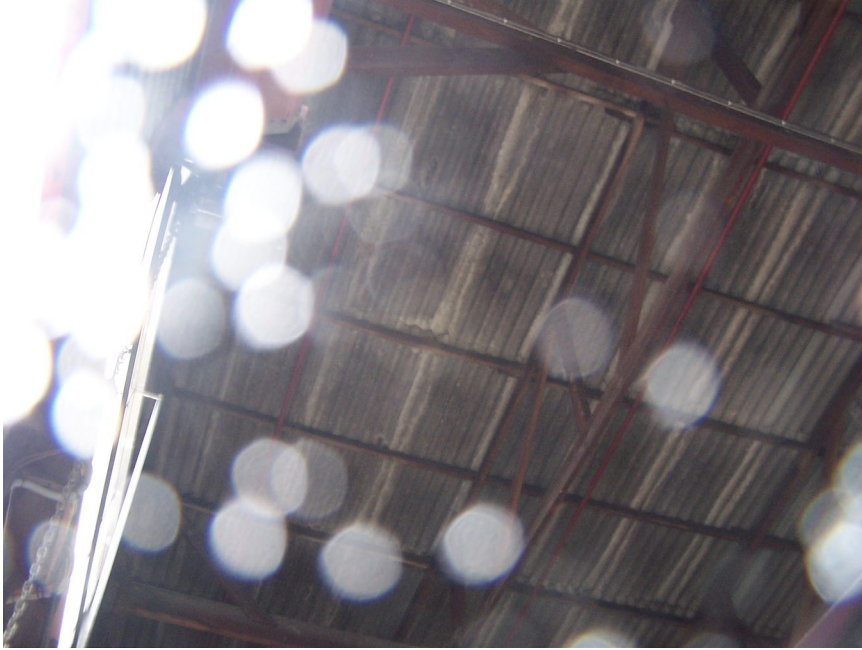
Photo No: 46

Roof – Roofing

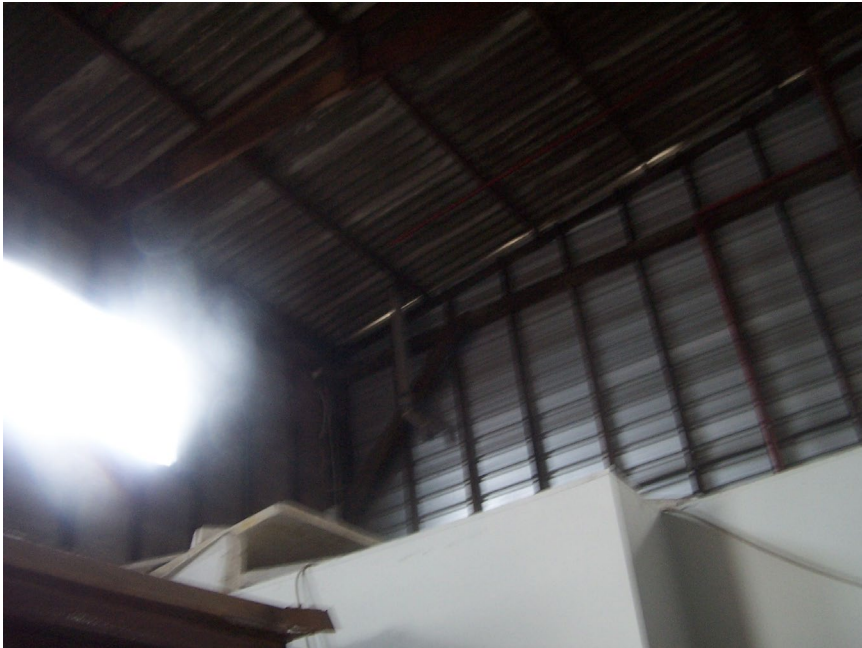
Photo No: 48

Above Toilets – Vent Stack

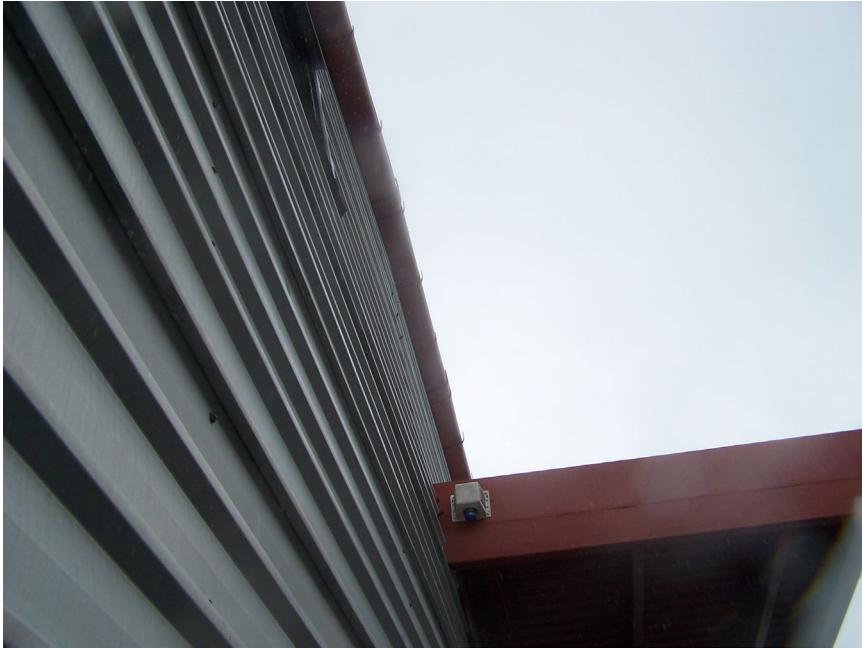
Photo No: 49

Roof – Gutter

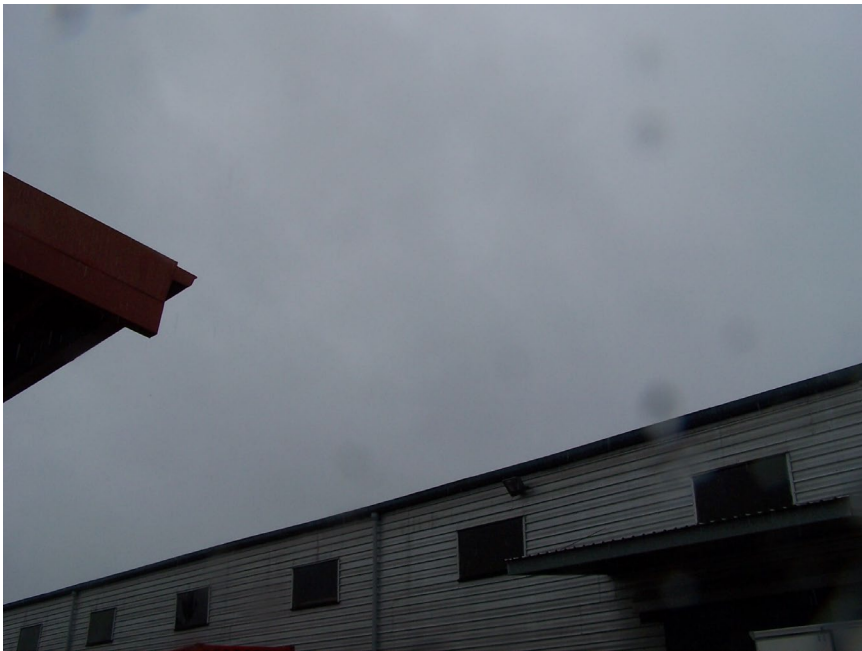
Photo No: 50

Roof - Gutter

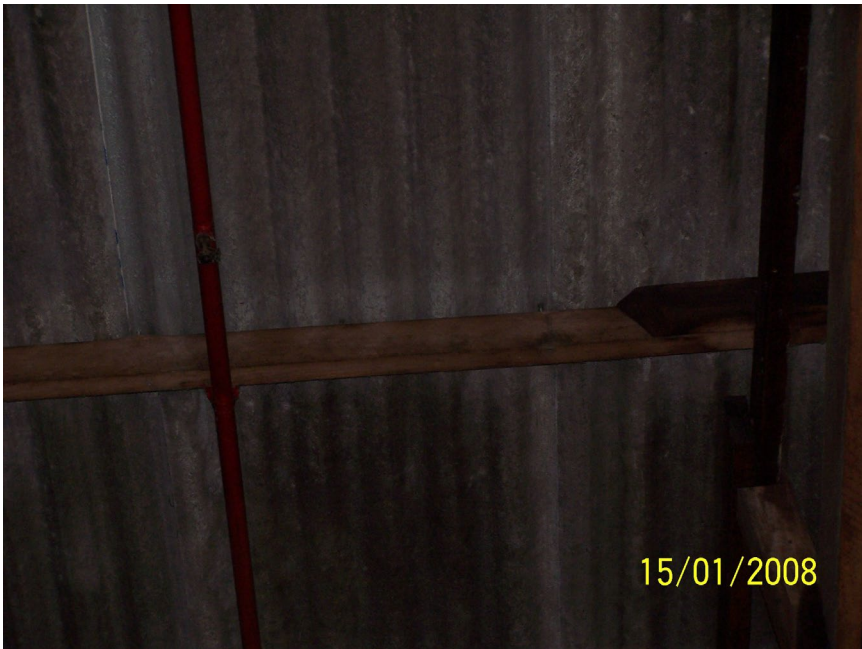
Photo No: 209

Roof - Roofing

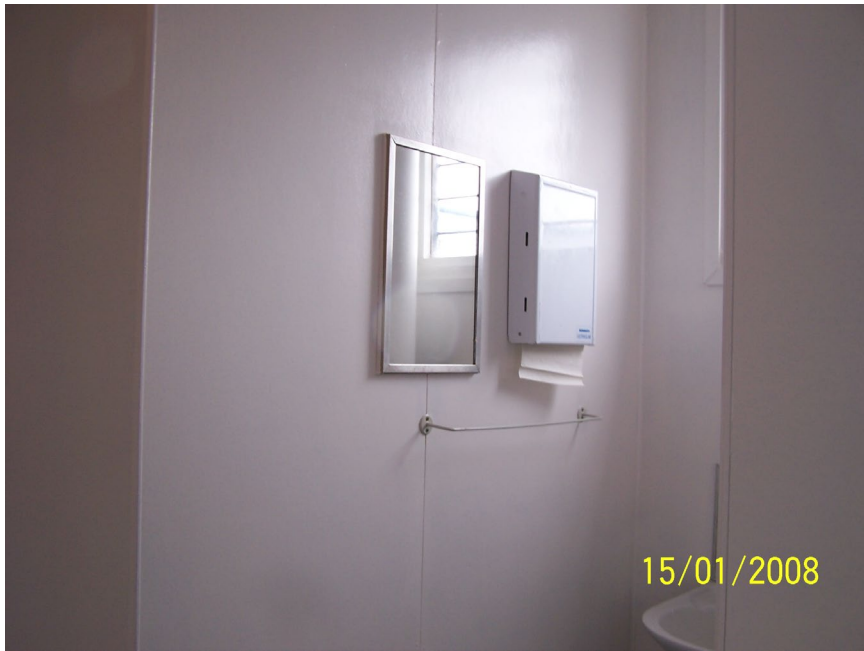
Photo No: 211

Toilets – Wall Lining

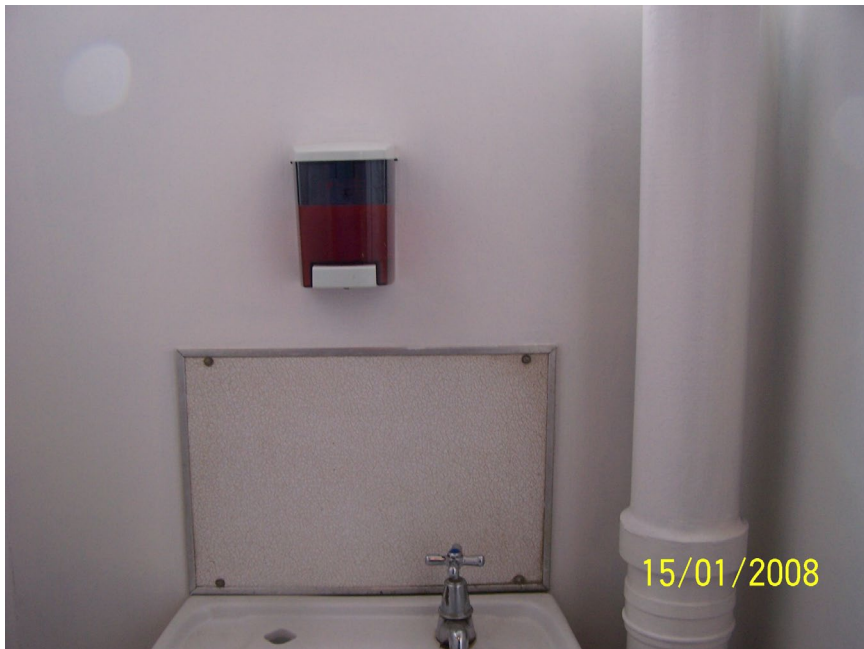
Photo No: 212

Toilets – Splash Back

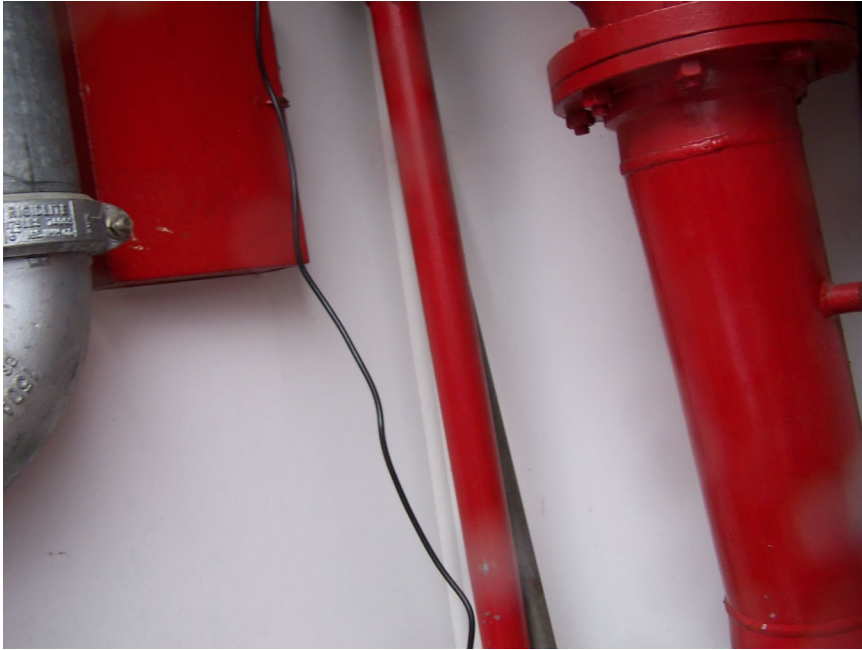
Photo No: 52

Asbestos Containing Materials Register											No Asbestos Detected		Areas with no Access				
Building Name: 143 St Vincents Rd, Virginia - Shed 8				Inspector: Paul Douglas													
Test Date: 06/05/22		Reinspect 05/05/27		Building Photo													
Lvl	Location	Component	Surface Treatment	Material Extent	Material Unit	Form	Type	State	Condition	Activity Frequency	Likelihood of Disturbance	Advise	Action	Action Date	Photo No:	Sample No:	Comment
	Roof	Gutter	P	60		Formed A/C Sheet	P	B	G	R	R	X			50		
	Roof	Roofing	RS	600		Super Six	P	B	G	R	R	X			209		
	Toilets	Wall Lining	P	33		A/C Sheet	P	B	G	R	R	X			211		
	Toilets	Vent Stack	P	1		A/C Pipe	P	B	G	R	R	X			213		
	Toilets	Shower Recess Lining SPLASH	P	6		Tilux	P	B	G	R	R	X			212		
	Fire Hydrant Cabinet	Lining	P	8		A/C Sheet	P	B	P	R	L	X			52

FIRE HYDRANT

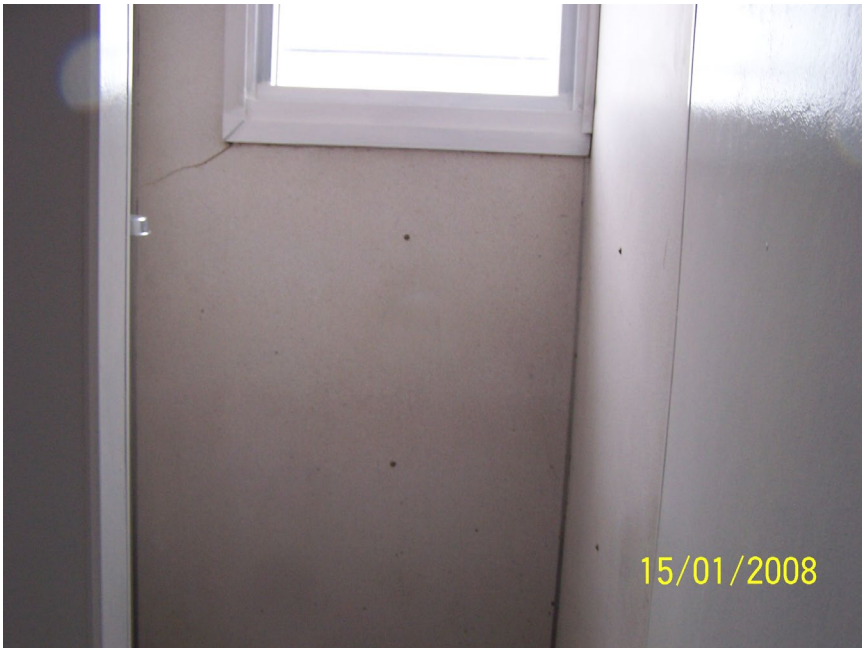
Photo No: 213

Toilets -VENT STACK
