Asbestos Containing Materials Report

42 Cleveland Street

Greenslopes Qld 4120

1st December 2014

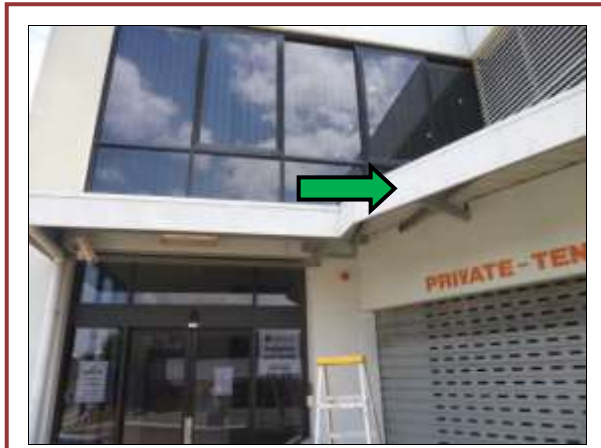
Photo #1

External

Front of building including main entrance

Fascia and bulkhead panels

Fibre cement

No asbestos detected

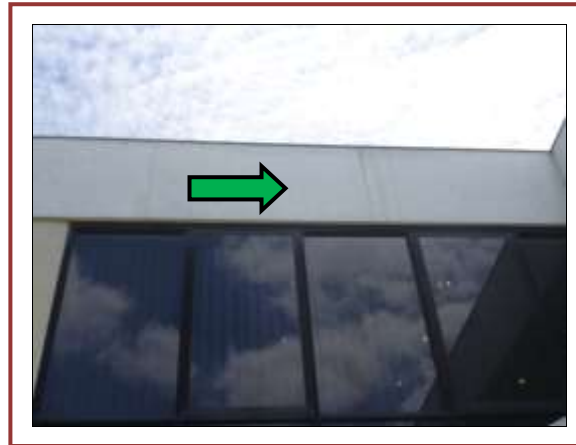
Photo #2

External

Front of building including main entrance

Fascia and bulkhead panels

Fibre cement

No asbestos detected

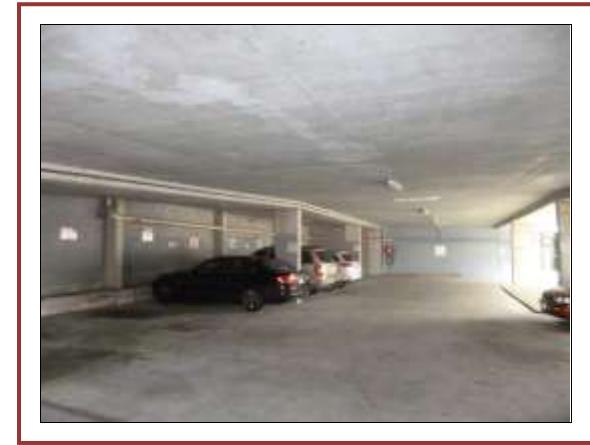
Photo #3

Internal

Basement car park
No asbestos identified

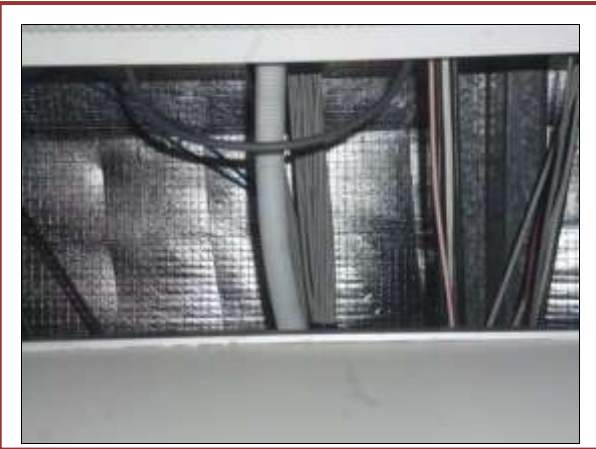
Photo #4
Internal
Ceiling voids
No asbestos identified

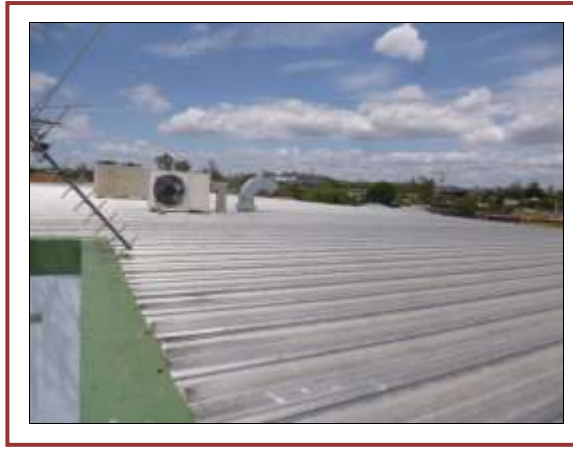
Photo #5
External
Roof area
No asbestos identified
