RE: Asbestos Report for 8-22 King Street, Caboolture Qld 4510

Report on Asbestos Containing Materials in the Workplace

Site name: Lakes Centre

Date of Inspection: 09/05/2022.

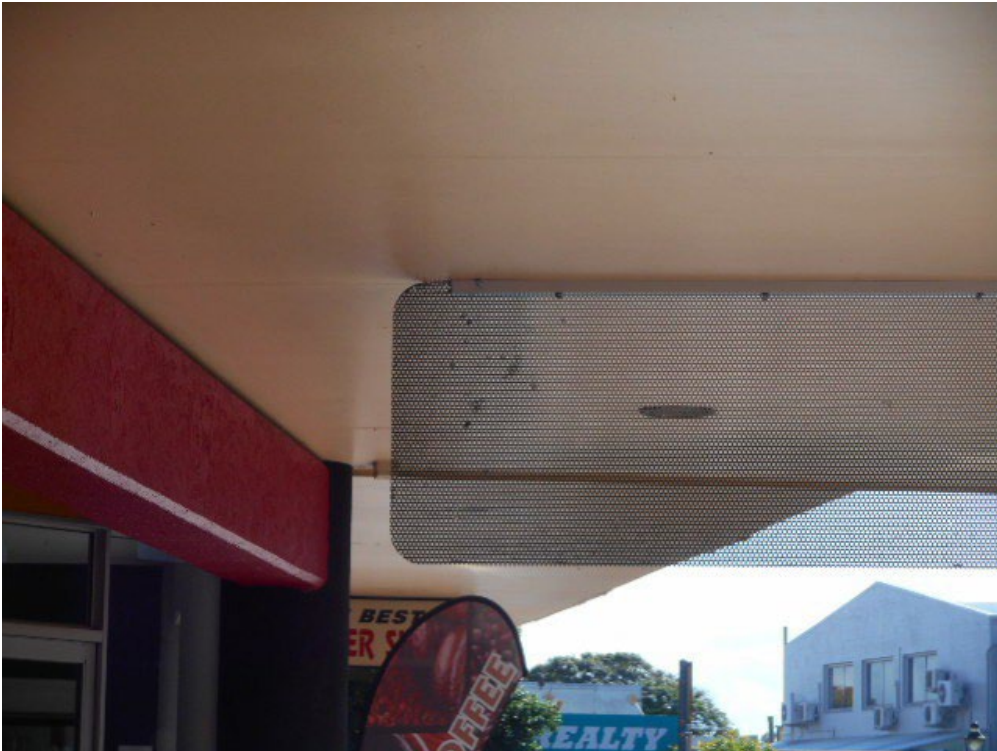
Photo 3384 - G - Soffit - Lining

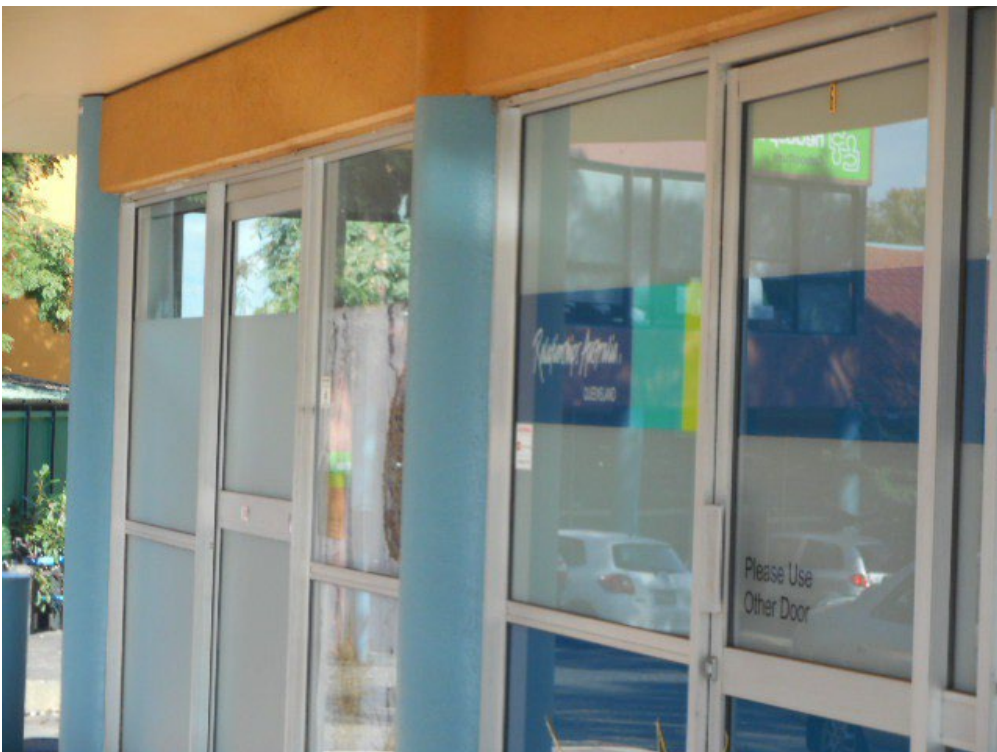
Photo 3385 - G - Exterior - Support Columns

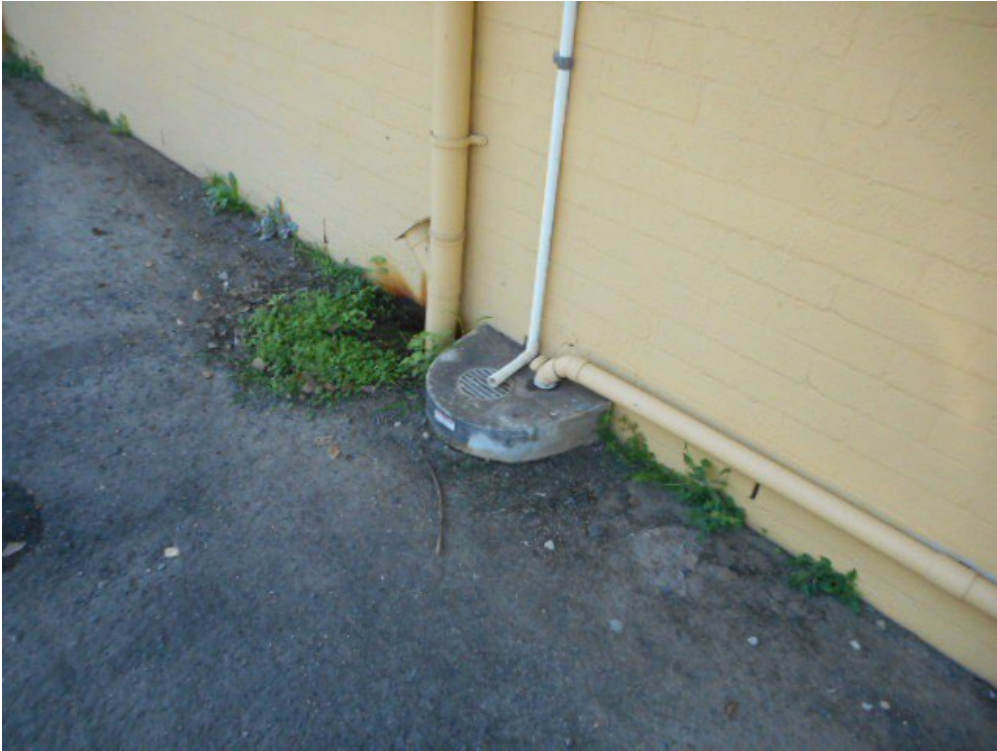
Photo 3387 - G - Exterior - ORG Surrounds

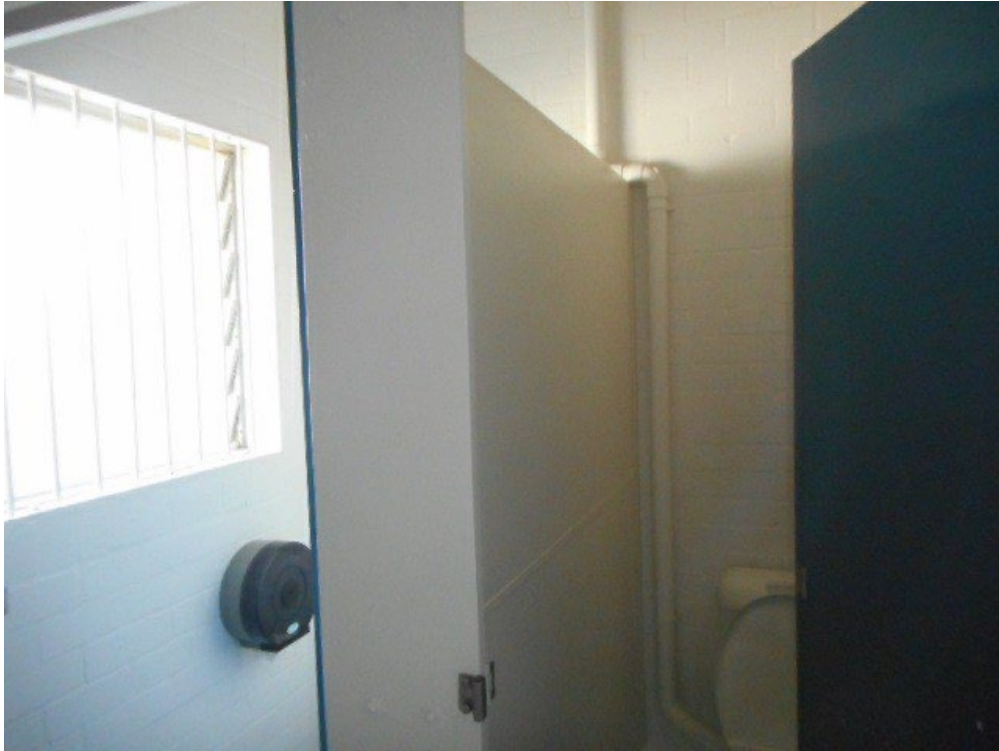
Photo 3389 - G - Toilets – Partitions

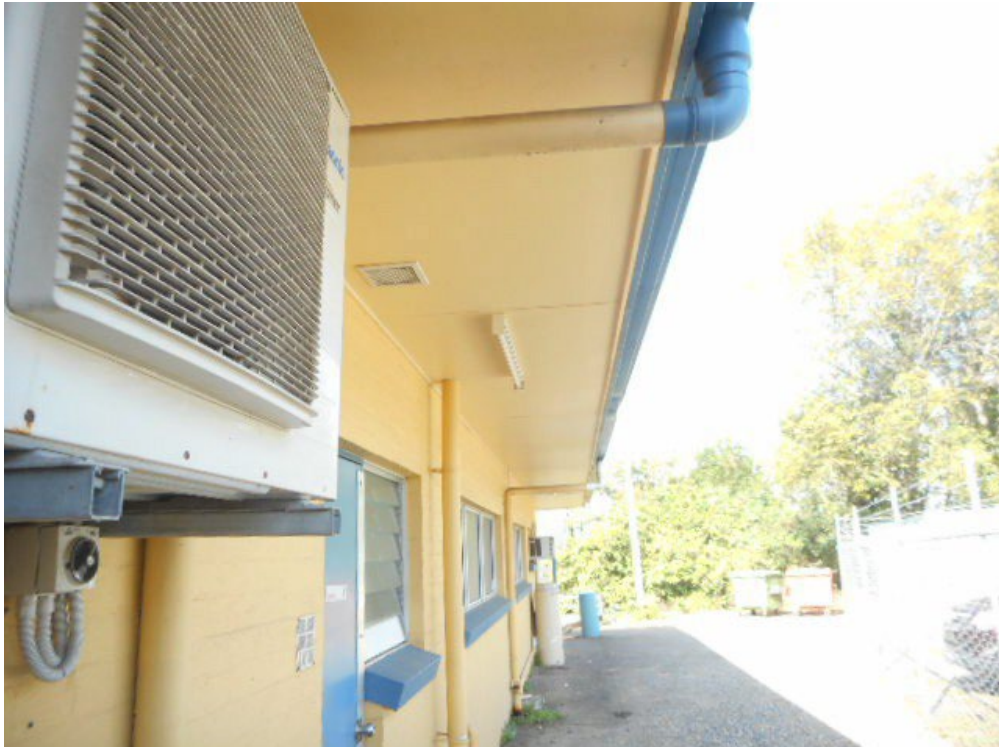
Photo 3390 - G - Rear Soffit - Lining

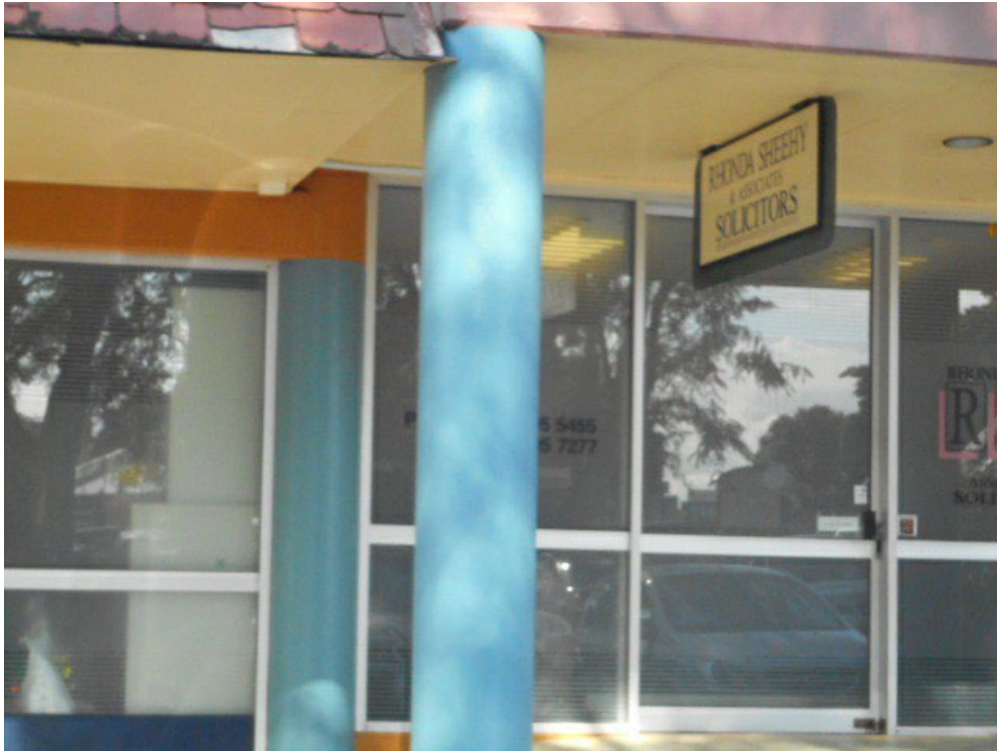
Photo 3378 - G - Exterior - Columns

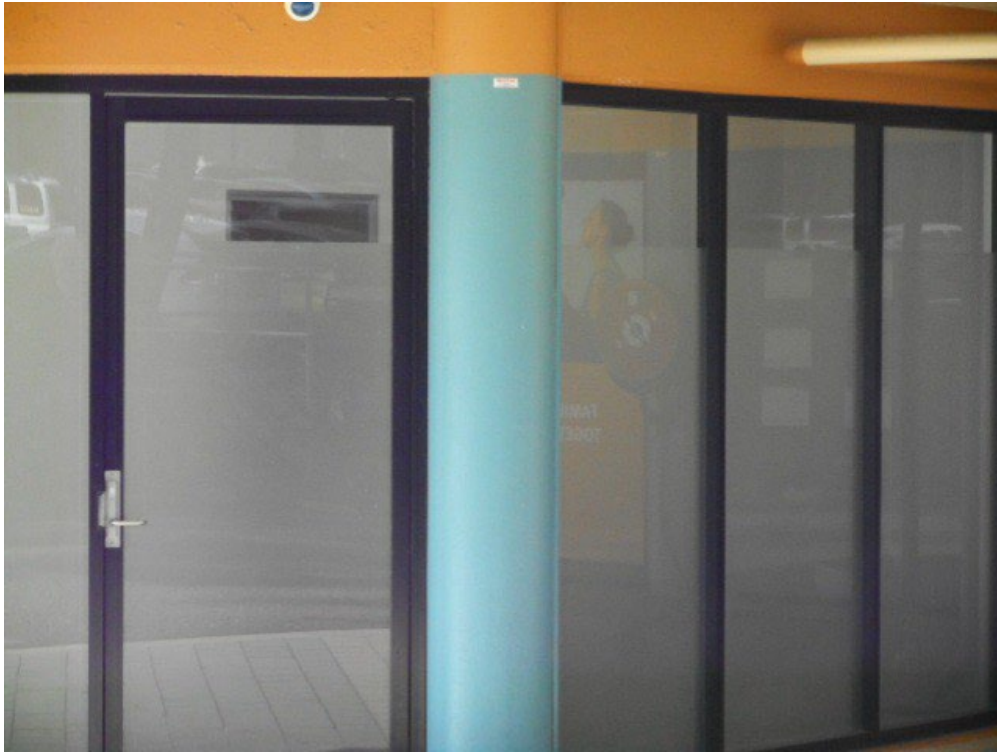
Photo 3373 - G - Exterior – Columns

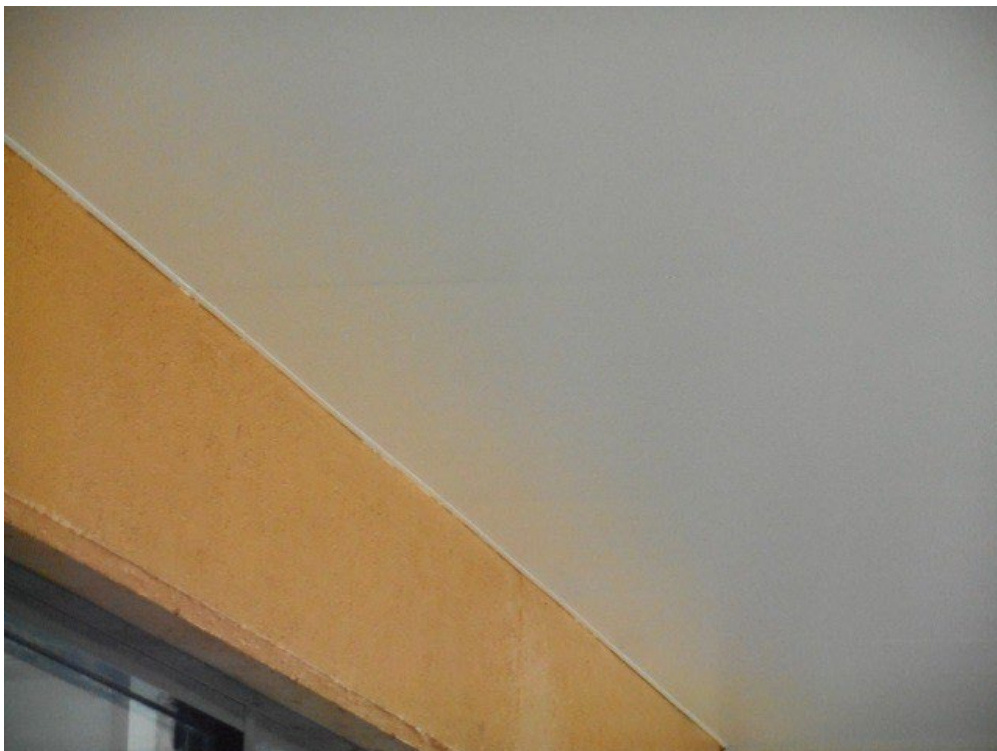
Photo 3375 - G - Soffit - Lining

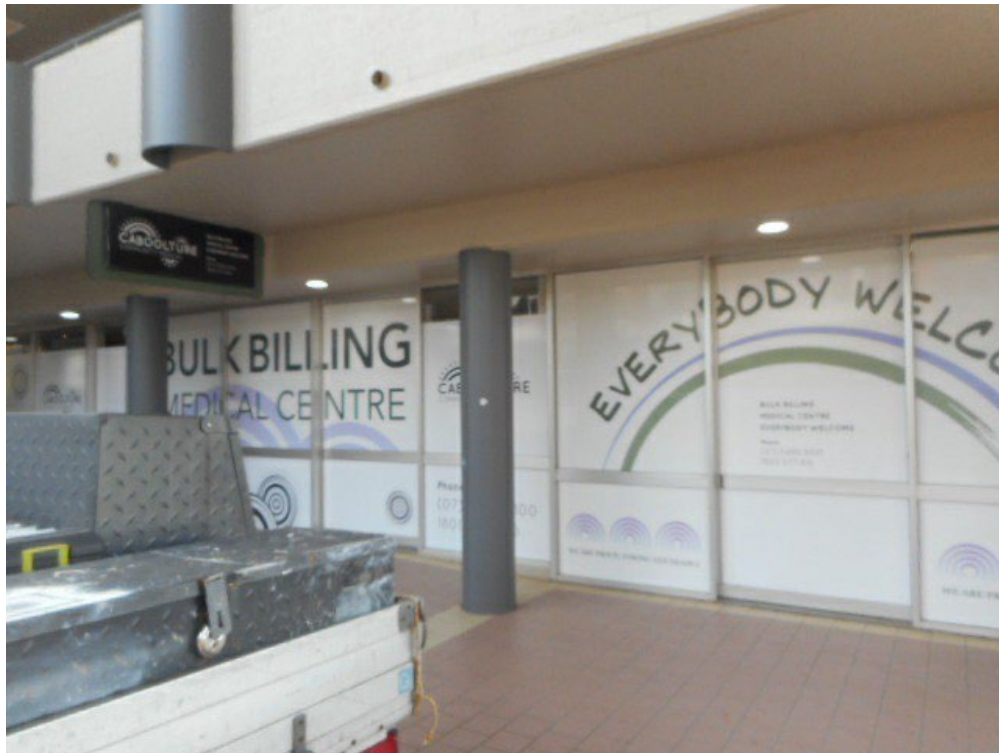
Photo 3361 - G - Exterior - Columns

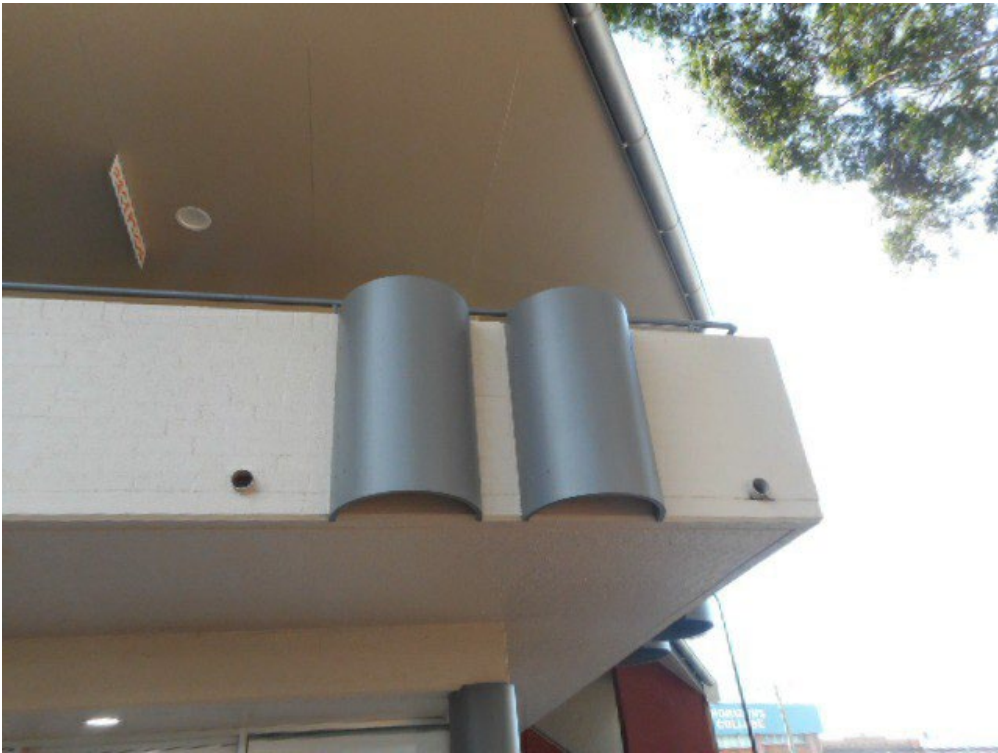
Photo 3362 - 1 - Planter Beds - Surrounds

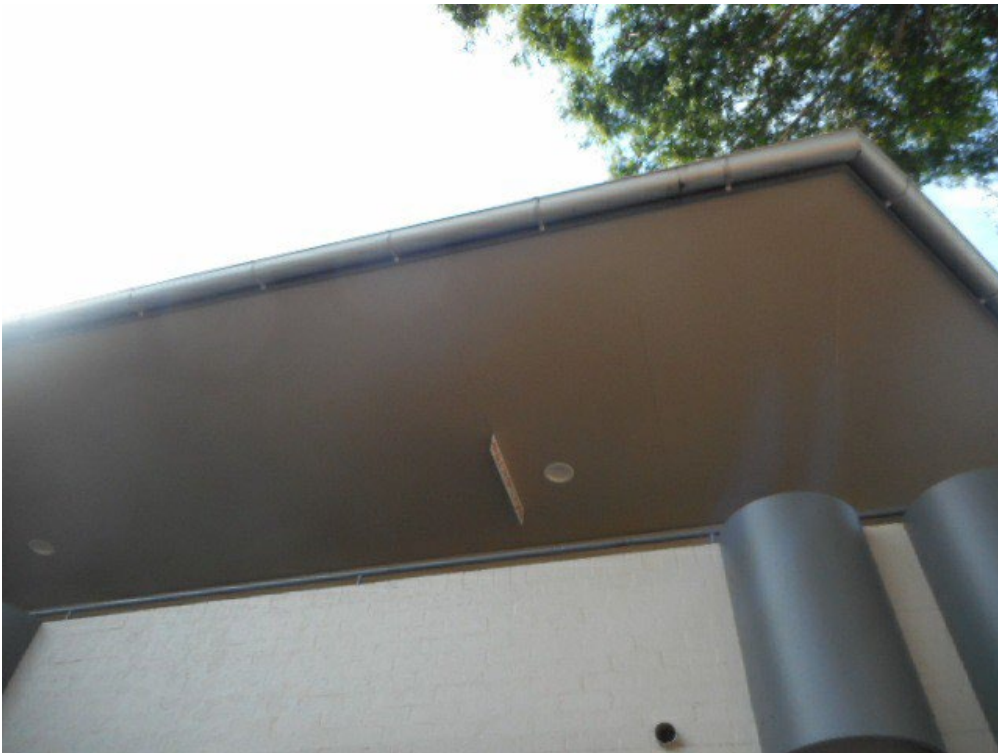
Photo 3363 - 1 - Soffit - Lining

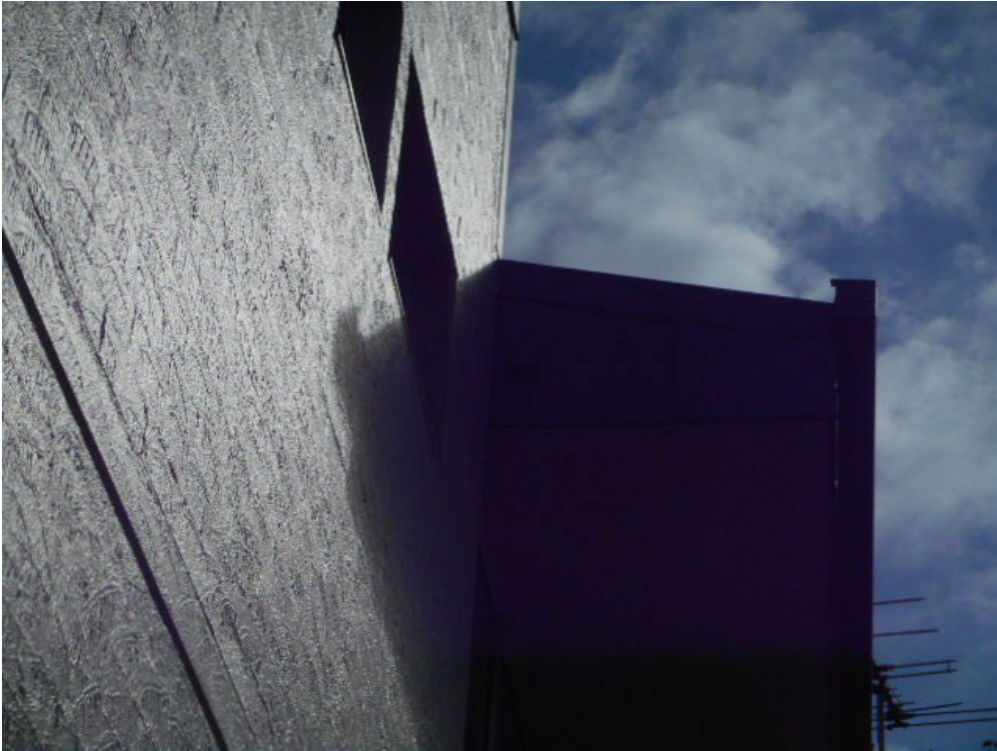
Photo 3364 - R - Roof - Gables

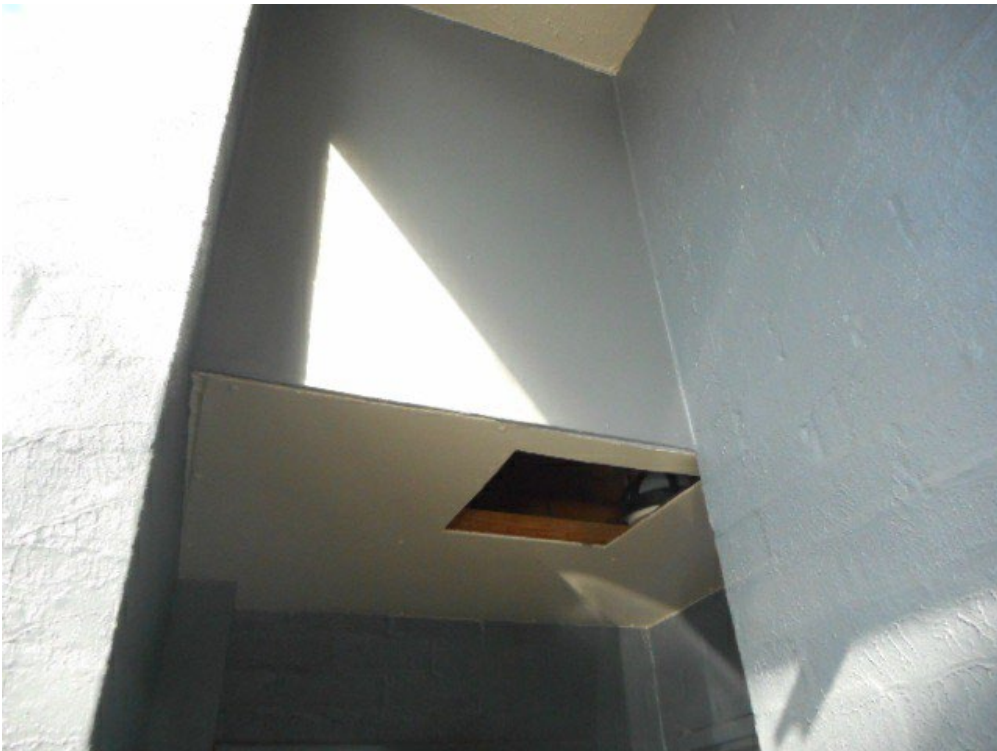
Photo 3365 - G - Toilets - Soffit Lining

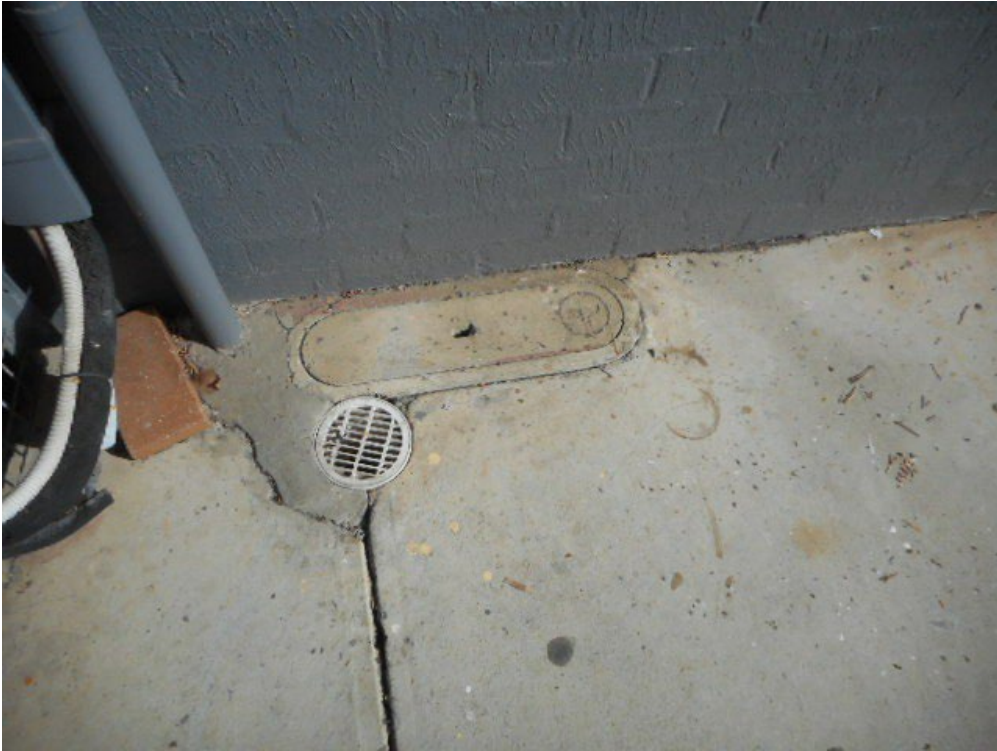
Photo 3366 - G - Telstra - Pit Surrounds

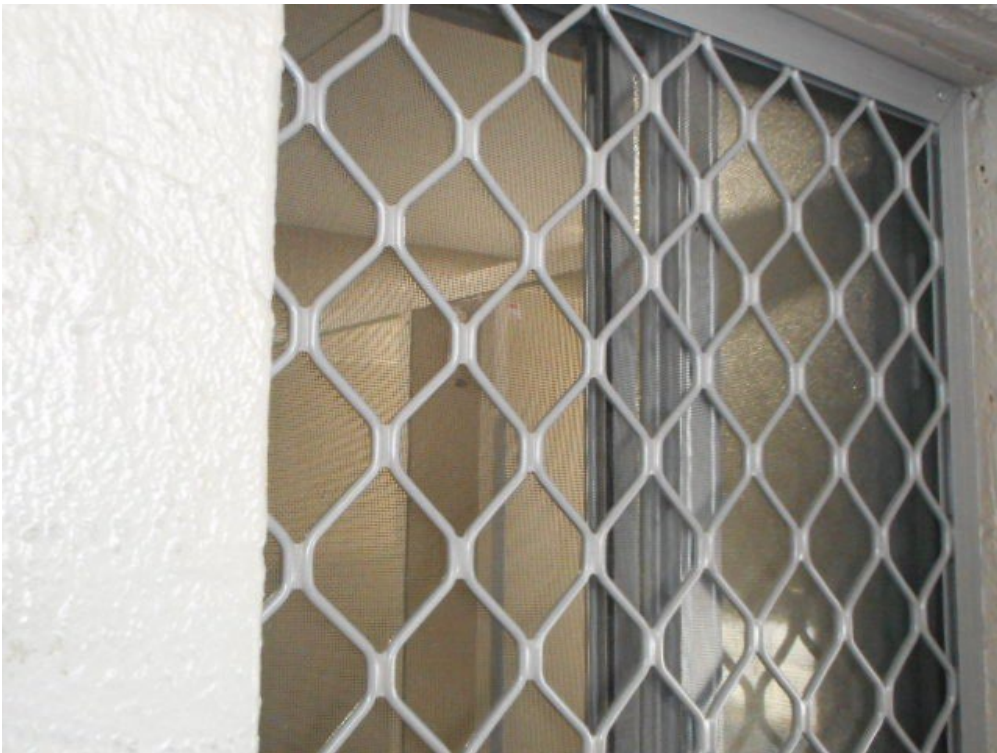
Photo 3369 - G - Toilets - Partitions

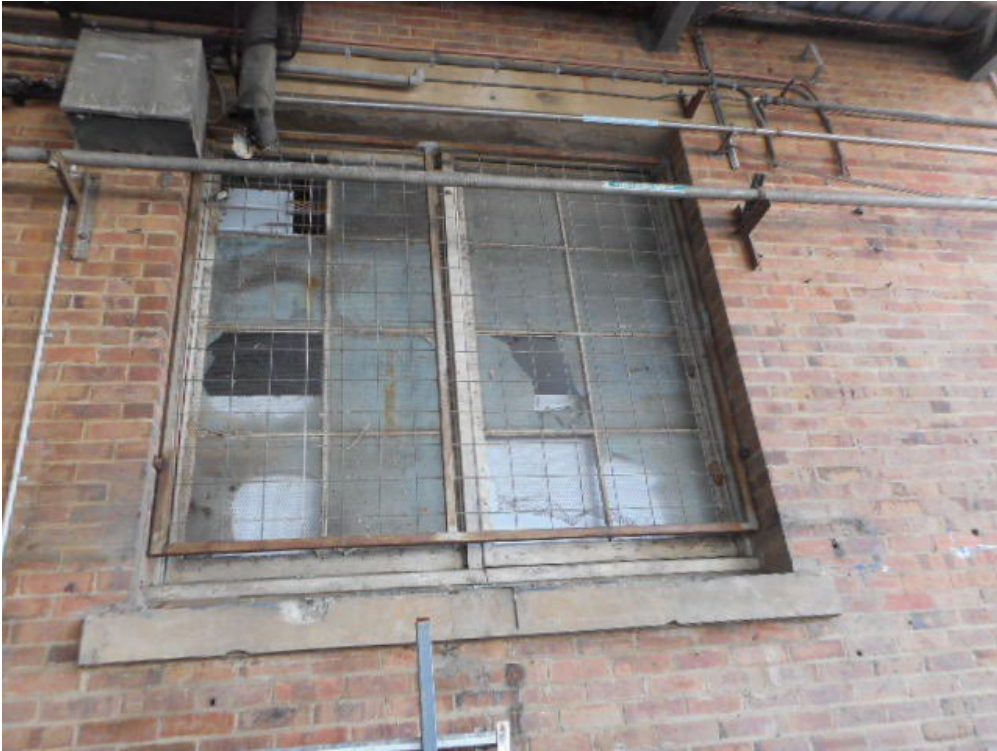
Photo 3357 - G - Exterior Windows - Putty

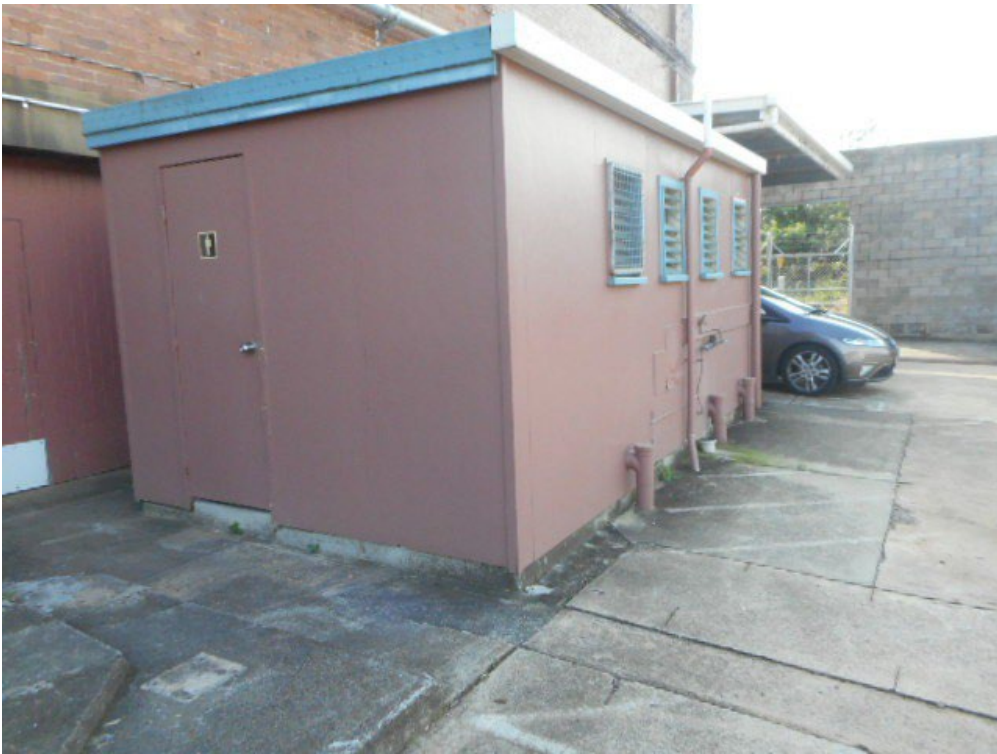
Photo 3358 - G - Toilets - Cladding

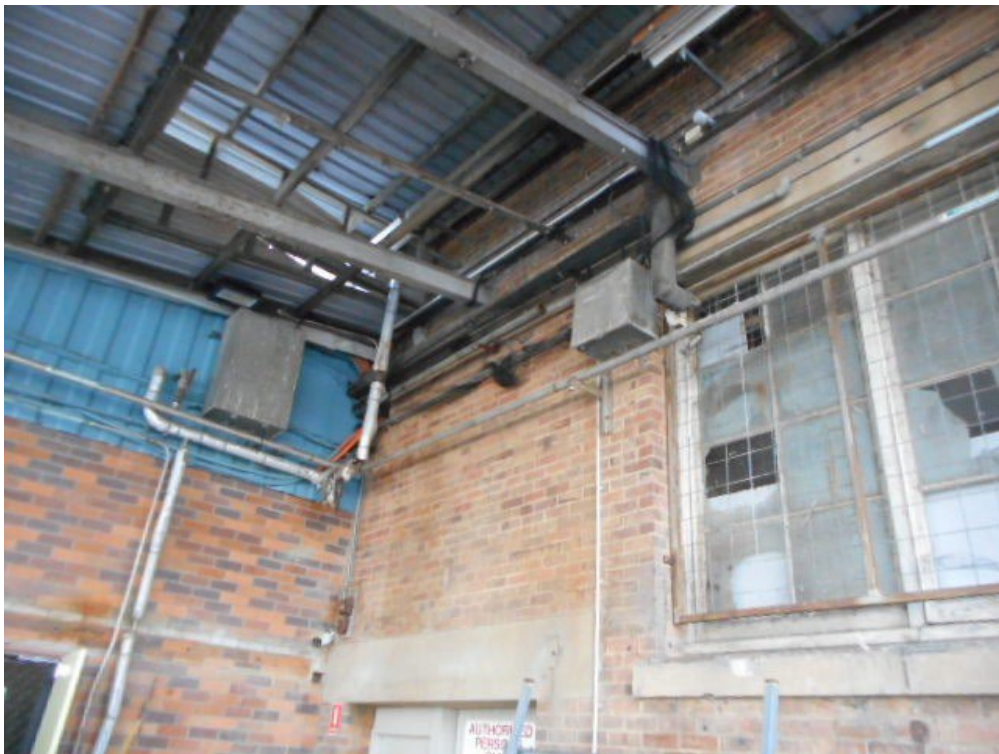
Photo 3359 - G - Switchboard - Backing

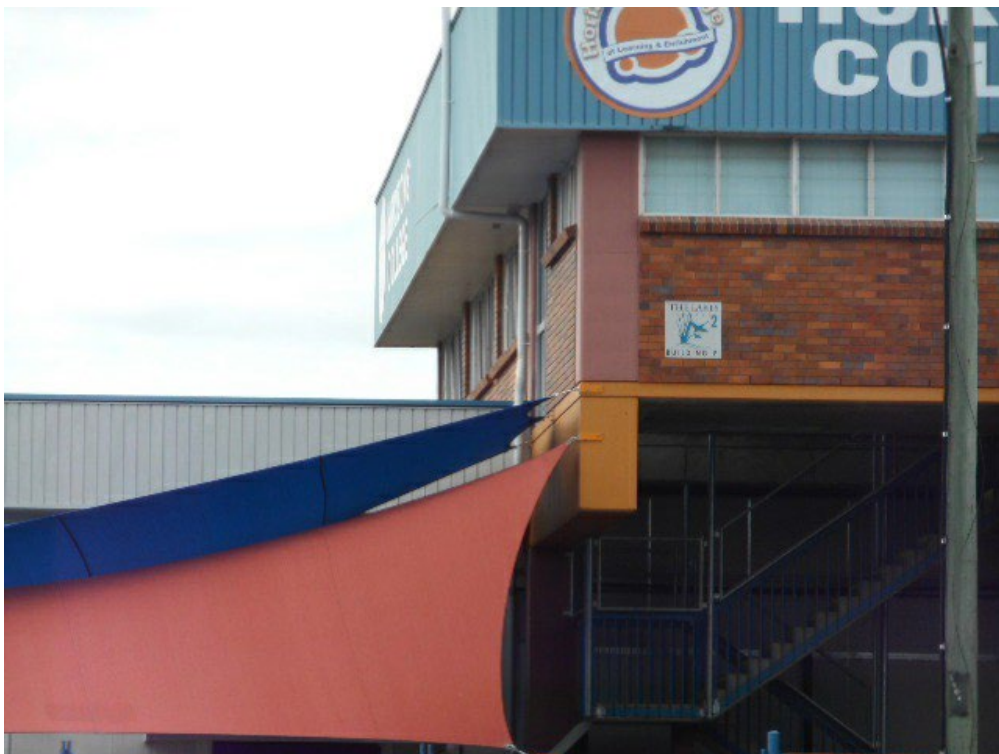
Photo 3403 - 2 - Exterior Soffit - Lining
