HEIGHT SAFETY INSPECTION REPORT

Inspection No. 2190

Site No. 2414
15 Astor Terrace, Spring Hill

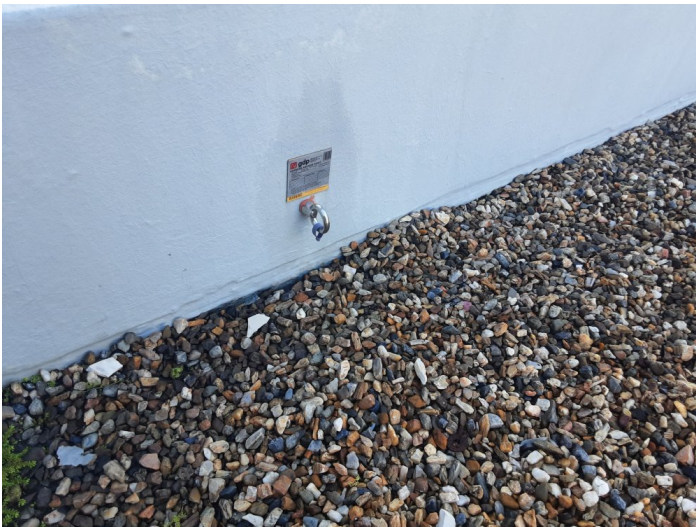
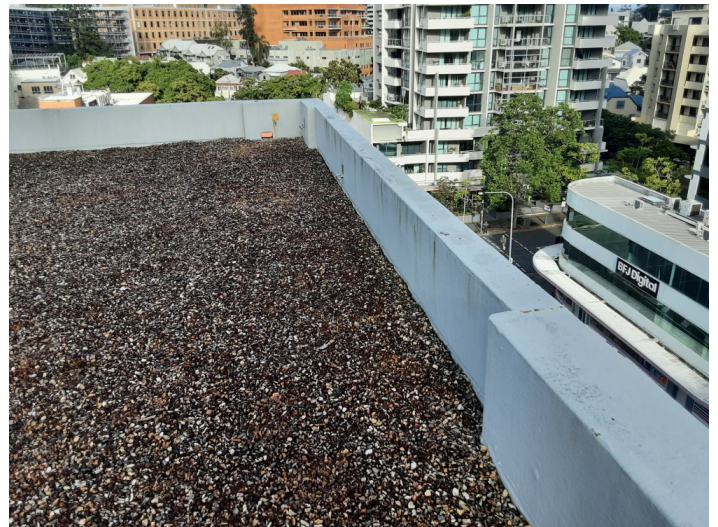
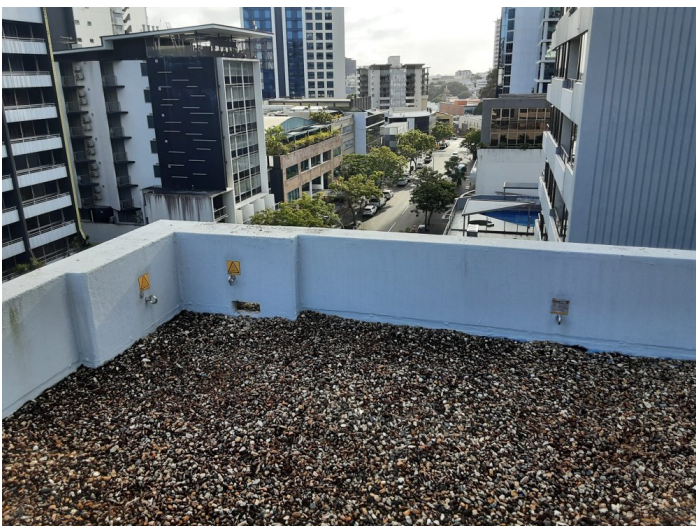
Item #1: Anchor Point Compliance Report

Anchor #	Fail Reason
3	Reason?...
6	Reason?...
7	Reason?...
11	Reason?...

4.6 Are all anchors tested to 7.5kN for 3 minutes with no sign of movement?	Yes
4.7 Is the concrete in good condition without any structural cracks or issues?	No
Notes: See anchor table. Recommend Structural engineer assess wall

Recommendations:	Warning: Anchor points have failed due to being installed into the side of a parapet wall. Structural integrity of the wall must be verified by a Structural Engineer stating that it is structurally capable of potential fall arrest loads imposed by anchor points before they can be certified. Some anchors are also within 200mm of a penetration and there are some evidence of wall cracks. DO NOT USE Anchor points #3, #6, #7, #11 have a penetration in the wall within 200mm - This issue can cause structural weakness in the wall and can affect the anchors capacity

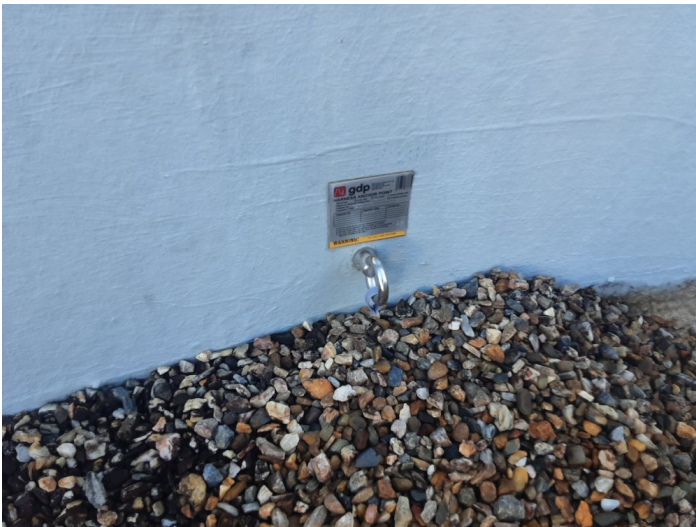
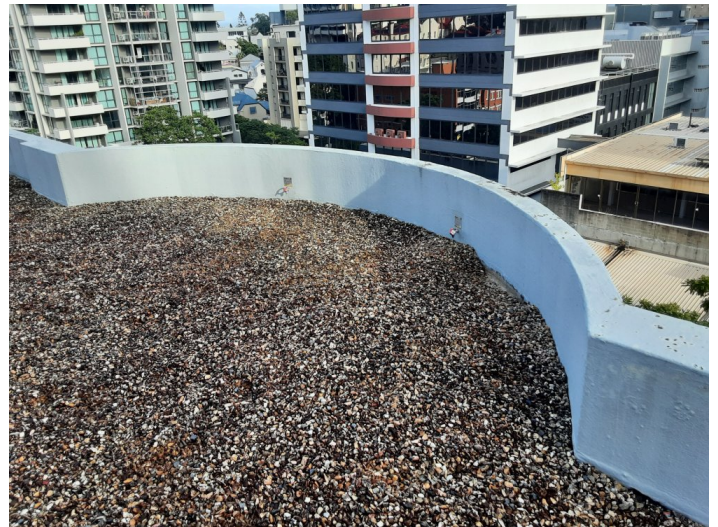
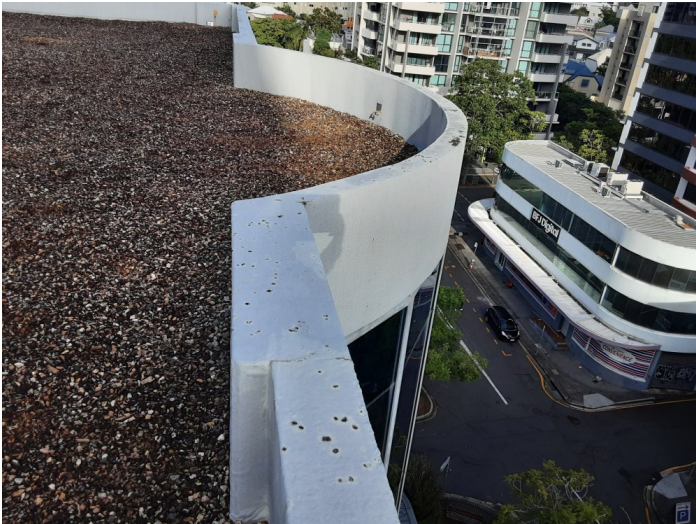
Item #2: Anchor Point Compliance Report

Anchor #	Fail Reason
1	Unable to determine structure integrity of wall. Recommend a structural engineer to conduct testing
2	Unable to determine structure integrity of wall. Recommend a structural engineer to conduct testing

4.7 Is the concrete in good condition without any structural cracks or issues?	No
Notes: See table and recommendations	
4.8 Is there anything else that must be noted?	No
5 Pitch of roof (in degrees)	0°
6 Does each anchor have clear labels stating manufacturer and rating?	Yes
7 Is the design of the system compliant, allowing 100% connection?	NA

7.1 Describe Purpose of System?	
Anchors are for abseil use	
8 Are there any pendulum risks? You must measure each anchor and ensure that: <ul style="list-style-type: none"> 1. The distance the anchor is from the closest fall edge is the same or LESS than to the next anchor 2. The distance between each anchor is no MORE than 6m 3. If any pendulum issues are found that the EXACT measurements are written clearly on the roof plan 	No
9 Is there a parapet wall?	
Has the system Passed/Failed?	FAIL
Fail Reason?	Structural integrity of the wall must be verified by a Structural Engineer stating that it is structurally capable of potential fall arrest loads imposed by anchor points before they can be cer
Recommendations:	Warning: Anchor points have failed due to being installed into the side of a parapet wall. Structural integrity of the wall must be verified by a Structural Engineer stating that it is structurally capable of potential fall arrest loads imposed by anchor points before they can be certified. DO NOT USE

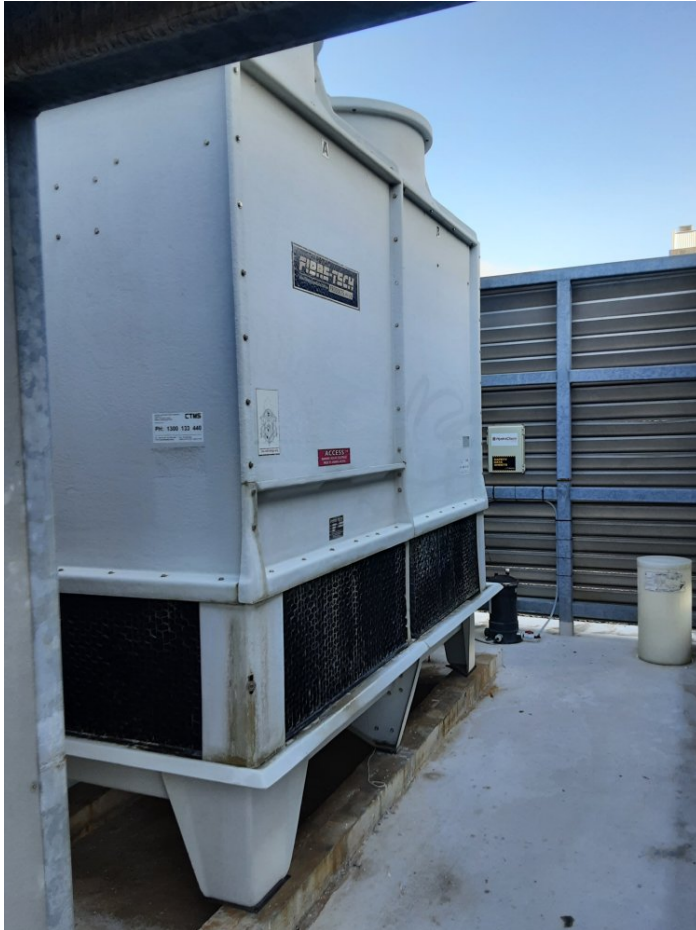
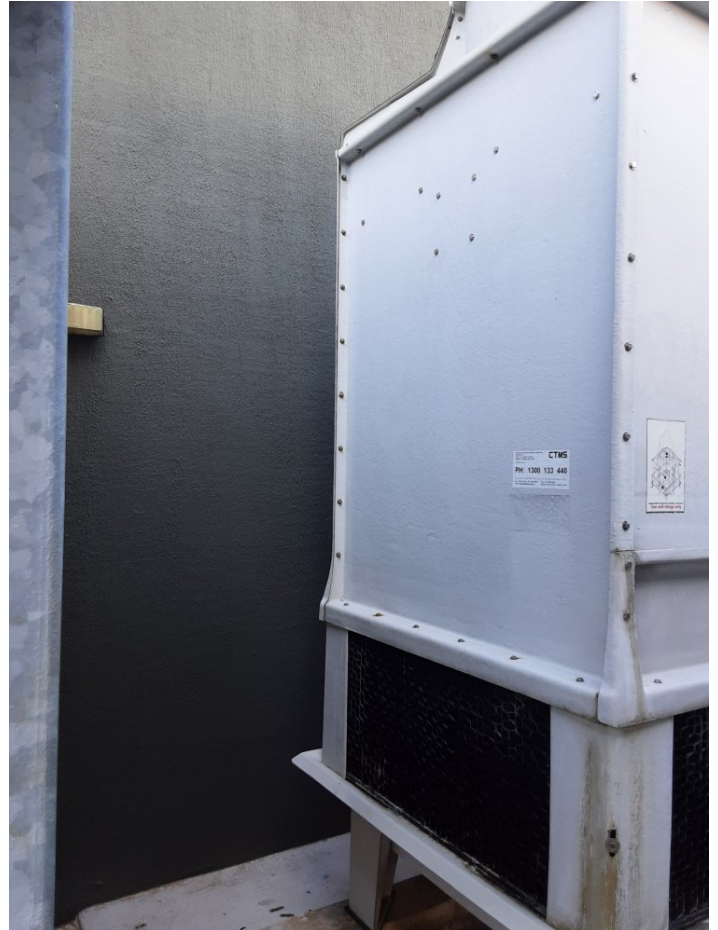
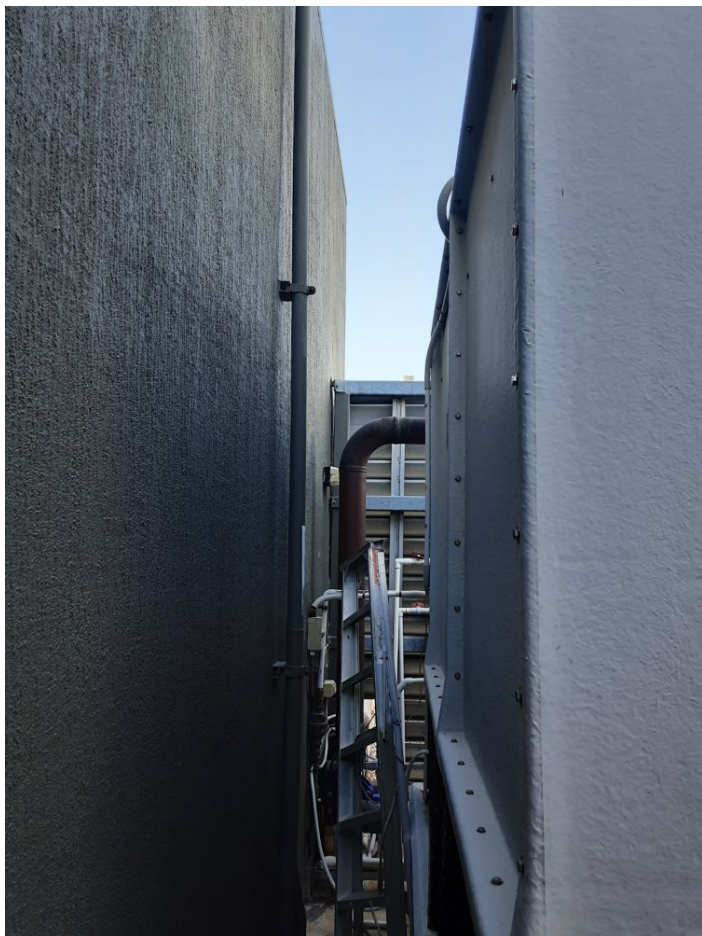
COOLING TOWER UNITS LEVEL 6 - Item #1: Observation

There is no safe access to the top of the cooling tower - review to roof audit from March 2022

Medium Risk - Identified hazard

There is no access to the top of this unit. This was identified in an audit report completed in March 2022 by Safe@Heights. Recommend a Safety-in-Design assessment is completed with the service company to ascertain what parts of the unit must be accessed and from this design a safe and compliant access system

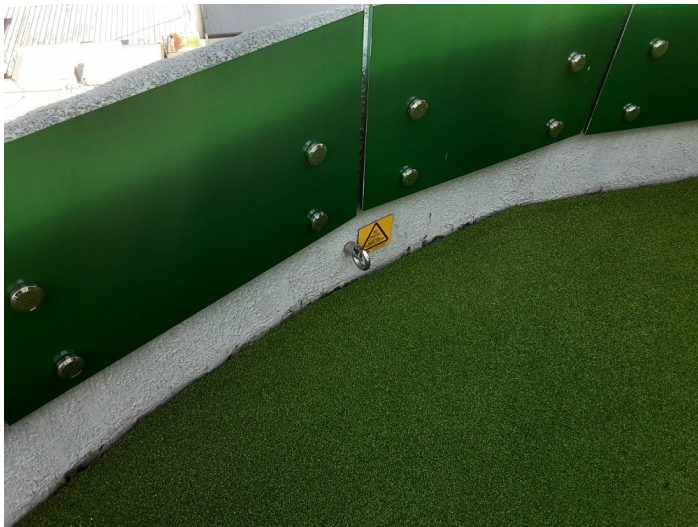
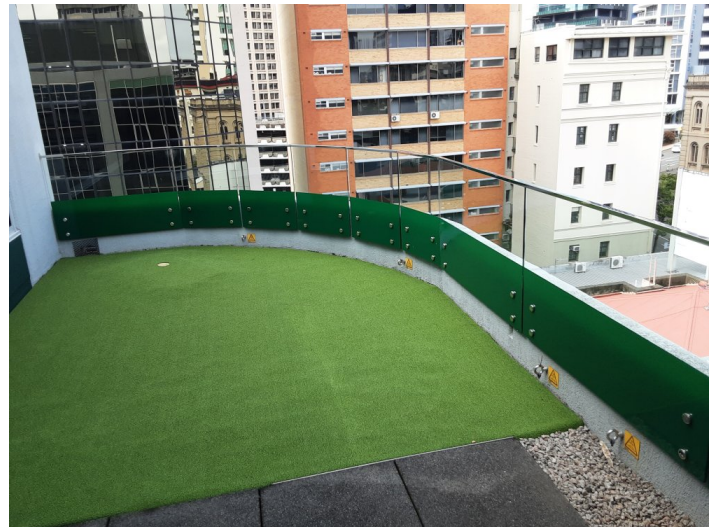
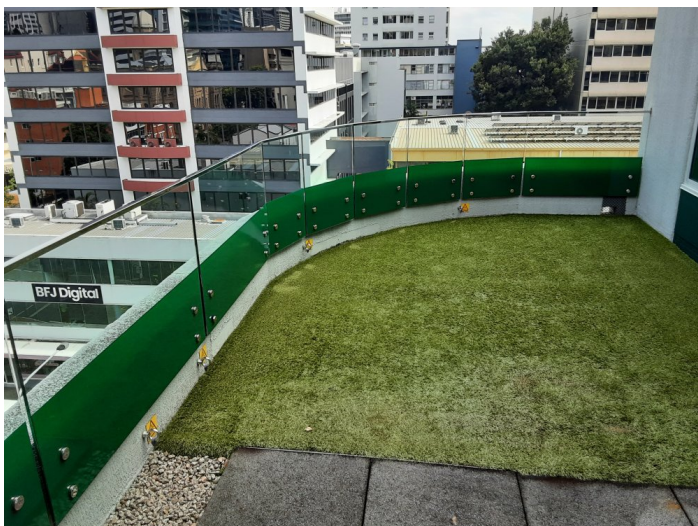
4.7 Is the concrete in good condition without any structural cracks or issues?	Yes
4.8 Is there anything else that must be noted?	Yes
Notes: Wall must be assessed by structural engineer. Glass balustrade attached to wall which prohibits the anchors from being used	
5 Pitch of roof (in degrees)	0°
6 Does each anchor have clear labels stating manufacturer and rating?	Yes
7 Is the design of the system compliant, allowing 100% connection?	NA

7.1 Describe Purpose of System?	
Anchors are for abseil use	
9 Is there a parapet wall?	No
Has the system Passed/Failed?	FAIL
Fail Reason?	Structural integrity of the wall must be verified by Structural Engineer that it is structurally capable of potential fall arrest loads imposed by anchor points before they can be certified. DO NOT USE
Recommendations:	Warning: Anchor points have failed due to being installed into the side of a parapet wall. Structural integrity of the wall must be verified by a Structural Engineer stating that it is structurally capable of potential fall arrest loads imposed by anchor points before they can be certified. There is also a Glass balustrade which cannot have ropes placed over the top. This must be part of the engineers assessment as to how these anchors would be used, i.e. are the glass panels removed during Abseiling works. These anchors cannot be used

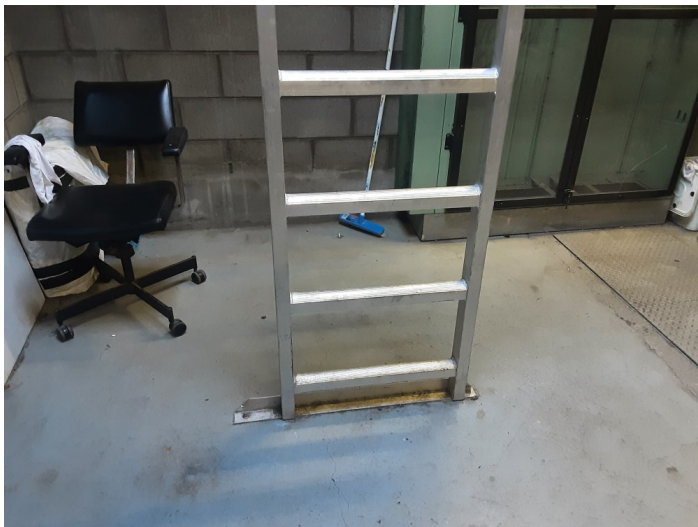
Q18 photo

2 Does the ladder have any form of fall arrest system installed?	No
Warning: Ladder does not comply with Managing the Risks of Falls at Workplaces Code of Practice. Provide further guidance to client	
3 What is the ladder made from?	Aluminium

Has the system Passed/Failed?	FAIL
Fail Reason?	Ladder has multiple non compliant issues
Recommendations:	Warning: Vertical ladder has failed due to multiple non-compliance issues with AS1657. This was identified in an audit conducted in March 2022. We recommend that the ladder is removed and replaced with a aluminium angled ladder between 70° and 75° in accordance with AS1657:2018 and Managing the Risk of Falls at Workplaces Code of Practice. As part of this rectification works, the hatch will require a guard railing safety system installed, which will provide safe transition from the new ladder to the roof

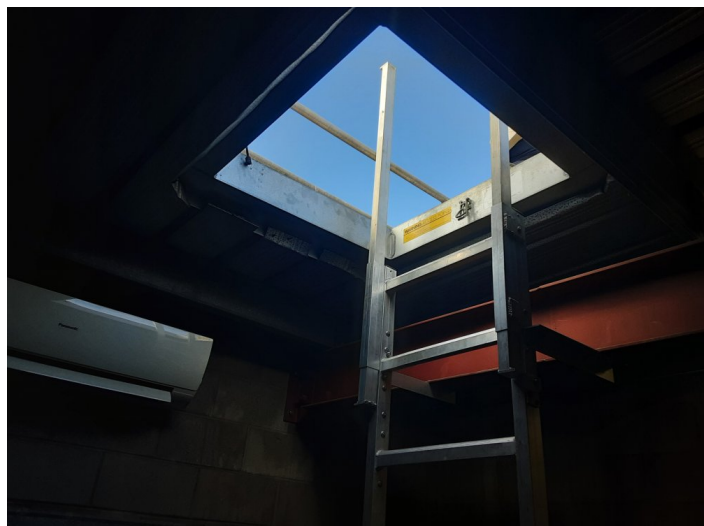
10.1 Warning: ladder has failed.	
Notes: Top rung is 300mm below step off point onto roof

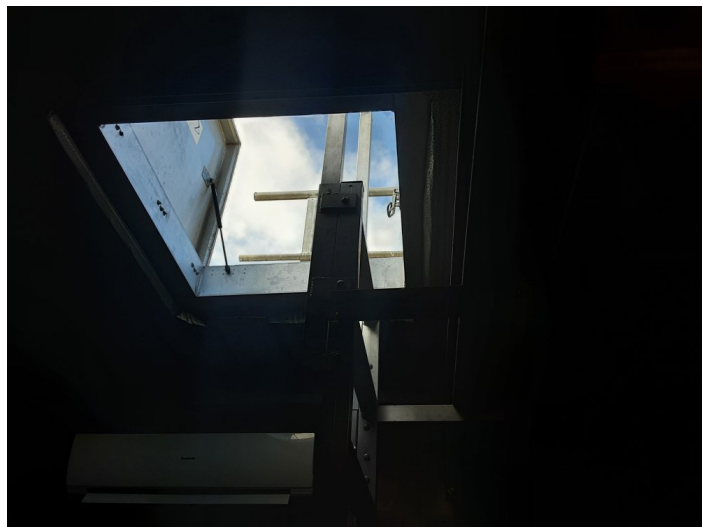
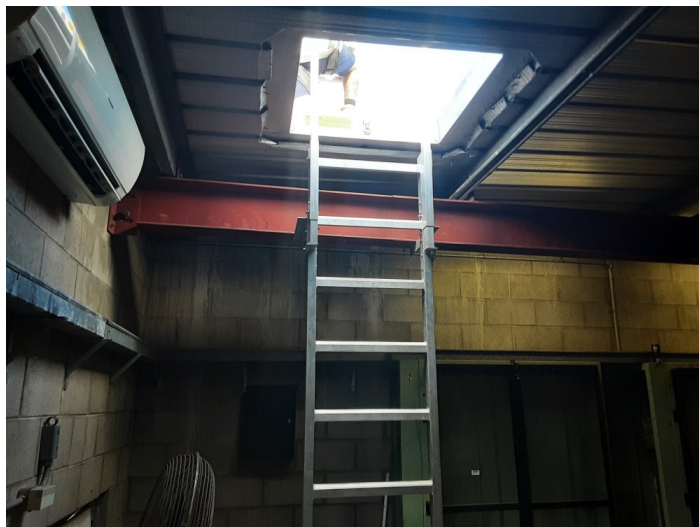
11 Is there an gap between the top rung and the platform?	Yes
11.1 The gap between the back of the rung and the platform must be not less than 50mm and not more than 100mm. Actual gap in mm is?	150mm
11.2 Describe if this can be rectified	
Notes: Ladder has multiple non compliant issues

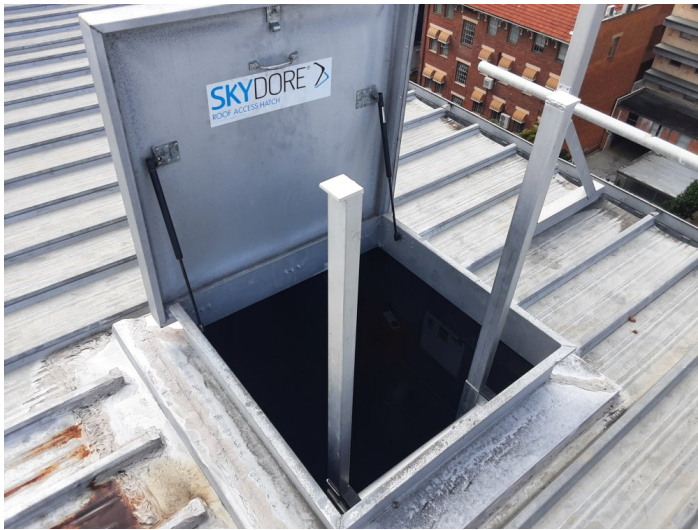
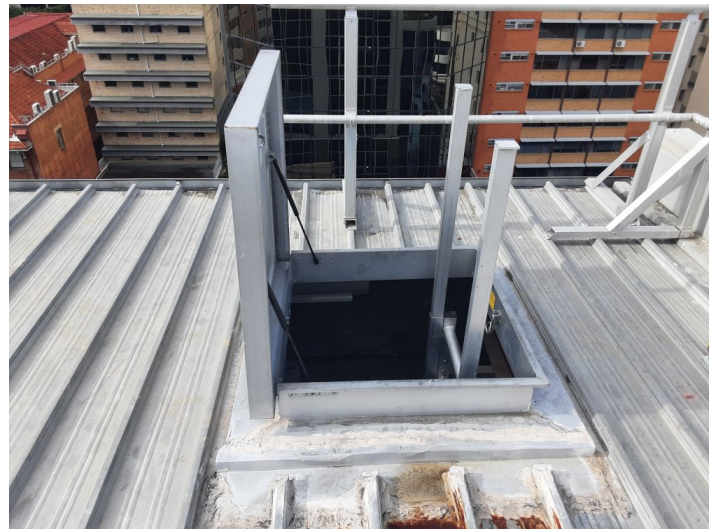
2 What system leads to the hatch?	Vertical Ladder
2.1 Vertical ladders should not be used for accessing through a hatch. Inform client access is considered high risk and should not be used	
3 What type of hatch is installed?	Standard Access Hatch
4 What are the opening measurements?	
Length (mm): 800mm	Width (mm): 800mm
5 Does the hatch have gas struts to help it open?	Yes
5.1 Are they in good working condition?	Yes
6 Is the opening size sufficient to allow a minimum of 750mm from front of ladder access rung to back edge of hatch? Record measurement in mm	650mm
7 How do you step out of the hatch?	Directly Forward
Has the system Passed/Failed?	FAIL
Fail Reason?	Hatch has no hatch guard rail kit Access ladder to hatch has failed due to multiple non compliant issues Measurement from from front of ladder to back of hatch is 650mm

Warning: Hatch has failed due to multiple non-compliance issues with AS1657, which were detailed in an audit conducted in March 2022. The hatch dimensions are 800x800mm. Minimum hatch depth is 1000mm to allow the required minimum distance of 750mm from ladder rung to any fixed object. The roof also has severe rust from water pooling along the hatch soaker tray. We would recommend that as part of this safety upgrade that the hatch is replaced with a 800x1000mm hatch and dry pan is installed to prevent water pooling

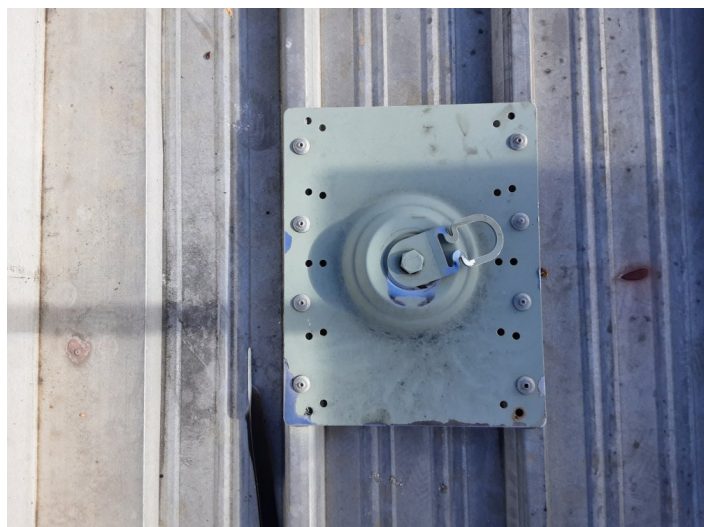
2 Is the system for:	Fall Arrest
3 What is the type of anchor?	Surface mounted
4 Surface type?	Metal Roof
4.1 Roof type	Kliploc 700
4.2 Is the system surface mounted or into a purlin with screws?	Surface Mounted
4.3 Is there a minimum of 3 x purlins under each sheet where an anchor is installed?	Yes
4.4 Is the roof sheeting in good condition and free from rust?	No
Notes: Rust marks in various areas	
4.5 Are there any penetrations in the same roof sheet that has the anchor installed that is within 2000mm?	Yes
Notes: Anchor installed on roof sheet that is along the edge of the roof and has roof hatch on the next sheet across. This anchor has insufficient support	
4.6 Are all the fixings installed correctly and in good condition?	Yes
4.7 Are the anchors installed on the correct lap?	No
4.7.1 Notes

Anchor installed on top side of roof lap

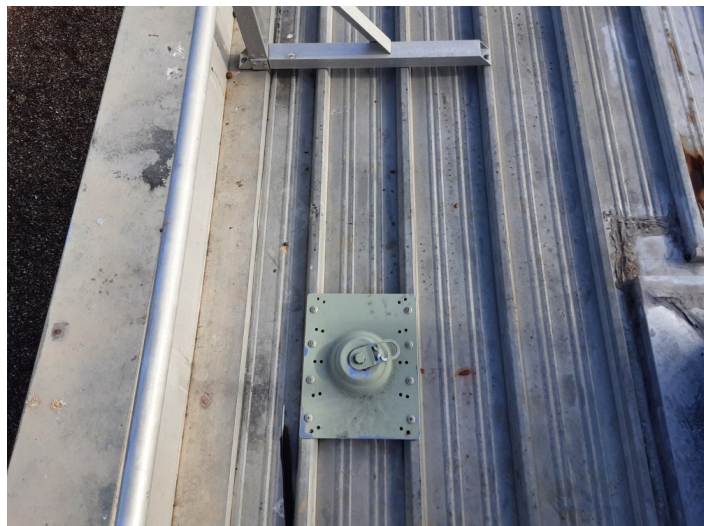
4.9.1 Warning: Anchors have failed

Notes: No additional 14g screws installed into purlin above or below

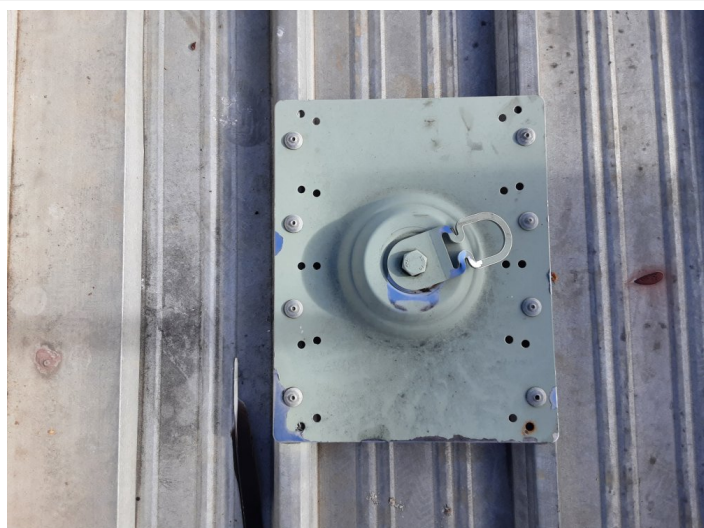
Notes: No manufacturer ratings or label

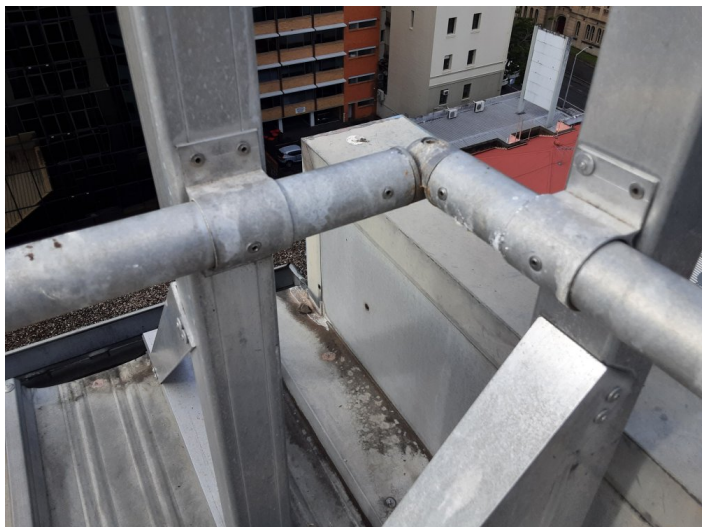
13.1 Note how many posts are missing screws and take photo	
Notes: Mid rail is riveted

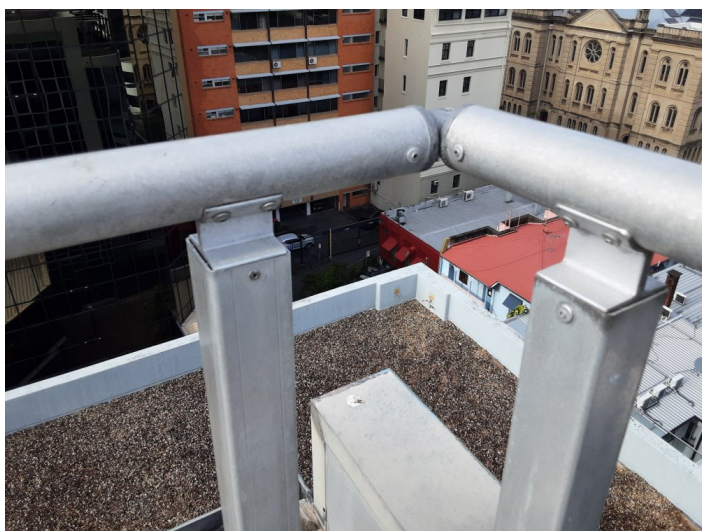
Notes: Top rail is riveted

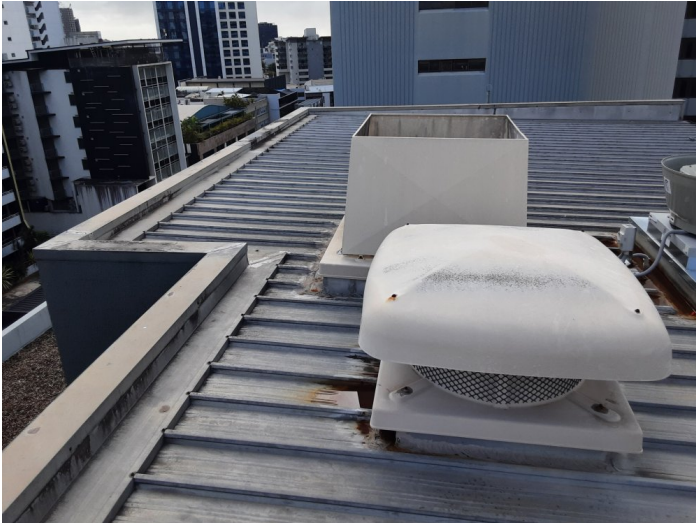
Identification #	OBS1 - No fall protection around vents
Date of Observation	01/07/2025
1 Name of Observation	No fall protection around vents
2 Take a photo of the observation

3 Describe the issue with as much detail as required	
There is no fall protection around vents, when working on the vents you will be within 2000mm of a fall edge - review safety audit from March 2022, Issue #5, option #1	
Observation Status:	High Risk - Identified hazard
Recommendations:	Warning: There is no fall protection around vents, when working on the vents you will be within 2000mm of a fall edge - review safety audit from March 2022, Issue #5, option #1. Where it is recommended that this roof has a perimeter guard railing system installed. This is still our recommendation
