HEIGHT SAFETY INSPECTION REPORT

Inspection No. 2214

Site No. 2419
Anglicare - 12 King Street, Caboolture

Inspection - Anglicare - 12 King Street, Caboolture

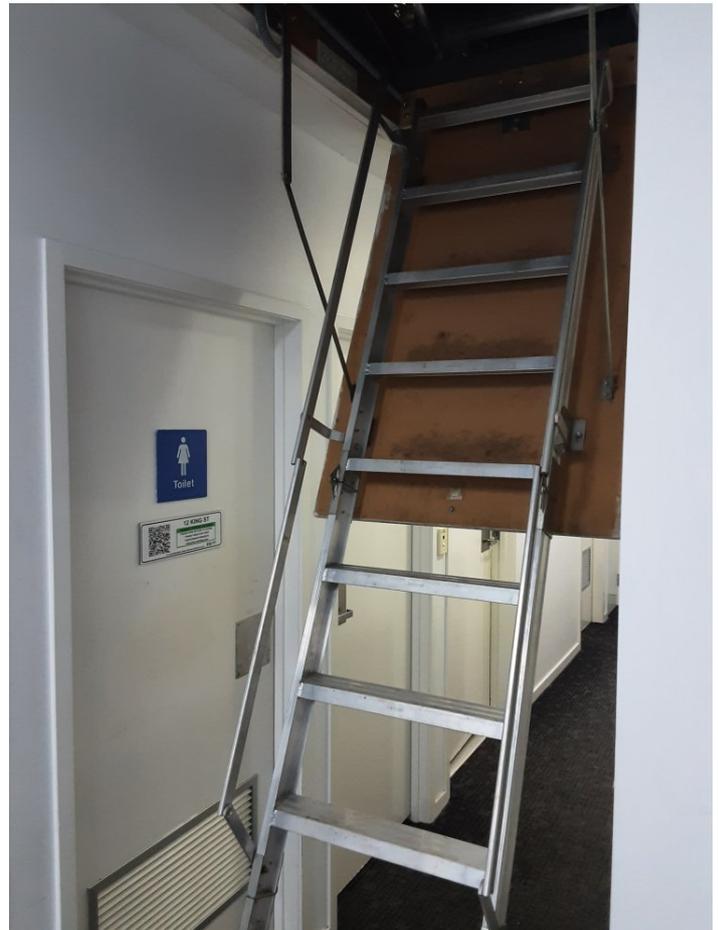
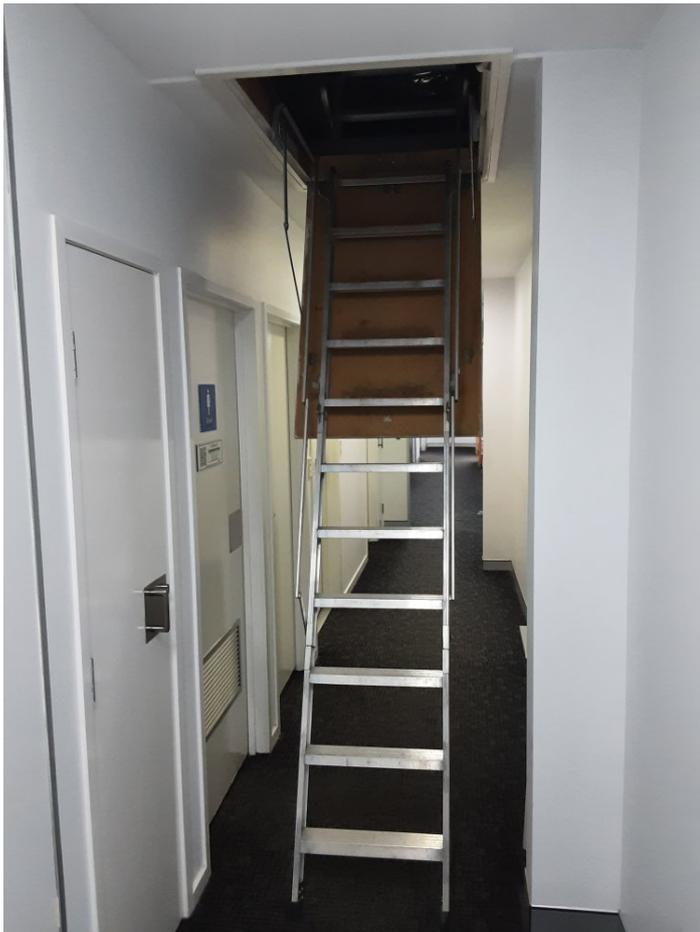
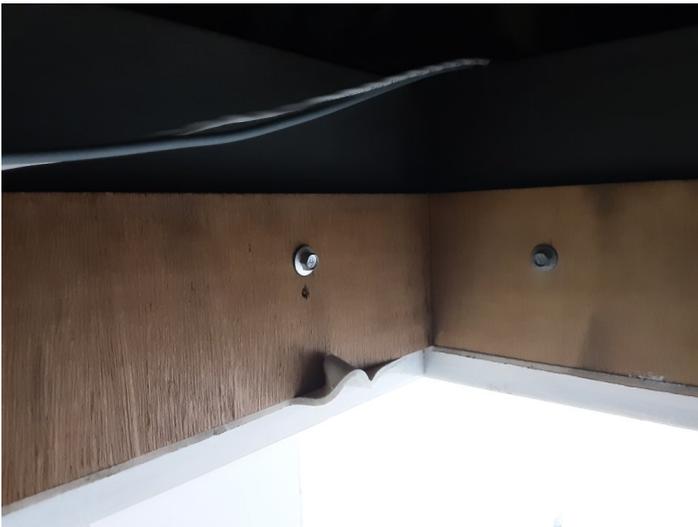
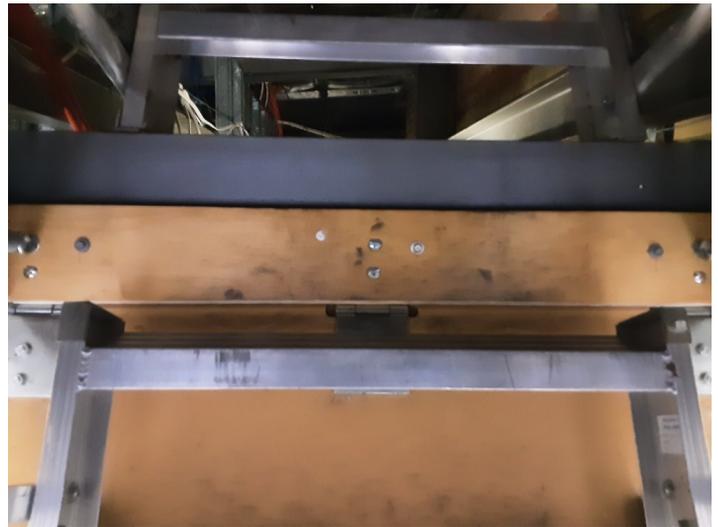
Item #1: Fold Down Ladder Compliance Report

Has the system Passed/Failed?	PWC
PWC Condition:	Minor noncompliance/Low risk. Additional care required during use/access. Prior to use/access person/s must be provided with this report and understand the issue. Only authorised person/s can access
PWC Details:	125mm foot clearance from front of ladder rung to the Fold Down Ladder lid Top step is 210mm from top of ladder rung to top of Fold Down Ladder User to be aware when climbing the lader
Recommendations:	Warning: Fold Down Ladder has Passed With Conditions (PWC) and approved for limited use. The non-compliances identified include: Minimal foot clearance between ladder rungs and the lid surface with also a smaller top step which may affect footing and stability when transitioning to the next ladder. Be sure to maintain 3 points of contact at all times when using the system. We recommend that the ladder is replaced to improve safety and reduce overall risk

Recommendations:	Warning: Fold Down Ladder has Passed With Conditions (PWC) and approved for limited use. The non-compliances identified include: Minimal foot clearance between ladder rungs and the lid surface with also a smaller top step which may affect footing and stability when transitioning to the next ladder. Be sure to maintain 3 points of contact at all times when using the system. We recommend that the ladder is replaced to improve safety and reduce overall risk		
Client Notes	Warning: Fold Down Ladder has Passed With Conditions (PWC) and approved for limited use. The non-compliances identified include: Minimal foot clearance between ladder rungs and the lid surface with also a smaller top step which may affect footing and stability when transitioning to the next ladder. Be sure to maintain 3 points of contact at all times when using the system. We recommend that the ladder is replaced to improve safety and reduce overall risk

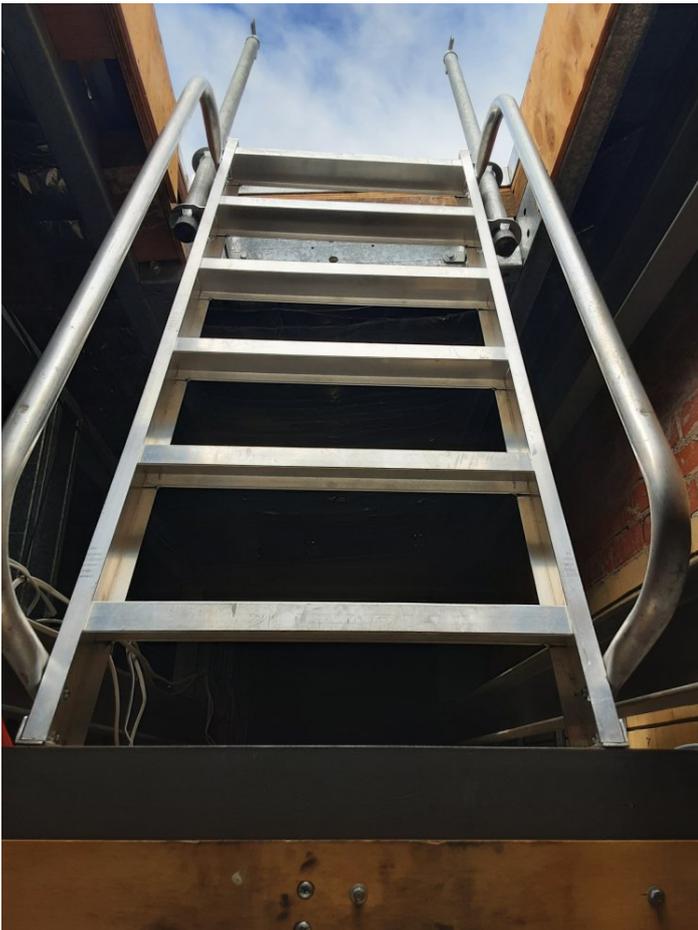
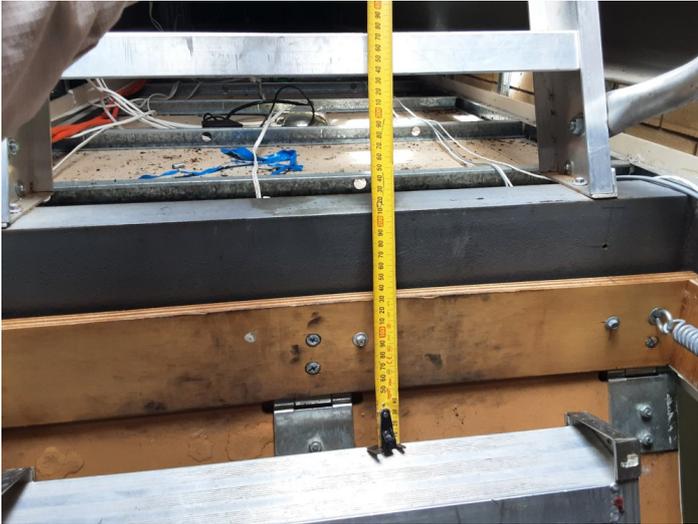
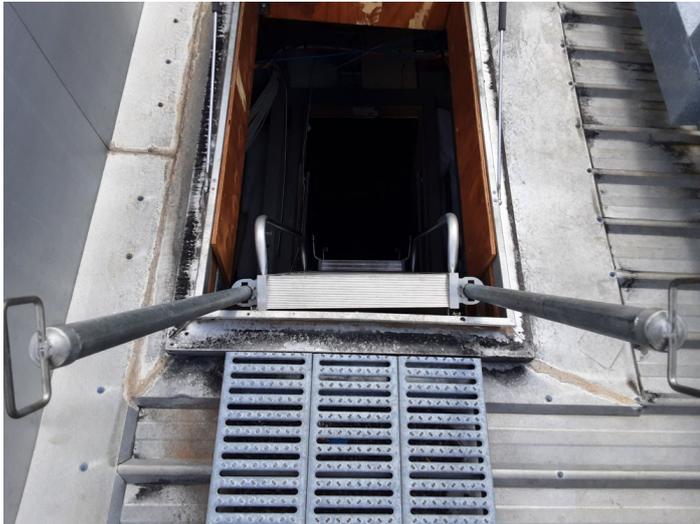
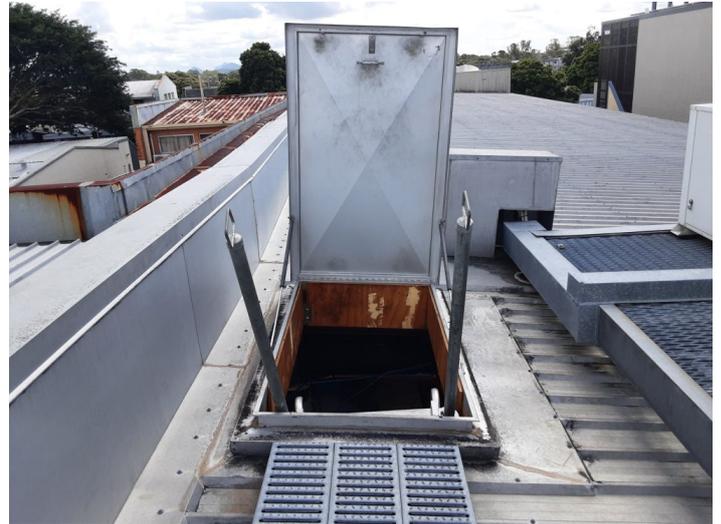
Item #2: Step Type Ladder Compliance Report

5 Excluding the bottom tread, are all the treads no less than 200mm and no more than 300mm and the same space apart, within ± 5 mm?	Yes
5.1 Tread Spacings (mm)	235mm
5.2 Height from top of bottom platform to top of first tread (mm). Must be within 10% of tread spacing.	150mm
5.3 Warning: Ladder has failed.

18 Are all the fixings in good condition?	Yes
19 Does the ladder have a:	NA
20 Is there anything else that needs to be addressed?	Yes
20.1 Describe the issues and take photos where applicable	
Notes: Access onto the roof does not comply

Has the system Passed/Failed?	PWC
PWC Condition:	Minor noncompliance/Low risk. Additional care required during use/access. Prior to use/access person/s must be provided with this report and understand the issue. Only authorised person/s can access
PWC Details:	Bottom rung is 150mm from steel beam - cut to size to fit in cavity between Fold Down Ladder and Hatch lid
Recommendations:	Warning: Step Type Ladder has Passed With Conditions (PWC) and has minor non-compliance with AS1657. The first step is smaller than standard - potentially impacting foot stability, and the system is positioned between a fold down ladder and hatch - requiring careful transition. System should only be used by trained personnel, maintain 3 points of contact at all times and take extra caution when stepping on/off the first rung. Access onto the roof does not comply with AS1657. See next item

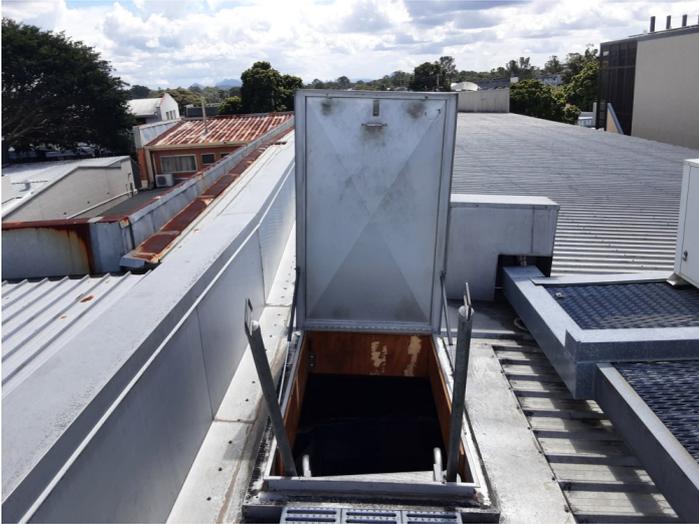
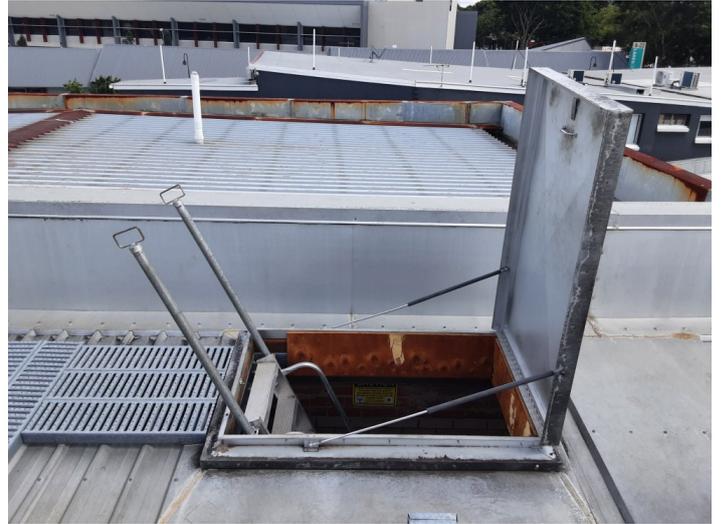
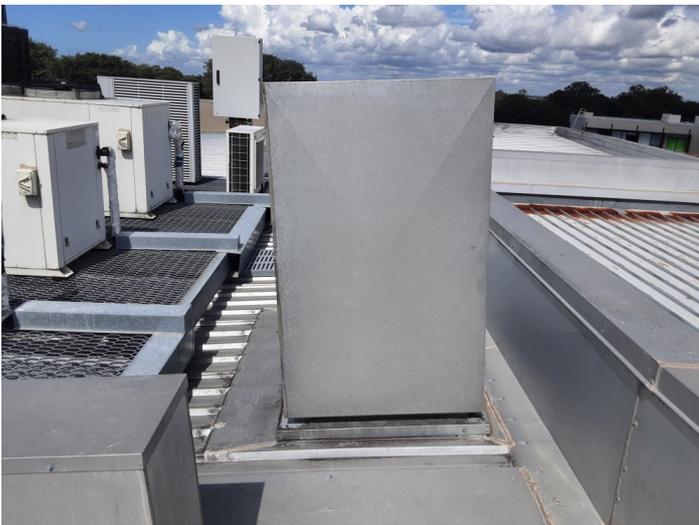
Item #3: Hatch Compliance Report

Length (mm): 1450mm	Width (mm): 840mm
5 Does the hatch have gas struts to help it open?	Yes
5.1 Are they in good working condition?	Yes
6 Is the opening size sufficient to allow a minimum of 750mm from front of ladder access rung to back edge of hatch? Record measurement in mm	1230mm
7 How do you step out of the hatch?	Directly Forward
Has the system Passed/Failed?	PWC
PWC Condition:	Part of Area/System has failed. Failed items/area cannot be used/accessed safely. Refer to report. Recommend no access until rectified and made safe. If use/access is required additional controls must be implemented and documented in SWMS prior to use/access. Do not use/access without authorisation and approval of the additional controls from PCBU and recorded in your SWMS
Recommendations:	The hatch is compliant, however it does not have three sides of guard railing as per requirement of AS1657:2018. We recommend the installation of a hatch guard rail safety system

Client Notes	The hatch is compliant, however it does not have three sides of guard railing as per requirement of AS1657:2018. We recommend the installation of a hatch guard rail safety system

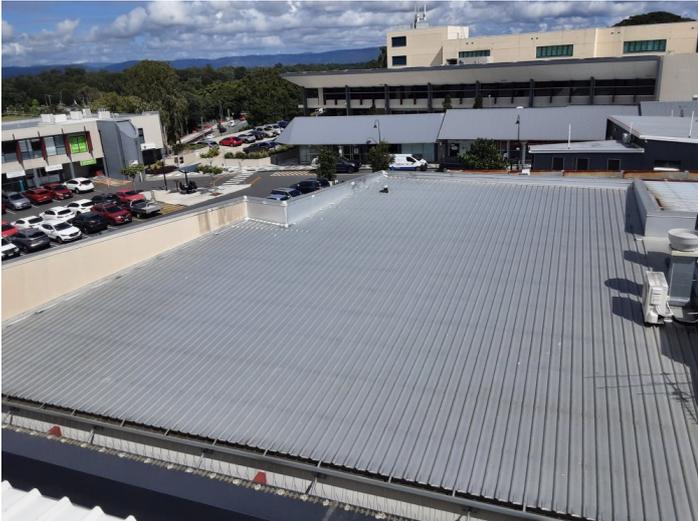
Photo taken from building next door - no systems installed

3 Describe the issue with as much detail as required	No height Safety systems on roof. May need anchors installed if work is to be done on the gutters
Observation Status:	High Risk - Identified hazard

Warning: This roof area is not equipped with compliant fall protection systems. Access to this roof should be limited until appropriate safety controls are installed and certified by a competent person

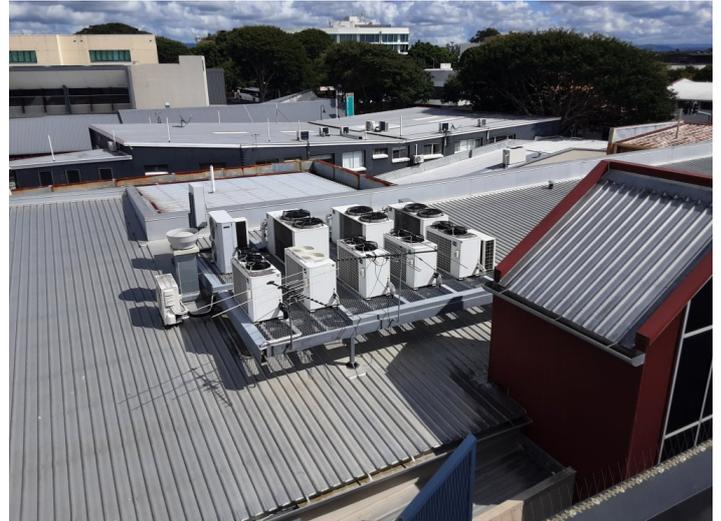
Photo taken from building next door - no systems installed

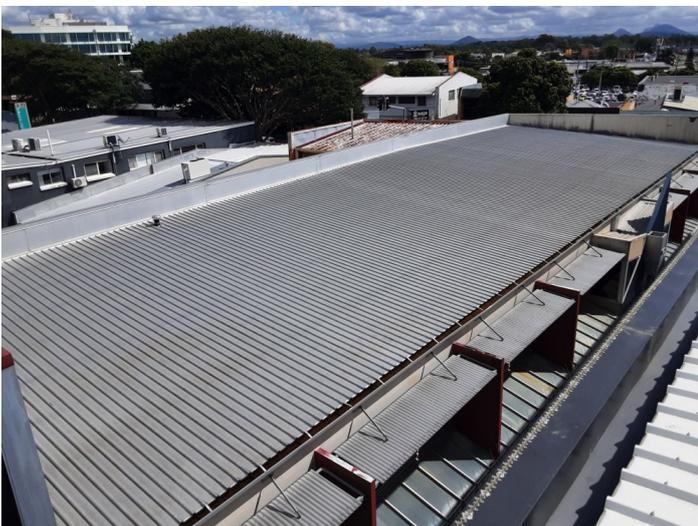
Photo taken from building next door - no systems installed

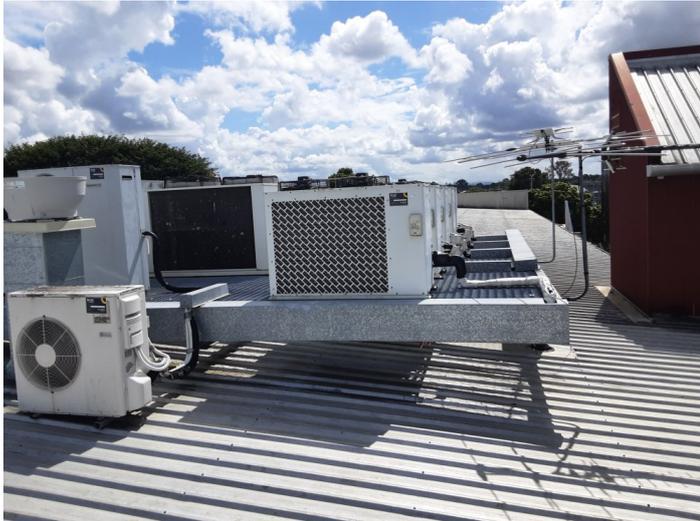
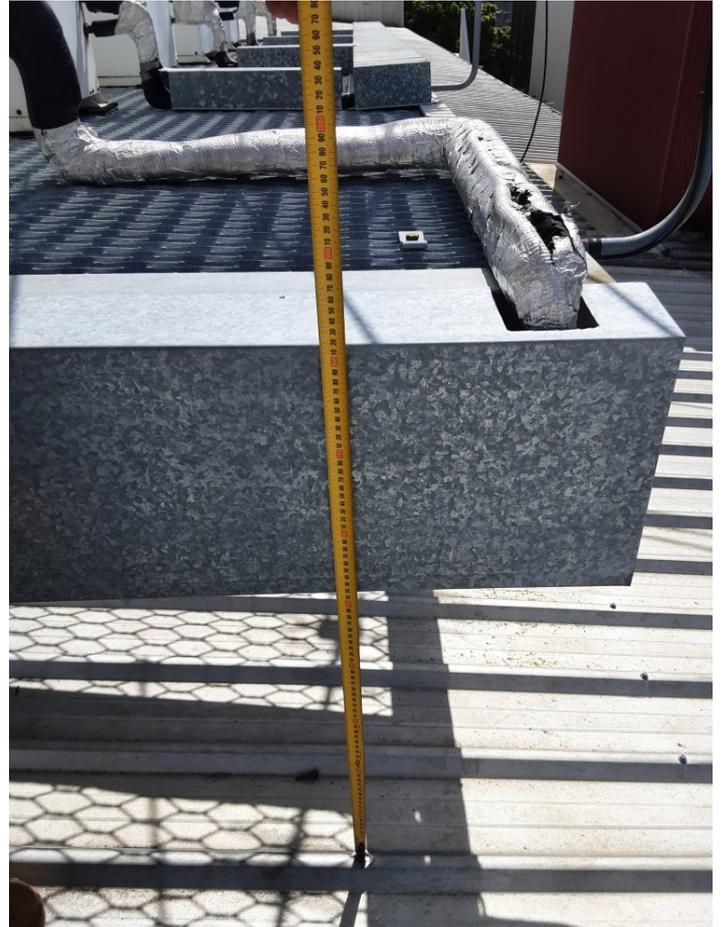
815mm drop off of plantdeck onto roof

Plant deck is over 300mm in height with no guard railing. AS1657 states where a platform is over 300mm guard railing must be installed. It would require 26m of side mount guardrail to go around plant deck. There are a number of aircon units on the plant deck.
The plant deck has a 75mm x 200mm c beam a 10mm thick around the perimeter.

Medium Risk - Identified hazard

Warning: This plant deck does not have compliant edge protection or guardrails, creating a fall hazard in breach of AS1657.2018

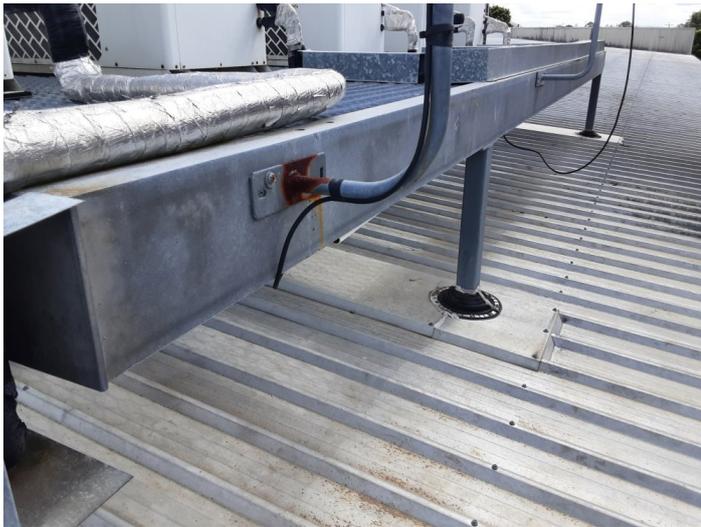
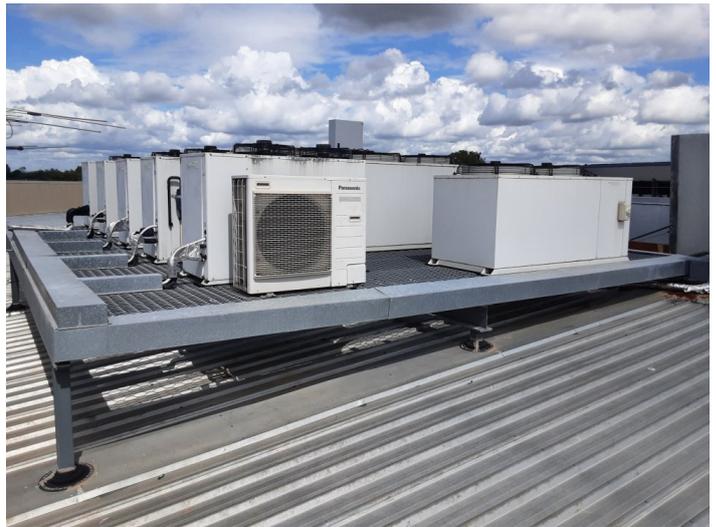
75x200 c beam

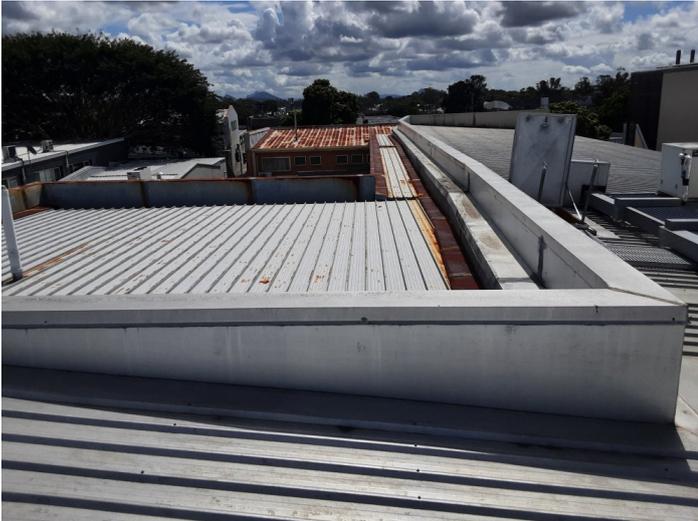
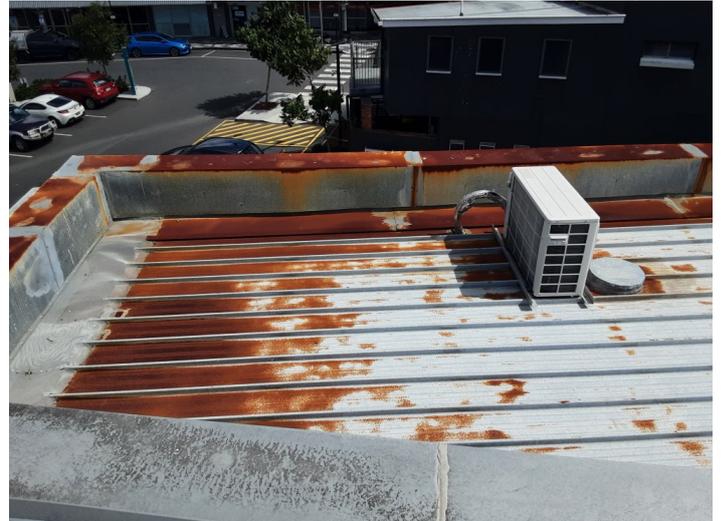
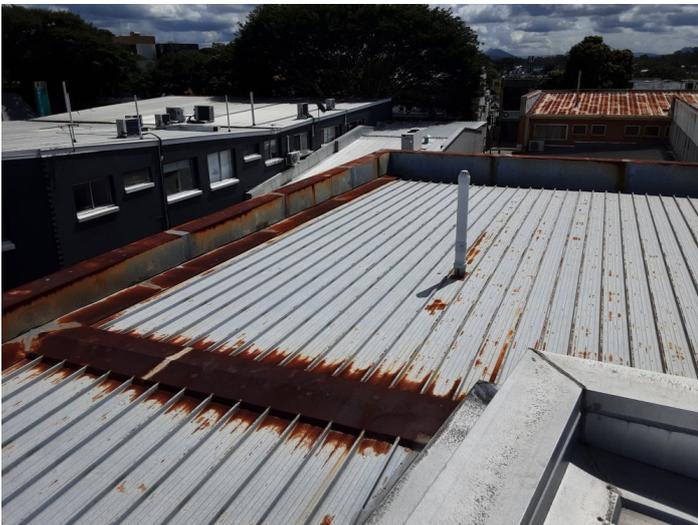
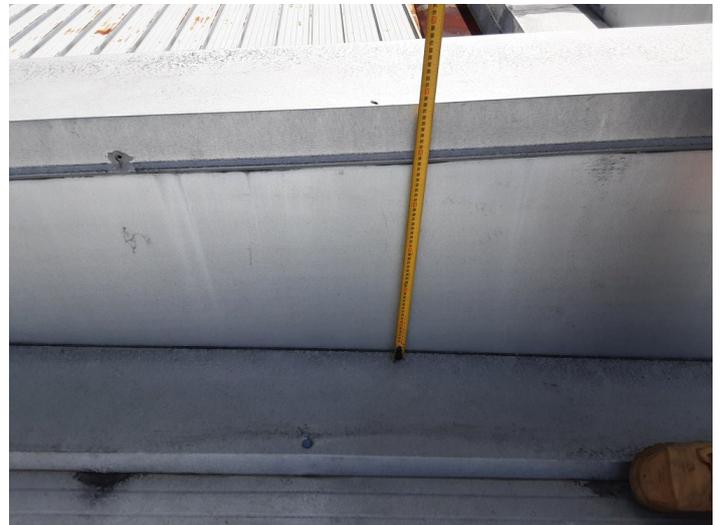
580mm parapet wall

Observation Status:	High Risk - Identified hazard
Recommendations:	Warning: DO NOT ENTER this lower roof area. Roof sheets have been identified as severely rusted and structurally compromised. This area is non-compliant without safe access and structural requirements under AS1657 and must not be accessed under any circumstances. Access should be prohibited until the roof is repaired and certified safe by a competent person. At the same time, fall prevention systems should be considered for accessing plant or having the plant removed and installed in a safe location

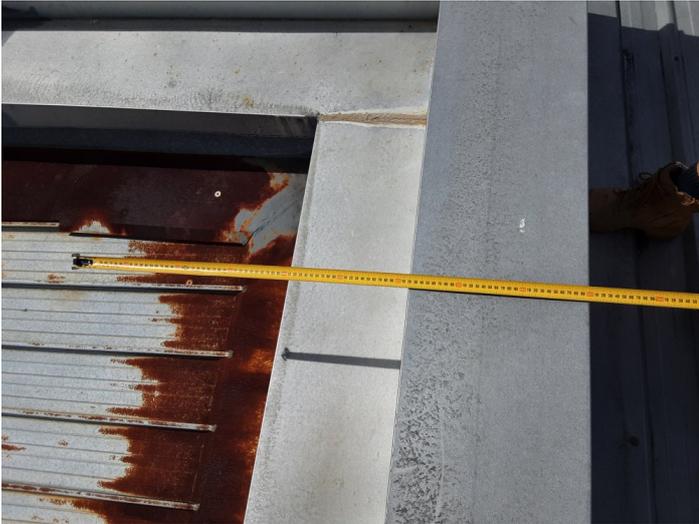
980mm crossover

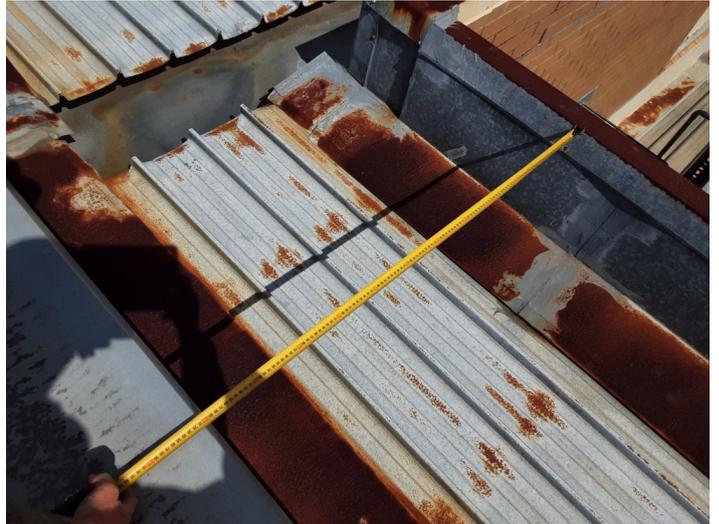
1200mm walkway space

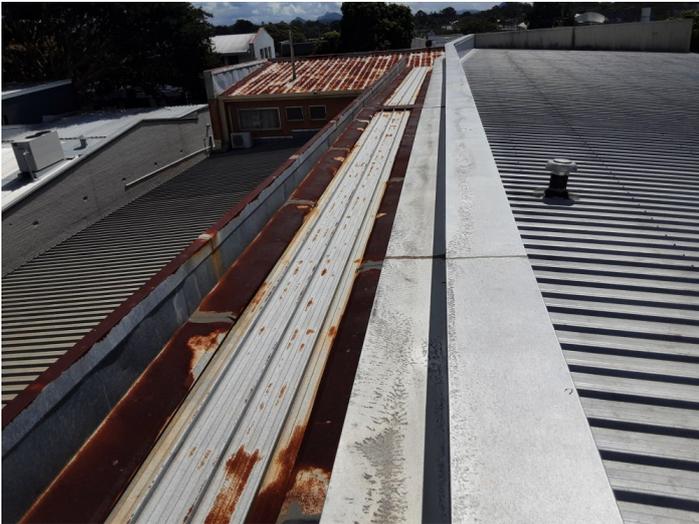
1200mm walkway space
