HEIGHT SAFETY INSPECTION REPORT

Inspection No. 2293

Site No. 2420
28 King Street, Caboolture

Inspection - 28 King Street, Caboolture - Services Australia

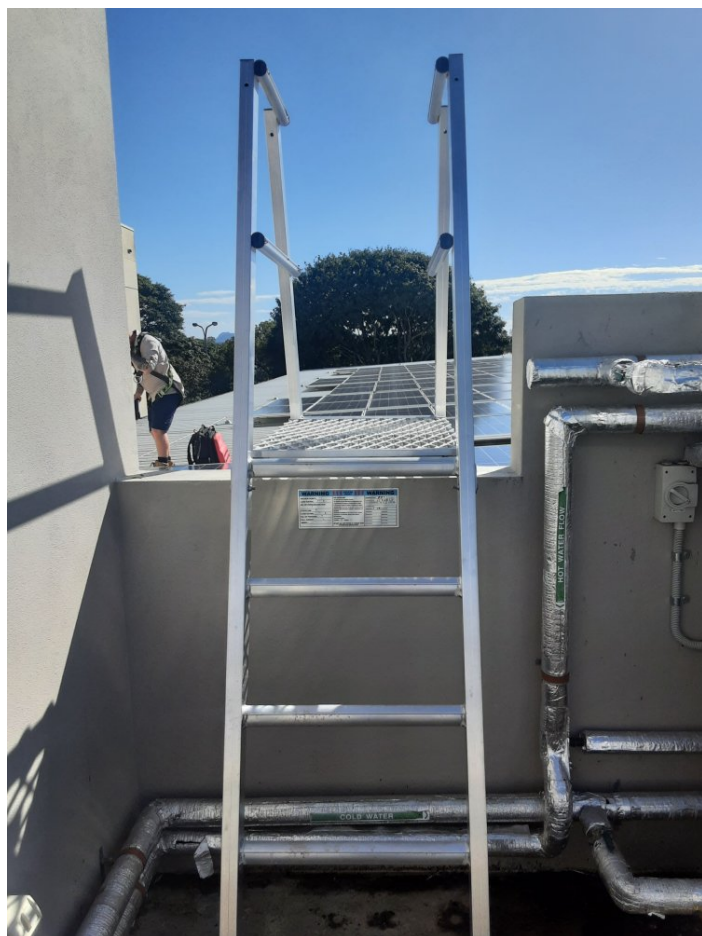
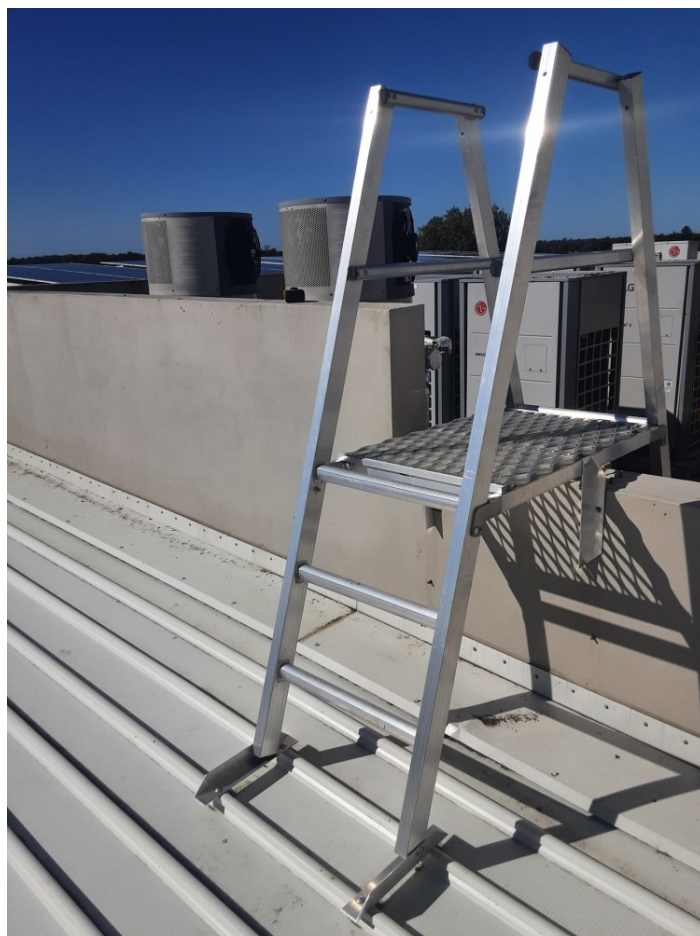
Item #1: Crossover Ladders Compliance Report

Has the system Passed/Failed?	FAIL
Fail Reason?	No bottom landing installed
Recommendations:	Warning: Crossover Ladder has failed due to not having a bottom landing to safely step on and off of the ladder. Recommend that the ladder be rectified to comply with AS1657

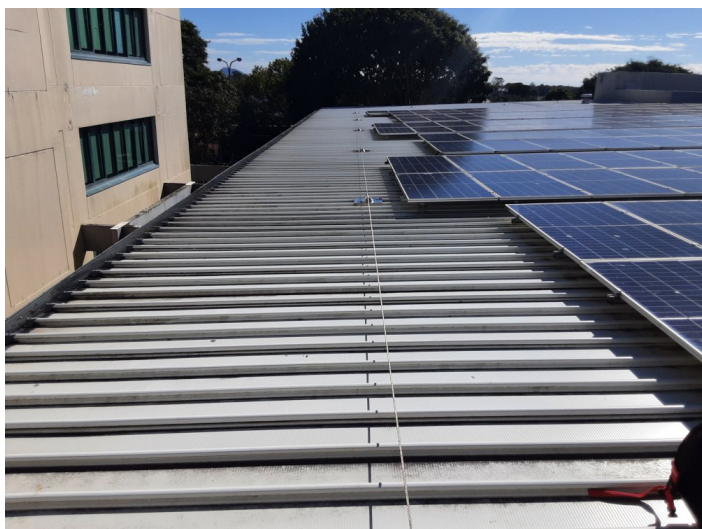
Item #2: Horizontal Static Line Compliance Report

8 Does the system have clear labels stating manufacturer, rating and number of users?	Yes
8.1 How many people is the Horizontal Static Line system rated for?	2 Person - 21kN
9 Are there any pendulum risks?	No
10 Is there a parapet wall?	No
11 Length of the system? (in metres)	30
12 Number of intermediate brackets?	4
13 Number of corners?	0
14 The ends are:	swaged
15 Have the ends been tested?	Yes
16 Method of testing?	Hydrajaws
Has the system Passed/Failed?	FAIL
Fail Reason?	No additional 14g screws for kliplok roof sheets No manufacturer or kN ratings Mounting plates are 1mm thick and not suitable for fall Arrest applications

Warning: Static line has failed due to non-compliance issues with AS1891 Series. The system is missing required 14g screws into a purlin above each plate, has no manufacturer or kN ratings - can not verify load capacity, and the mounting plates are only 1mm thick - which are not suitable for fall Arrest applications which require static line end plates to withstand a force of 20kN (2000kg). Recommend that the static line is removed and replaced as it cannot be rectified

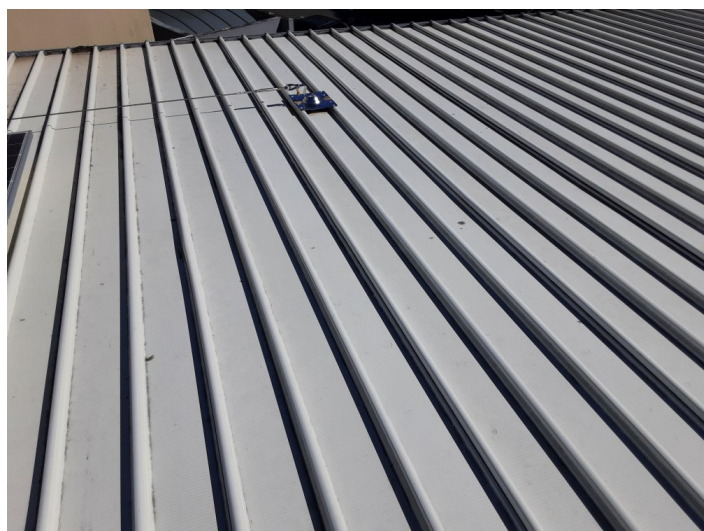
7.6 Are all the fixings installed correctly and in good condition?	Yes
7.7 Are the plates installed on the correct lap?	Yes
7.8 Is there anything else that must be noted?	No
7.9 For Kliploc: Is there the required additional screws in the sheets?	No
7.9.1 Warning: System has failed	
Notes: No additional screws for kliploc

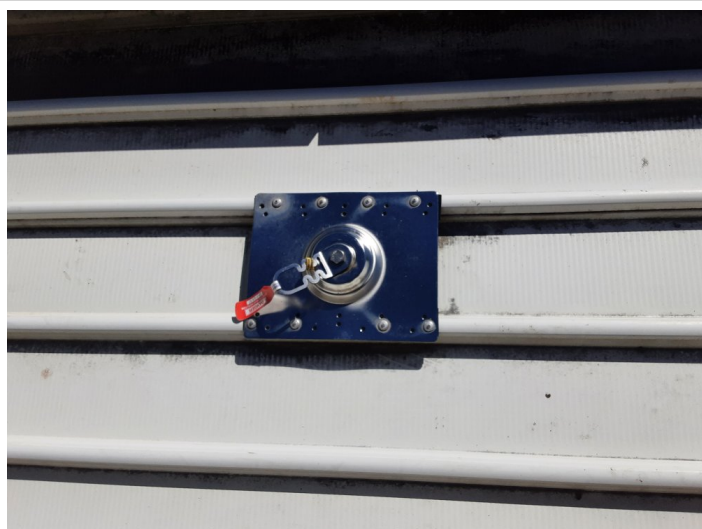
Item #3: Anchor Point Compliance Report

2 Is the system for:	Fall Arrest
3 What is the type of anchor?	Surface mounted
4 Surface type?	Metal Roof
4.1 Roof type	Kliploc 700
4.2 Is the system surface mounted or into a purlin with screws?	Surface Mounted
4.3 Is there a minimum of 3 x purlins under each sheet where an anchor is installed?	Yes
4.4 Is the roof sheeting in good condition and free from rust?	Yes
4.5 Are there any penetrations in the same roof sheet that has the anchor installed that is within 2000mm?	No
4.6 Are all the fixings installed correctly and in good condition?	Yes
4.7 Are the anchors installed on the correct lap?	Yes
4.8 Is there anything else that must be noted?	No
4.9 For Kliploc: Is there the required additional screws in the sheets?	No
4.9.1 Warning: Anchors have failed

Client Notes	Warning: Anchor points have failed due to non-compliance issues with AS1891.4. Anchor points do not have any manufacturer markings or kN rates as required. They have not been installed in a manner that other similar anchors on the market would be installed to meet compliance. We recommend that they are removed and replaced with compliant anchors		
For a list of failed anchors and the reason for failure, please see the attached table.

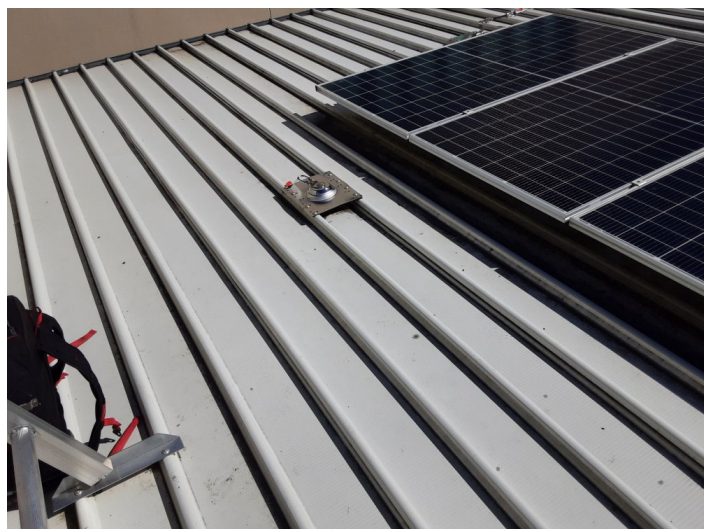
Notes: No additional 14g screws

5 Pitch of roof (in degrees)	3°
6 Does each anchor have clear labels stating manufacturer and rating?	Yes
7 Is the design of the system compliant, allowing 100% connection?	Yes
8 Are there any pendulum risks? You must measure each anchor and ensure that: <ul style="list-style-type: none"> 1. The distance the anchor is from the closest fall edge is the same or LESS than to the next anchor 2. The distance between each anchor is no MORE than 6m 3. If any pendulum issues are found that the EXACT measurements are written clearly on the roof plan 	No
9 Is there a parapet wall?	No
Has the system Passed/Failed?	FAIL
Fail Reason?	No additional 14g screws into purlin above Anchor plates are 1mm thick No manufacturer or kN ratings
Recommendations:	Warning: Anchor points have failed due to non-compliance issues with AS1891.4. Anchor points do not have any manufacturer markings or kN rates as required. They have not been installed in a manner that other similar anchors on the market would be installed to meet compliance. We recommend that they are removed and replaced with compliant anchors

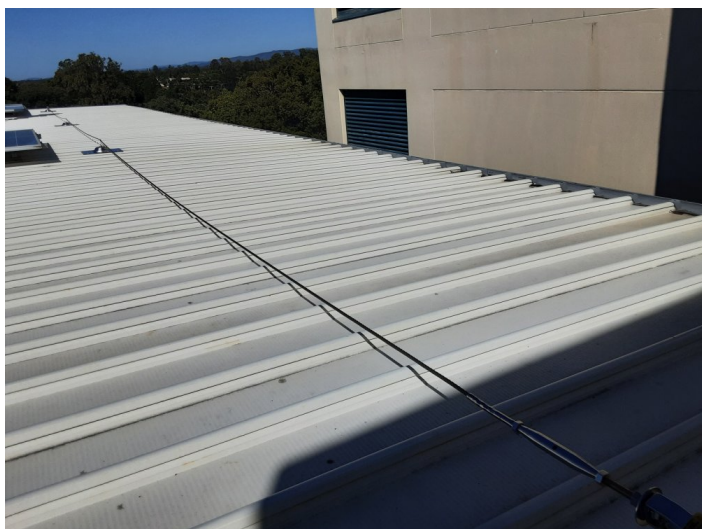
1 Example Photo

8 Does the system have clear labels stating manufacturer, rating and number of users?	Yes
8.1 How many people is the Horizontal Static Line system rated for?	2 Person - 21kN
9 Are there any pendulum risks?	No
10 Is there a parapet wall?	No
11 Length of the system? (in metres)	18
12 Number of intermediate brackets?	2
13 Number of corners?	0
14 The ends are:	swaged
15 Have the ends been tested?	No
16 Method of testing?	
Has the system Passed/Failed?	FAIL
Fail Reason?	No additional 14g screws for kliplok roof sheets No manufacturer or kN ratings Mounting plates are 1mm thick and not suitable for fall Arrest applications
Recommendations:	Warning: Static line has failed due to non-compliance issues with AS1657. The system is missing required 14g screws into a purlin above each plate, has no manufacturer or kN ratings - can not verify load capacity, and the mounting plates are only 1mm thick - which are not suitable for fall Arrest applications. Recommend that the static line be replaced to comply with AS1657

Client Notes	Warning: Static line has failed due to non-compliance issues with AS1657. The system is missing required 14g screws into a purlin above each plate, has no manufacturer or kN ratings - can not verify load capacity, and the mounting plates are only 1mm thick - which are not suitable for fall Arrest applications. Recommend that the static line be replaced to comply with AS1657

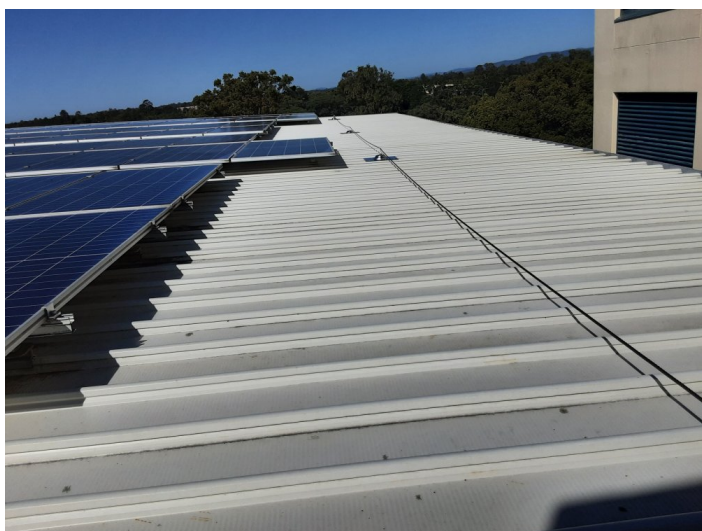
7.6 Are all the fixings installed correctly and in good condition?	Yes
7.7 Are the plates installed on the correct lap?	Yes
7.8 Is there anything else that must be noted?	No
7.9 For Kliploc: Is there the required additional screws in the sheets?	No
7.9.1 Warning: System has failed	
Notes: No additional 14g screws
