# HEIGHT SAFETY INSPECTION REPORT

**Inspection No. 2294**

**Site No. 2415**  
490 Upper Edward Street, Spring Hill

## Inspection - 490 Upper Edward Street, Spring Hill - 490 Upper Edward

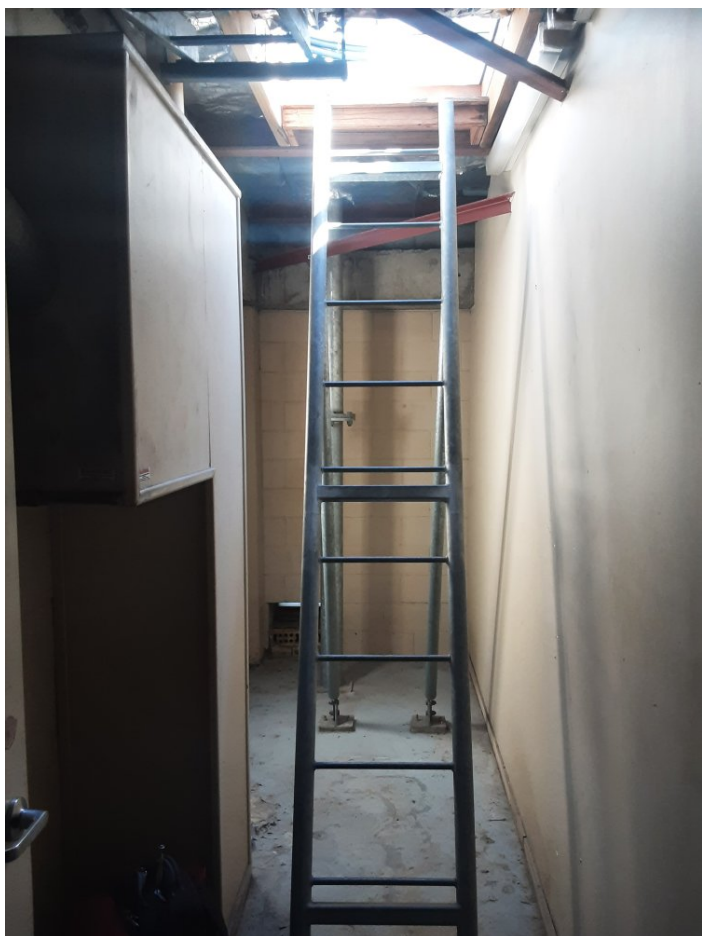
<b>Fail Reason?</b>	Rungs are not nonslip There are steel bars welded inbetween the ladder rungs causing trip hazards Top rung does not have 200mm clear space Space between ladder rung and hatch is only 520mm. Minimum is 750mm Ladder is not able to extend up 1000mm above roof height and does not have grab rails at entry point
<b>Recommendations:</b>	Refer to Quote dated March 2022

<b>Recommendations:</b>	Refer to Quote dated March 2022

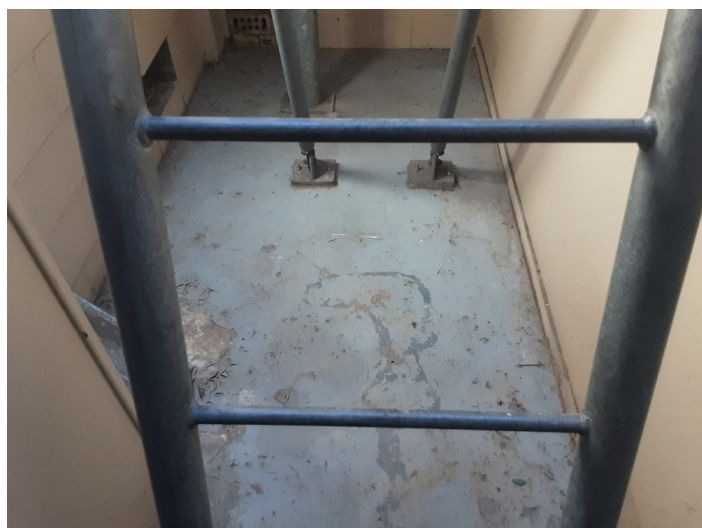
5 Excluding the bottom rung, are all the rungs no less than 250mm and no more than 300mm and the same space apart, within $\pm 5$ mm?	No
5.1 List of rung gaps	Rung 1: 320mm Rung 2: 320mm Rung 3: 320mm Rung 4: 320mm Rung 5: 320mm Rung 6: 320mm Rung 7: 320mm Rung 8: 320mm
6 The rung width must not be less than 20mm and not more than 50mm. Rung width:	20mm
7 Do the rungs have a knurled or anti-slip surface?	No
7.1 Warning: Ladder has failed.	
<b>Notes:</b> No anti-slip rungs

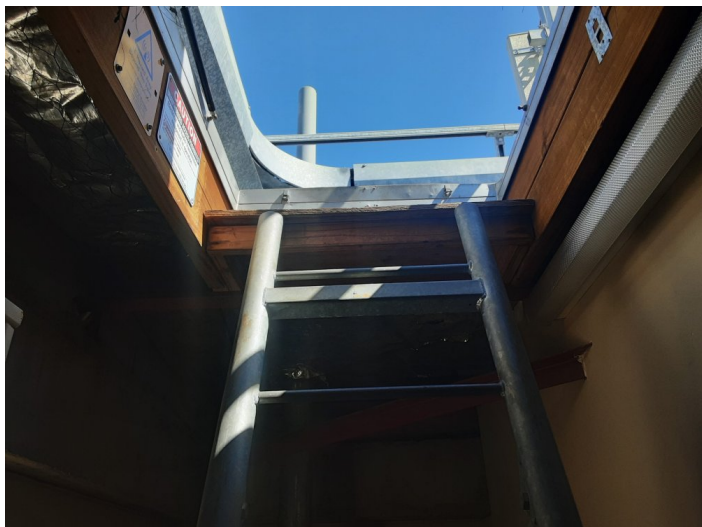
8 Is there a minimum distance of 200mm behind the back of each rung and any object?	Yes
9 Is the top rung level with the top platform?	No
9.1 Warning: Ladder has failed.	
<b>Notes:</b> Ladder is for access through the hatch

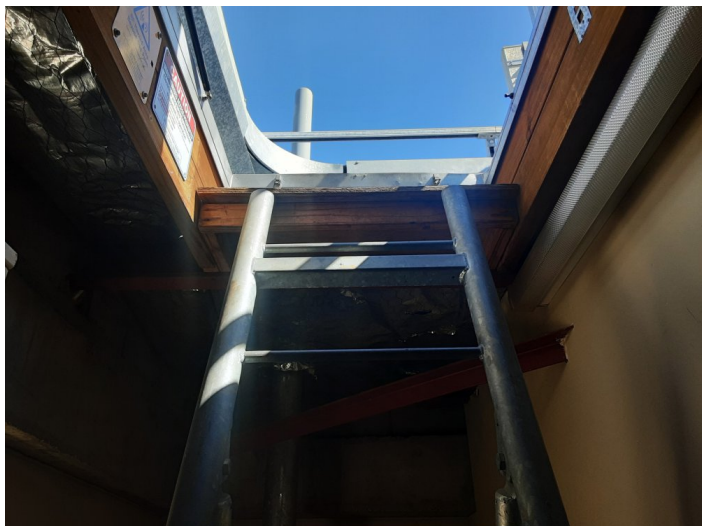
<b>10</b> Is there an gap between the top rung and the platform?	No
<b>11</b> What is the distance between the inside of the stiles of the main ladder body? Must be between 375mm and 525mm	430mm
<b>12</b> What is the width between stiles at step off point? Must be between 525mm and 675mm.	430mm
<b>12.1</b> Warning: Ladder has failed.	
<b>Notes:</b> 430mm at exit point

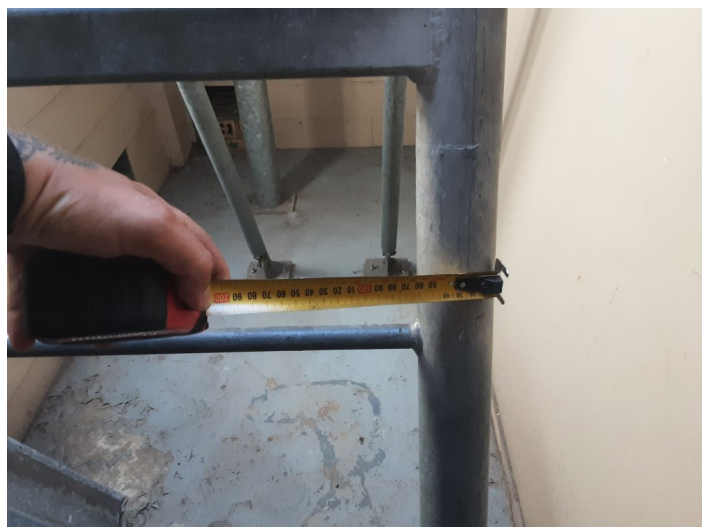
<b>13</b> What are the dimensions of the stiles? Shape must fit within an 80mm circle.	
Stile Width (mm): 60	Stile Depth (mm): 60
<b>13.1</b> Warning: Ladder has failed.	
<b>Notes:</b> 60mm tube

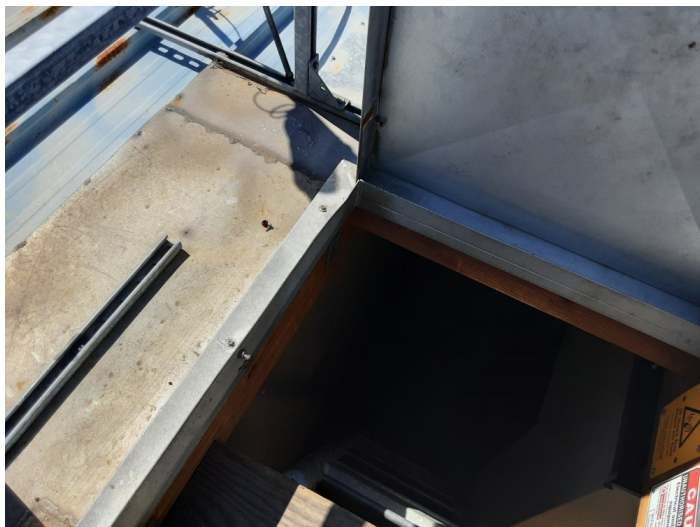
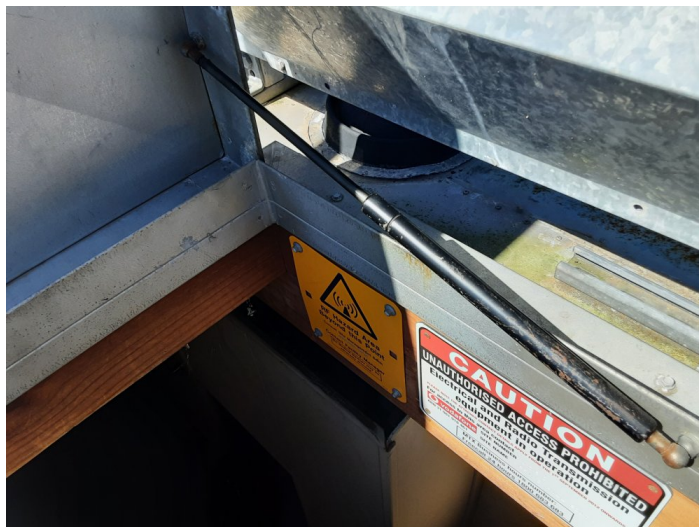
2 What system leads to the hatch?	Angled Ladder
3 What type of hatch is installed?	Standard Access Hatch
4 What are the opening measurements?	
Length (mm): 800mm	Width (mm): 800mm
5 Does the hatch have gas struts to help it open?	Yes
5.1 Are they in good working condition?	No
5.1.1 Record sizes and ratings of the struts	
<b>Notes:</b> 1 x gas strut is missing - hatch still opens and closes safely 250mm long x 20mm thick

6 Is the opening size sufficient to allow a minimum of 750mm from front of ladder access rung to back edge of hatch? Record measurement in mm	500mm
7 How do you step out of the hatch?	Directly Forward
Has the system Passed/Failed?	PASS
Recommendations:	Warning: The hatch lid only has one working gas strut installed to help with opening and closing the hatch lid. Recommend that a new strut be installed

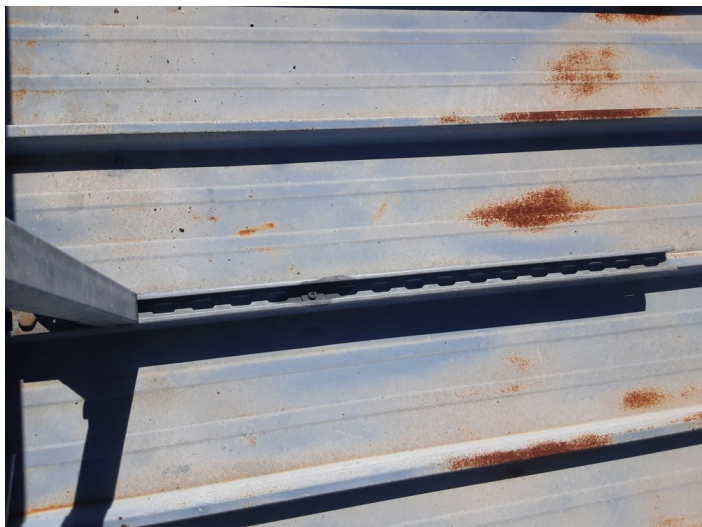
2 What is the guard railing made from?	Steel
3 How long is the section of guard railing in metres?	30m
4 How many corners?	6
4.1 All corners must have one post within 300mm one side and 2000mm the other if only a single post (1 x bay) construction or 400mm one side and 2200mm the other if more than two posts continuing in the run. Are all corners compliant?	Yes
5 What type of surface is the guard railing mounted to?	Metal Roof
5.1 Metal Roof type	Kliploc 700
5.2 Are the bases a minimum of 800mm long or have an approved short base design and installed using either 3 x 7.7mm rivets or 4 x 5.2mm rivets?	No
5.2.1 Are the bases considered compliant?	No
5.2.2 Describe the issues and list how many	
<b>Notes:</b> Only 1 screw in bases

Has the system Passed/Failed?	FAIL
Fail Reason?	The bases only have one screw installed causing the guard railing to rock back and forth over the 100mm allowed in AS1657 The maximum gap between the top and mid rail must not exceed 450mm. The gap ranges from 460mm to over 480mm
Recommendations:	Refer to Quote dated March 2022

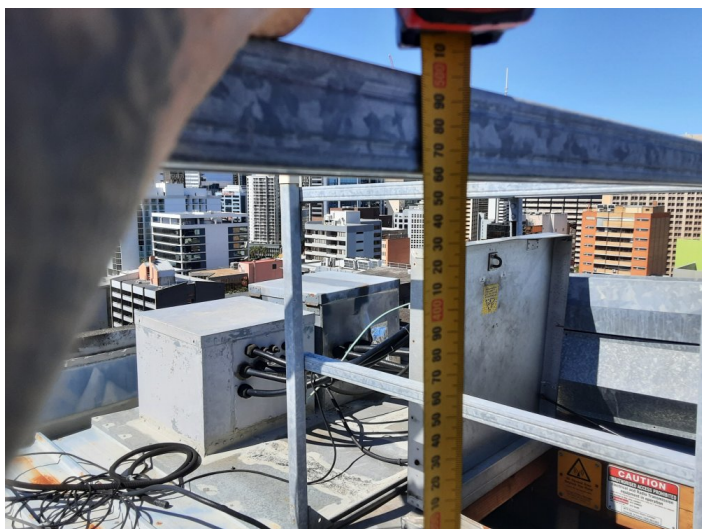
6 When applying pressure to the guard railing posts, is there more than 100mm of movement?	No
7 What is the height from surface to top of top rail? (must be between 900mm and 1100mm)	1100mm
8 What is the height from the under side of the top rail to the top side of the mid rail? (must be below 450mm)	460mm
8.1 Warning: system has failed.	
<b>Notes:</b> Height from underside of top rail to top of mid rail is 460

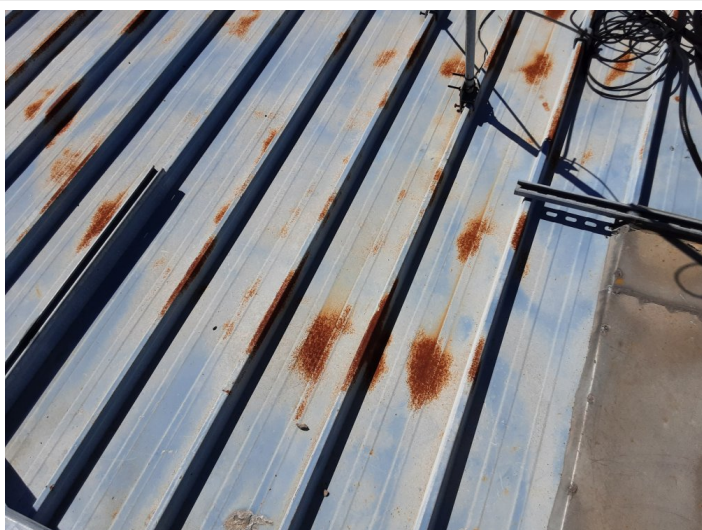
5 How long is the section of walkway in metres?	13m
6 Walkway must be a minimum of 600mm wide. The width of the walkway is:	600mm
7 What is the pitch of the roof in degrees?	3°
8 Does the walkway run across the roof pitch?	Yes
9 Does the walkway run up the roof pitch?	No
10 Are all the joiner and end bars correctly installed and with require fixings?	Yes
11 Are all the fixings in good condition and installed correctly?	Yes
12 Anything else needs to be noted?	Yes
12.1 Describe the issues	
<b>Notes:</b> Roof is showing signs of rust

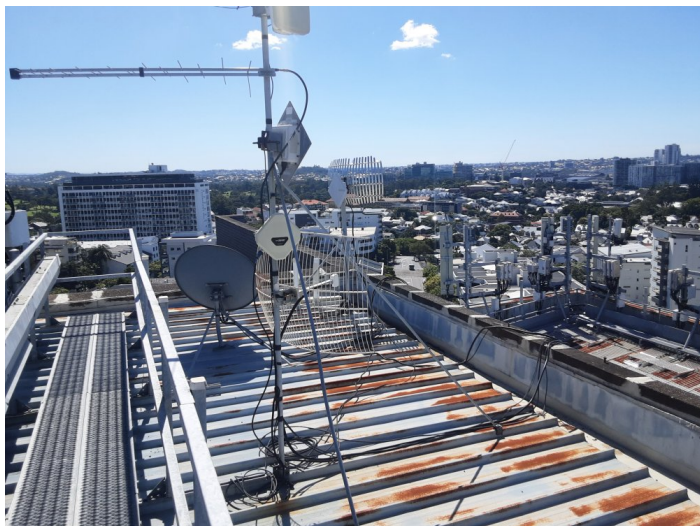
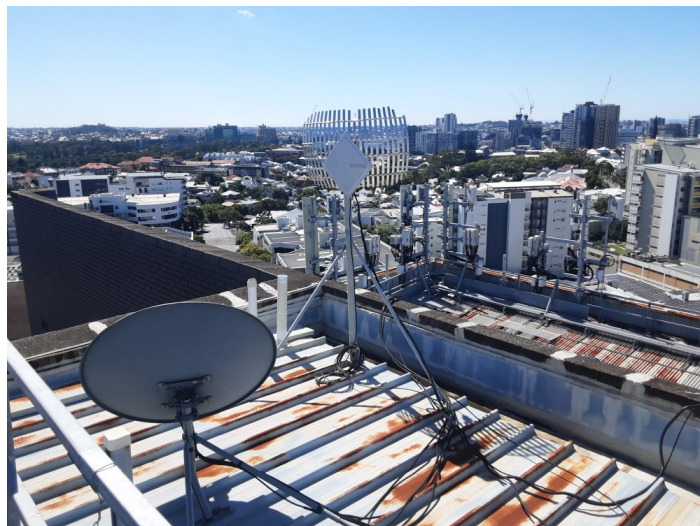
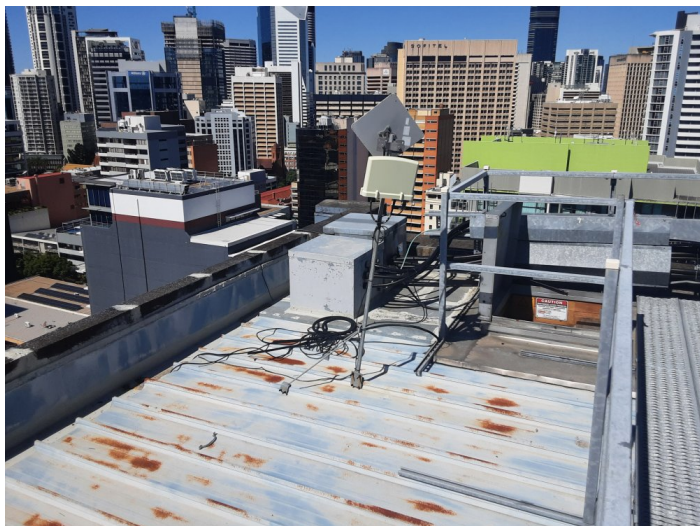
If work needs to be done on services, there is no access or height Safety installed - there is guardrail installed that prevents you from entering this section of the roof without climbing over it  
Roof is showing signs of rust

Warning: There is no access to be able to work on the services on the roof if needed, there is guardrail installed next to the walkway that you would have to climb through. There are also no height safety systems in place to attach to, to work safely near the roofs edge. The roof sheeting is also showing signs of rust and should be monitored.

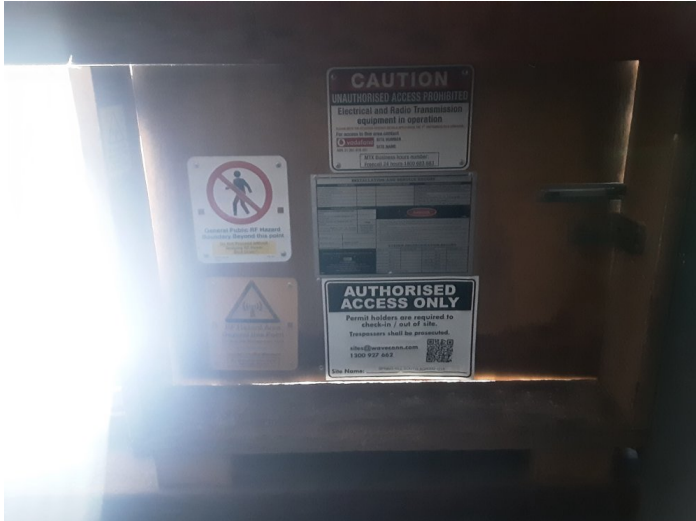
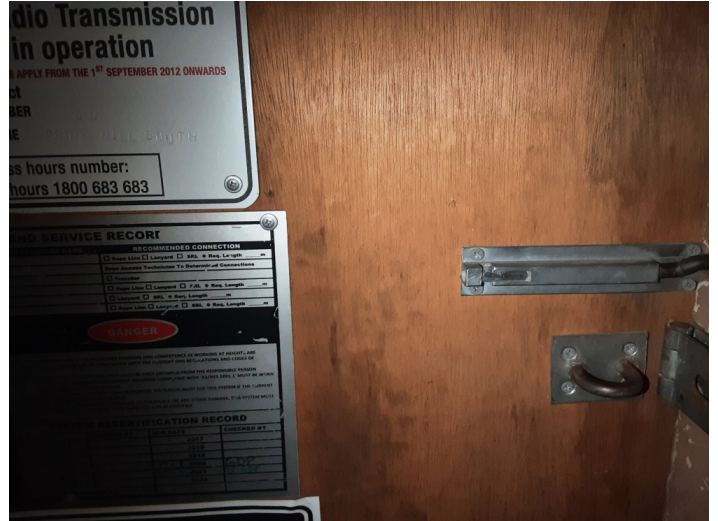
<b>3 Describe the issue with as much detail as required</b>	
The sliding pin lock is broken on the door to get out onto the Lower Roof, unable to slide the pin to unlock the door and get out onto the roof unless you pull the door towards you to release the tension - spoke to Kai and he already knew about it	
<b>Observation Status:</b>	Information for Client, not risk related
<b>Recommendations:</b>	Warning: The sliding pin lock is broken on the door to get out onto the Lower Roof, recommend that the lock be replaced

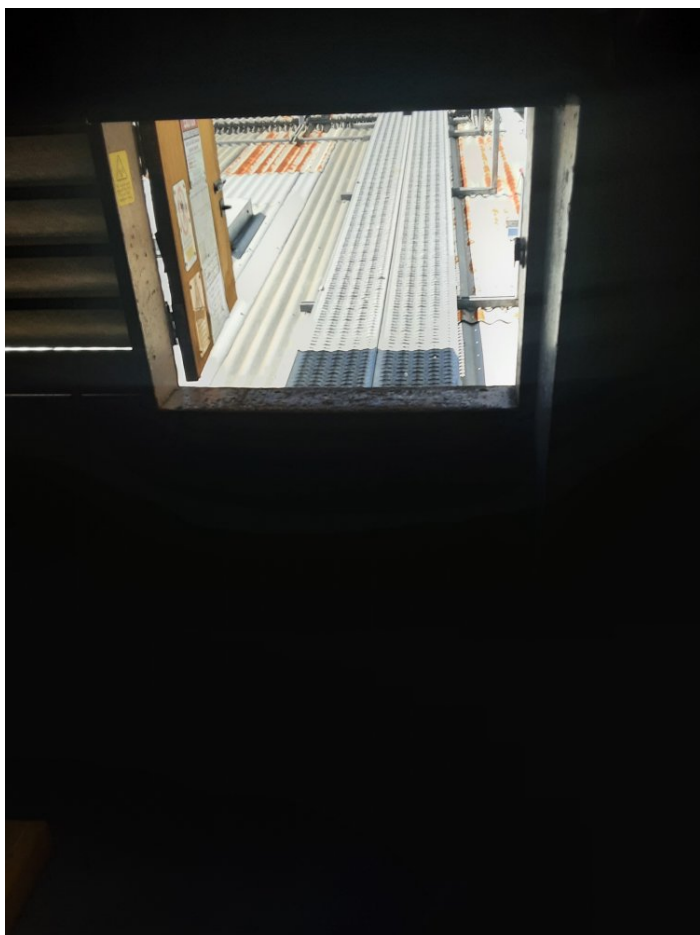
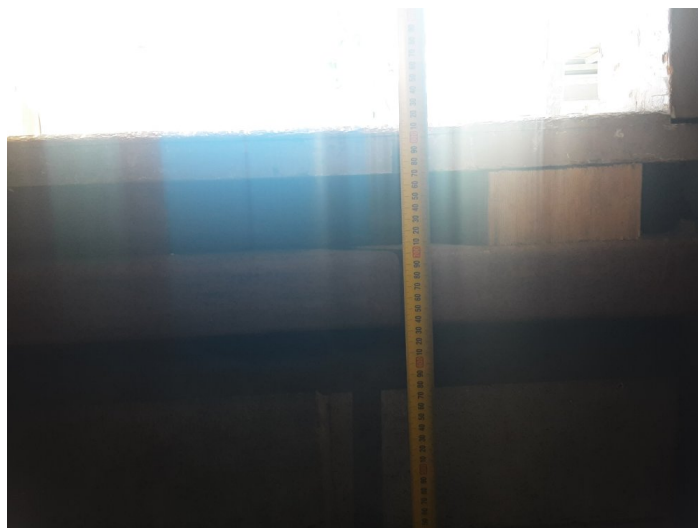
810mm step up through little door

3 Describe the issue with as much detail as required	
Step through small door: 810mm	
Recommendations:	Refer to Quote dated March 2022

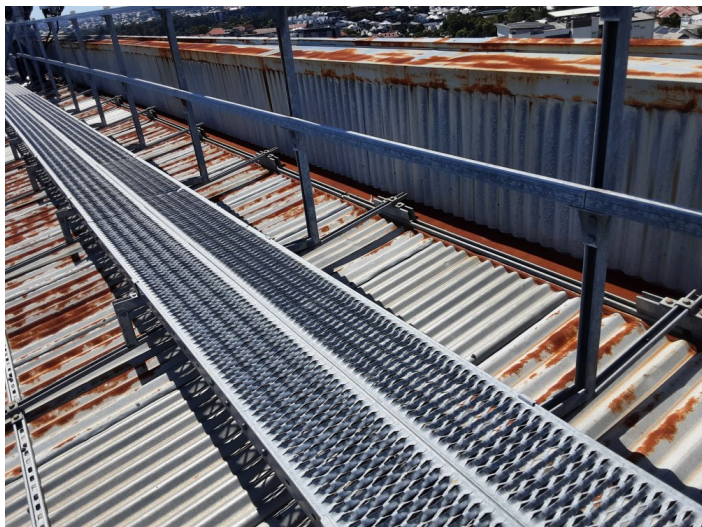
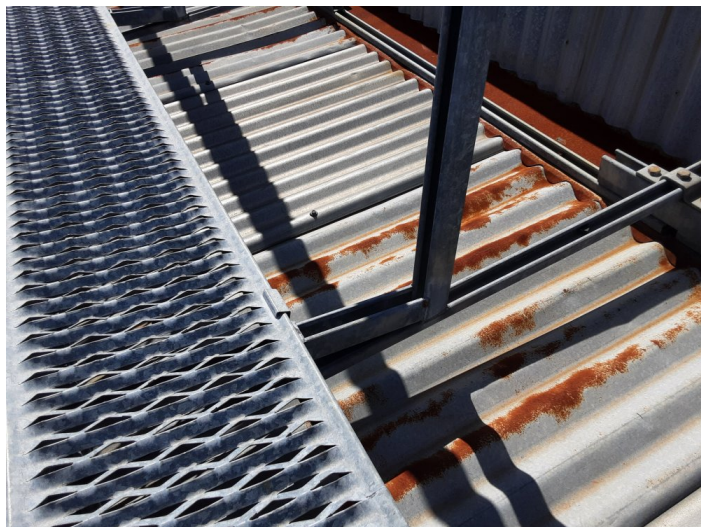
5.3 Does each base and post have a compliant brace at approximately 45°?	No
5.3.1 Describe the issues and how many are non-compliant	
Notes: No braces at any post

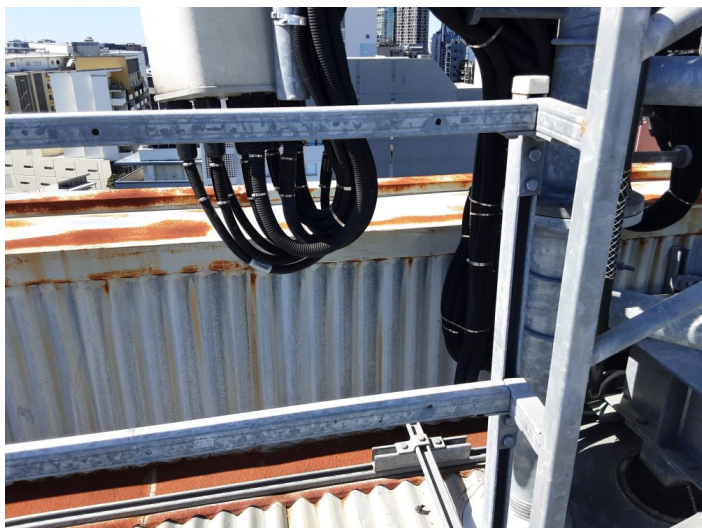
**Notes:** No braces are installed at all

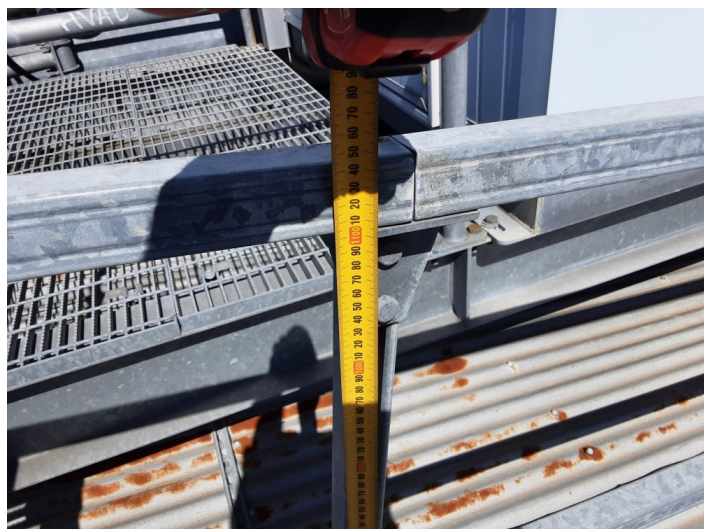
**Notes:** Height from surface to top of top rail is 1150

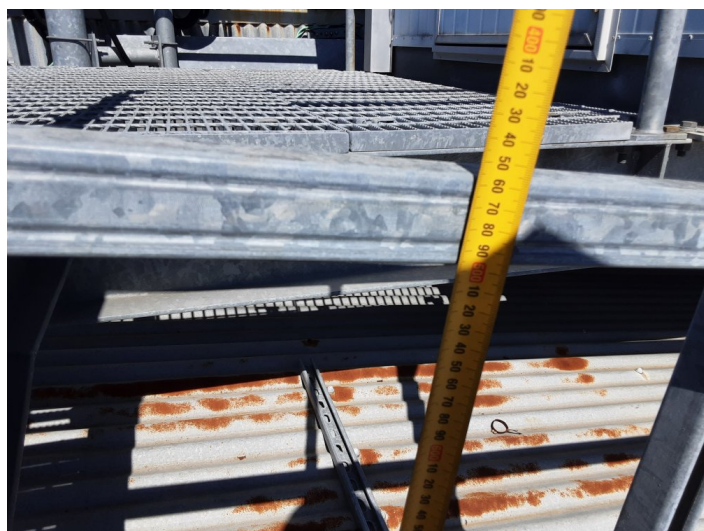
**Notes:** Height from underside of top rail to top of mid rail is 455

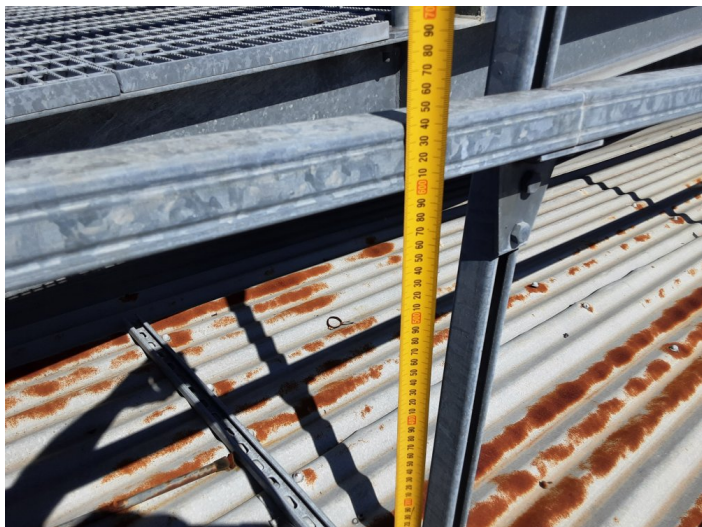
**Notes:** Height from surface to bottom of mid rail is 600

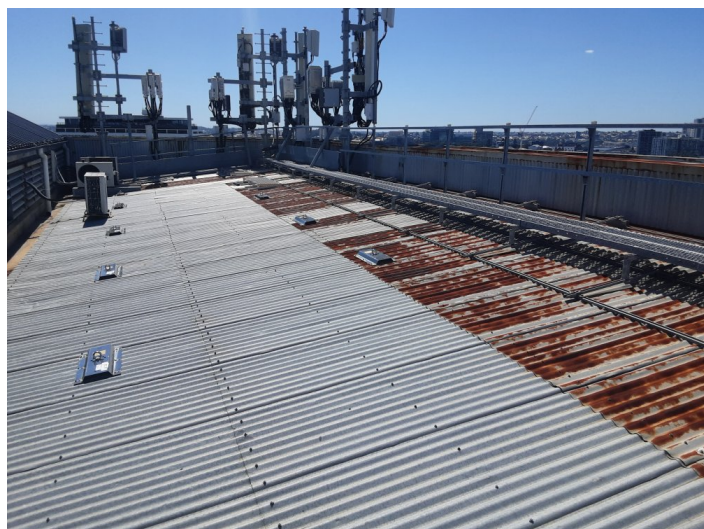
**Notes:** 4 x anchors installed on rusted sheets

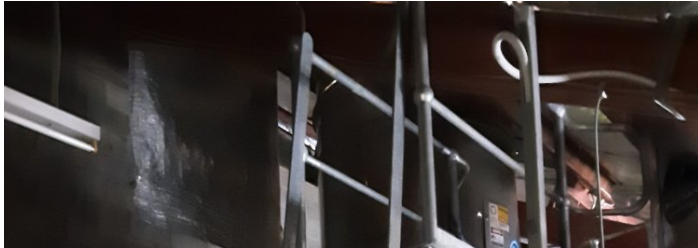
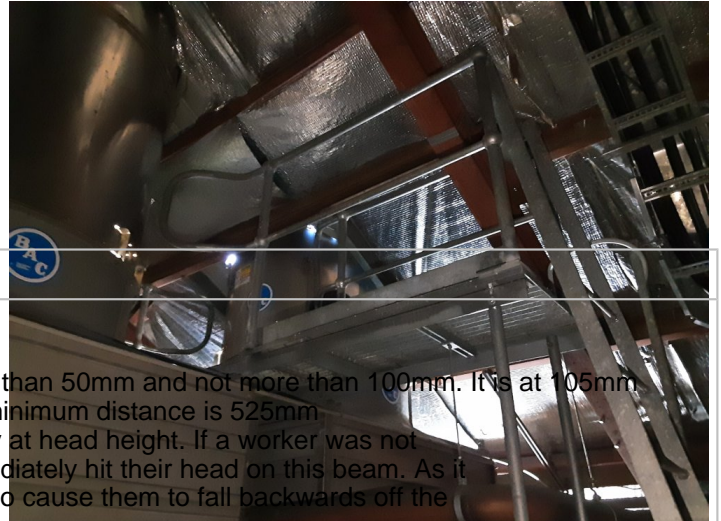
Bottom rung is not within 10%  
 The rungs do not have a non slip surface  
 The top rung is not within the specified tolerance of not less than 50mm and not more than 100mm. It is at 105mm  
 Distance between top stiles is 465mm. AS1657 states the minimum distance is 525mm  
 Upon reaching the top of the ladder, there is a beam directly at head height. If a worker was not watching when they stepped off the ladder they would immediately hit their head on this beam. As it is right on the edge of the platform, this is most likely going to cause them to fall backwards off the ladder  
 Bottom of the ladder does not have the minimum required 600mm clearance

This ladder is not able to be rectified due to the location of the beam. We would recommend that we remove the ladder, extend the platform and install a new ladder at 90°. This will allow workers to be fully on the platform and away from the edge when they are required to duck under the beam. Remove and dispose of the current noncompliant ladder Installation of a custom platform 600mm wide by 900mm with guard railing and self supporting legs (vertical height from top of platform to slab 2660mm) Installation of custom made aluminium angled ladder Note, may require a lower levelled platform to bridge across services Low head room sign for beam
