HEIGHT SAFETY INSPECTION REPORT

Inspection No. 2214

Site No. 2419
Anglicare - 12 King Street, Caboolture

Inspection - Anglicare - 12 King Street, Caboolture

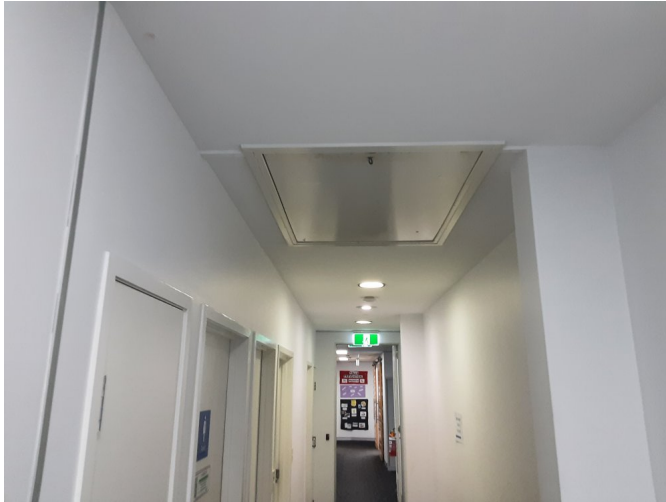
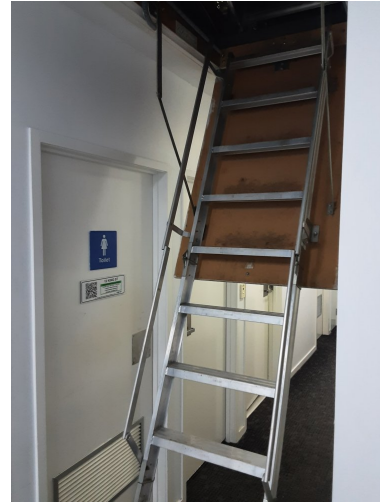
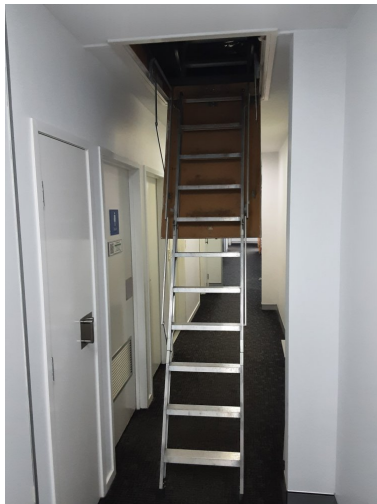
1 Example Photo

2 Type of fold down ladder	Other
2.1 Other	
3 What is the vertical height from ceiling to floor?	3000mm
4 What is the width of the ladder between the stiles?	465mm
5 What angle in degrees is the ladder when extended?	69°
6 What is the width of the ladder rungs?	80mm

System Type	Item Status	Recommendation
MAIN ROOF - Item #1 - Fold Down Ladder	PWC	Warning: Fold Down Ladder has Passed With Conditions (PWC) and approved for limited use. The non-compliances identified include: Minimal foot clearance between ladder rungs and the lid surface with also a smaller top step which may affect footing and stability when transitioning to the next ladder. Be sure to maintain 3 points of contact at all times when using the system. This ladder should be upgraded or modified to comply with AS1657.

Has the system Passed/Failed?	PWC
PWC Condition:	Minor noncompliance/Low risk. Additional care required during use/access. Prior to use/access person/s must be provided with this report and understand the issue. Only authorised person/s can access
PWC Details:	125mm foot clearance from front of ladder rung to the Fold Down Ladder lid Top step is 210mm from top of ladder rung to top of Fold Down Ladder User to be aware when climbing the ladder
Recommendations:	Warning: Fold Down Ladder has Passed With Conditions (PWC) and approved for limited use. The non-compliances identified include: Minimal foot clearance between ladder rungs and the lid surface with also a smaller top step which may affect footing and stability when transitioning to the next ladder. Be sure to maintain 3 points of contact at all times when using the system. This ladder should be upgraded or modified to comply with AS1657.

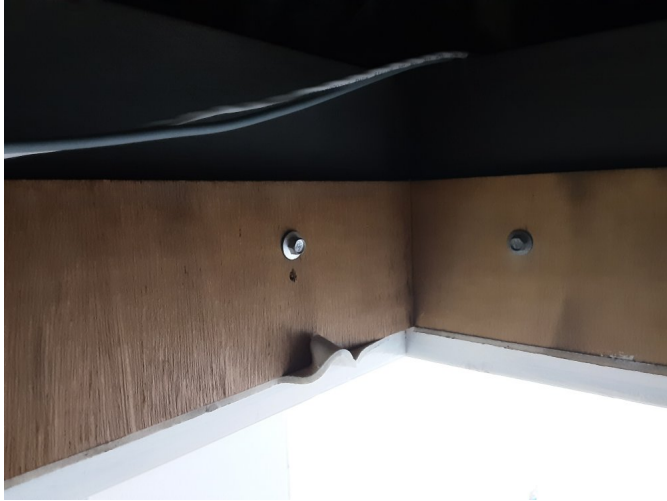
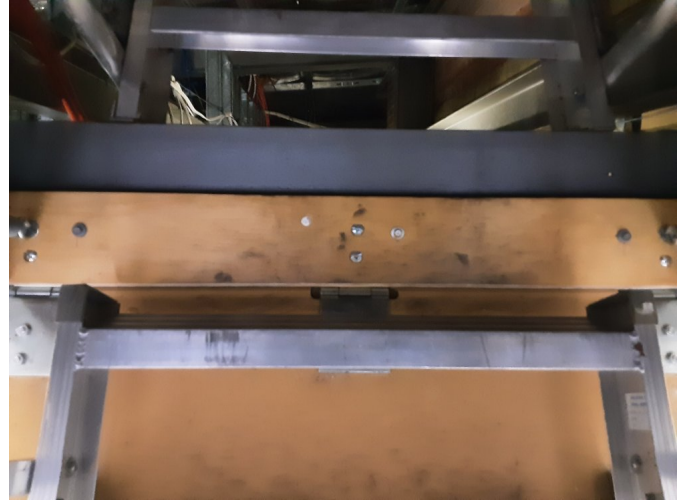
7 How is the ladder installed?	Fixed into solid frame
7.3 Take a photo and describe how it has been fixed to the frame and if there are any issues	
Notes: Tek screws into steel frame

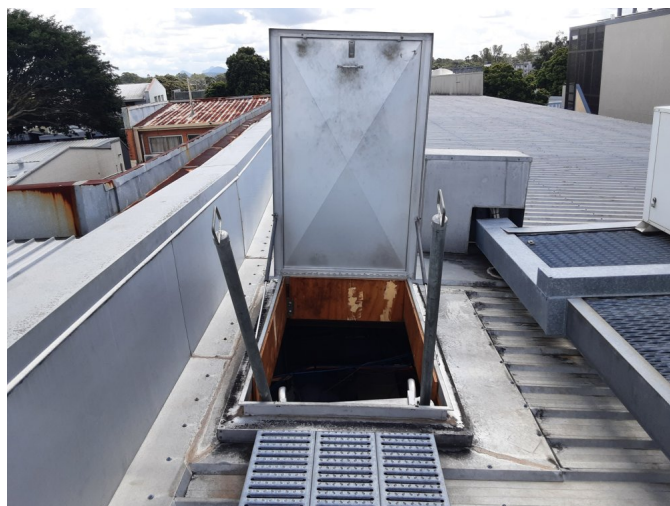
20.1 Describe the issues and take photos where applicable	
Notes: Step Type Ladder is to get through hatch

Has the system Passed/Failed?	PWC
PWC Condition:	Minor noncompliance/Low risk. Additional care required during use/access. Prior to use/access person/s must be provided with this report and understand the issue. Only authorised person/s can access
PWC Details:	Bottom rung is 150mm from steel beam - cut to size to fit in cavity between Fold Down Ladder and Hatch lid
Recommendations:	Warning: Step Type Ladder has Passed With Conditions (PWC) and has minor non-compliance with AS1657. The first step is smaller than standard - potentially impacting foot stability, and the system is positioned between a fold down ladder and hatch - requiring careful transition. System should only be used by trained personnel, maintain 3 points of contact at all times and take extra caution when stepping on/off the first rung.

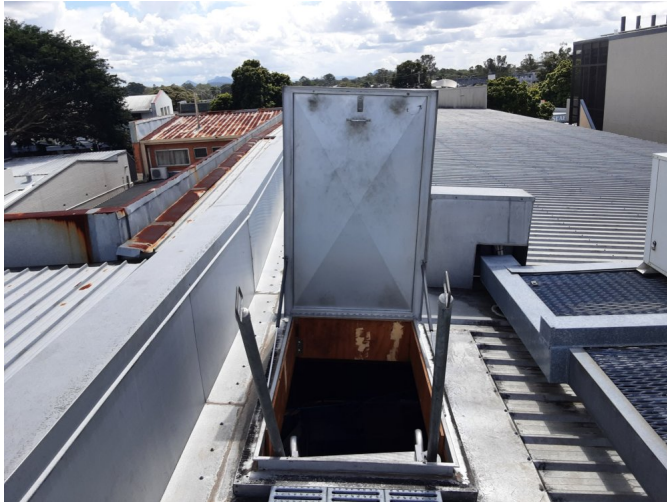
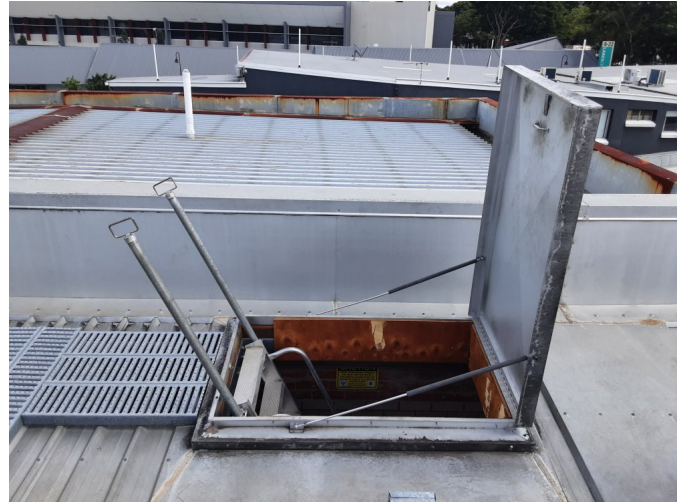
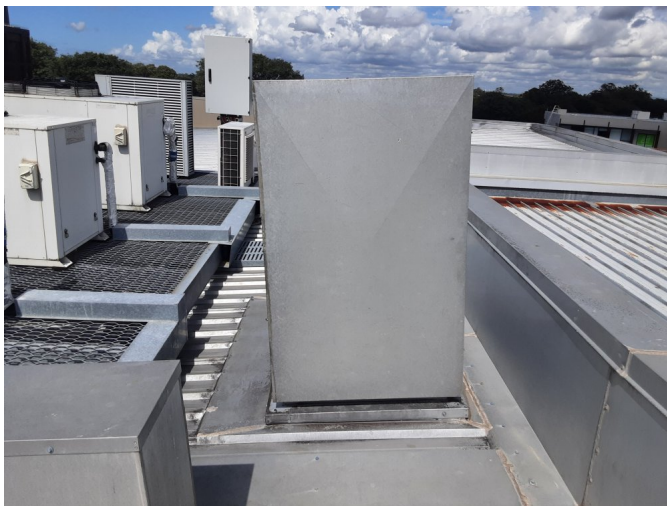
1 Example Photo

2 What system leads to the hatch?	Step Type Ladder
3 What type of hatch is installed?	Standard Access Hatch
4 What are the opening measurements?	
Length (mm): 1450mm	Width (mm): 840mm
5 Does the hatch have gas struts to help it open?	Yes
5.1 Are they in good working condition?	Yes

6 Is the opening size sufficient to allow a minimum of 750mm from front of ladder access rung to back edge of hatch? Record measurement in mm	1230mm
7 How do you step out of the hatch?	Directly Forward
Has the system Passed/Failed?	PASS

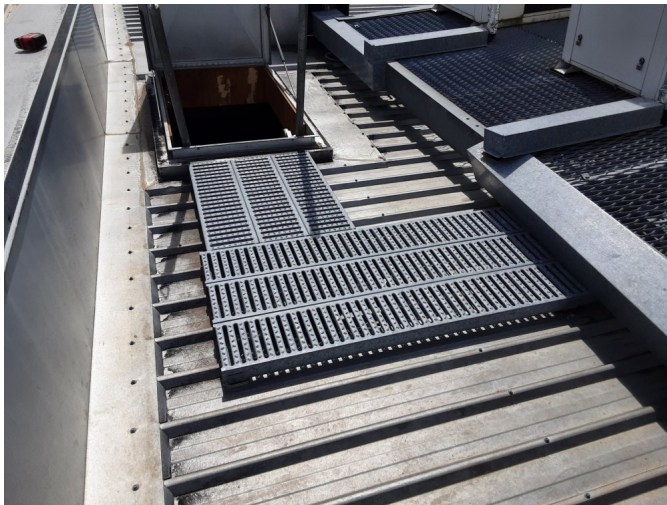
1 Example Photo

2 What is the walkway made from?	Steel
3 Type of surface it is mounted to	Trimdek
4 Take a photo of the roof profile

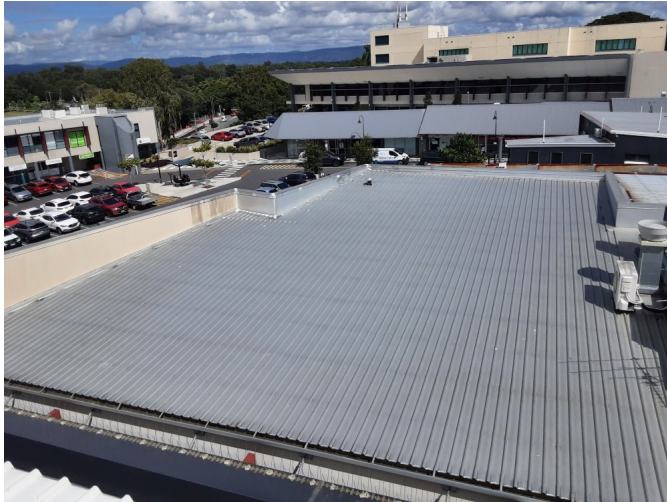
Photo taken from building next door - no systems installed

3 Describe the issue with as much detail as required	No height Safety systems on roof. May need anchors installed if work is to be done on the gutters
--	--

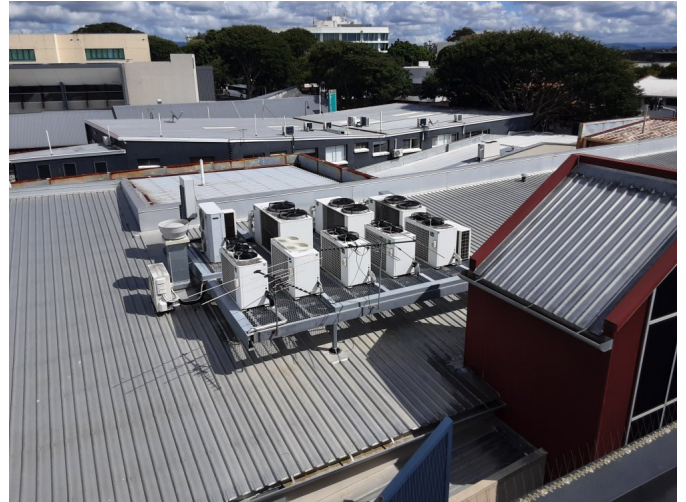
Photo taken from building next door - no systems installed

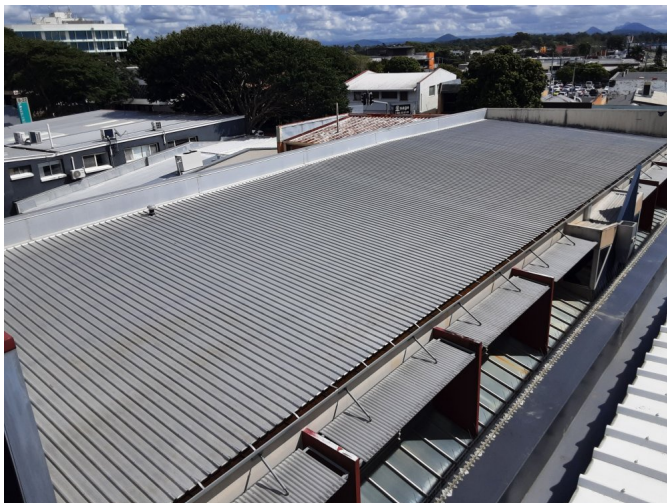
Photo taken from building next door - no systems installed

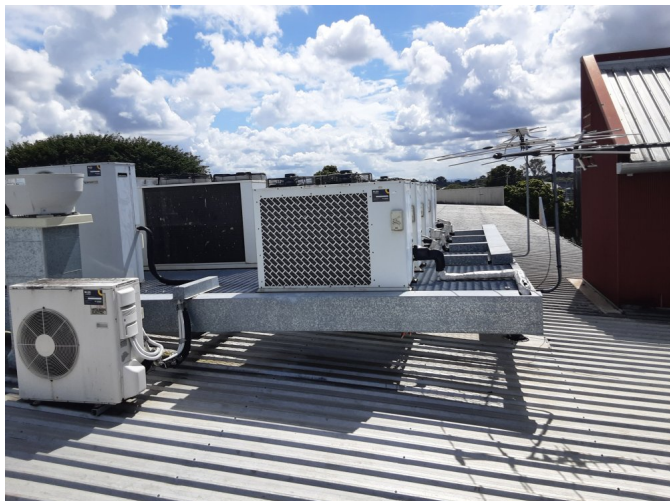
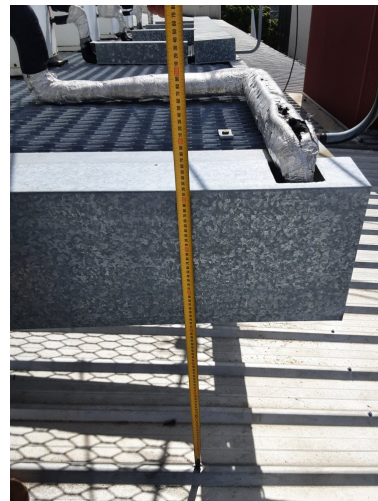
815mm drop off of plantdeck onto roof

26m of side mount guardrail to go around plant deck. There are a number of aircon units on the plant deck. The plant deck has a 75mm x 200mm c beam a 10mm thick around the perimeter.

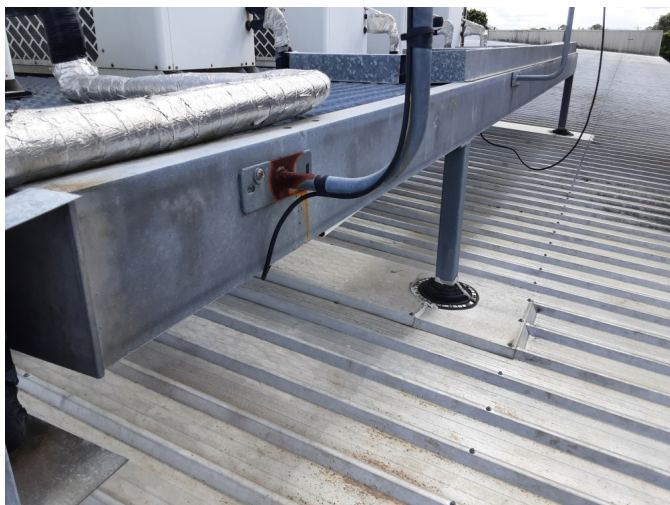
75x200 c beam

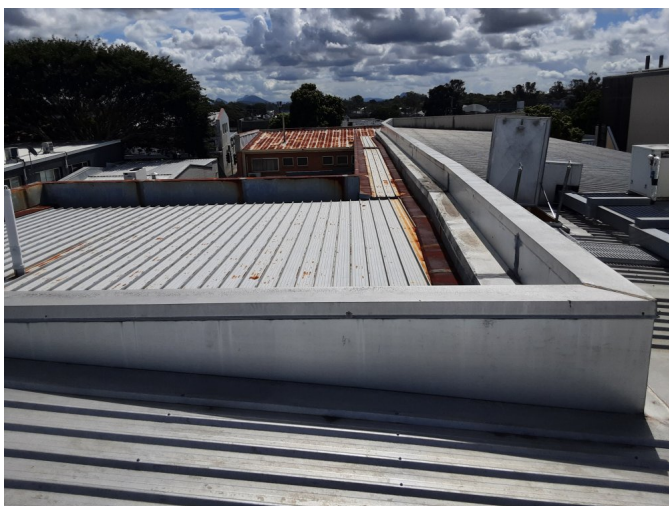
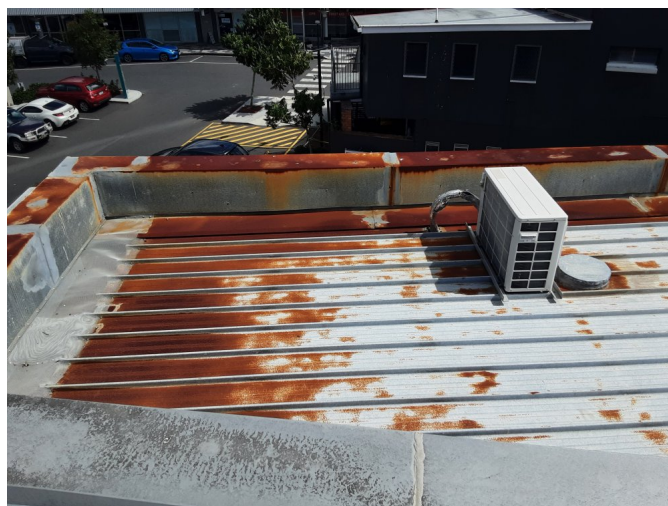
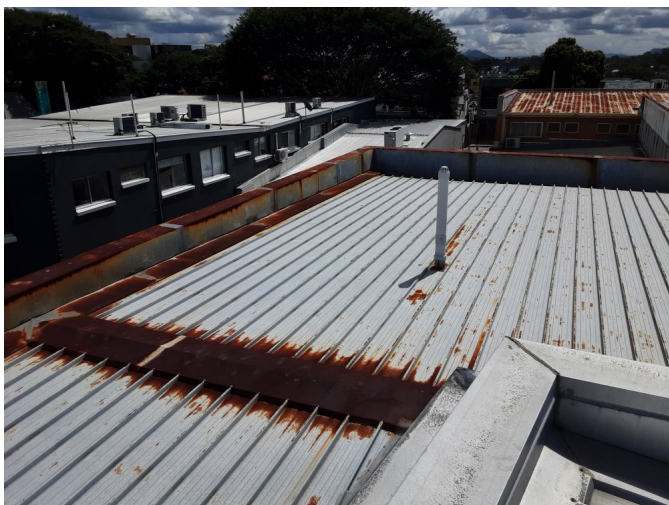
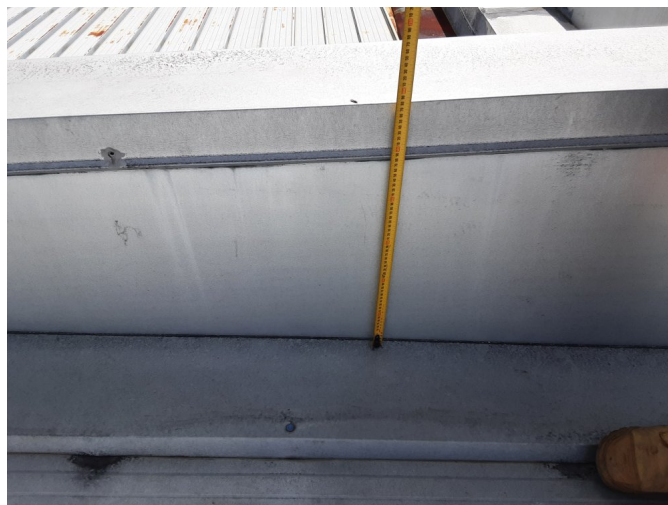
MAIN ROOF - Item #7 - Observation		Warning: DO NOT ENTER this lower roof area. Roof sheets have been identified as severely rusted and structurally compromised. This area is non-compliant with safe access and structural requirements under AS1657 and must not be accessed under any circumstances. Access should be prohibited until the roof is repaired and certified safe by a competent person.

580mm parapet wall
