HEIGHT SAFETY INSPECTION REPORT

Inspection No. 2217

Site No. 2421
10 King Street, Caboolture

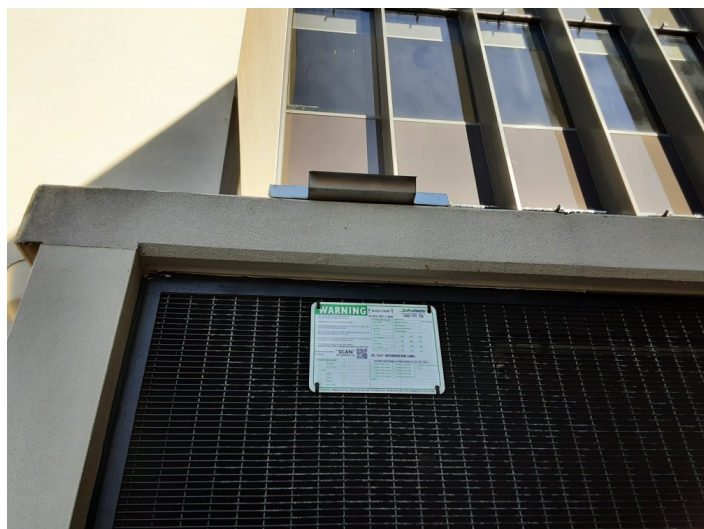
1 Example Photo

Identification #	LB1
Date of Certification	11/04/2025
Date of Next Certification	11/04/2026
Date Installed	Unknown
Who installed this system?	
Brand/Model	Safemaster Ladder bracket

14 Is there a compliant anchor and strop in place?	No. There is an anchor and strop but it has failed. See next item
Warning: This is a failure	
Warning: Fail ladder bracket due to no strop	
Has the system Passed/Failed?	FAIL
Fail Reason?	Non-compliant strop cable attached to anchor for safe access on and off of the roof
Recommendations:	Warning: Ladder bracket has failed as it does not have a ladder securing cable and the fall arrest strop cable has failed. See next item for details on strop cable

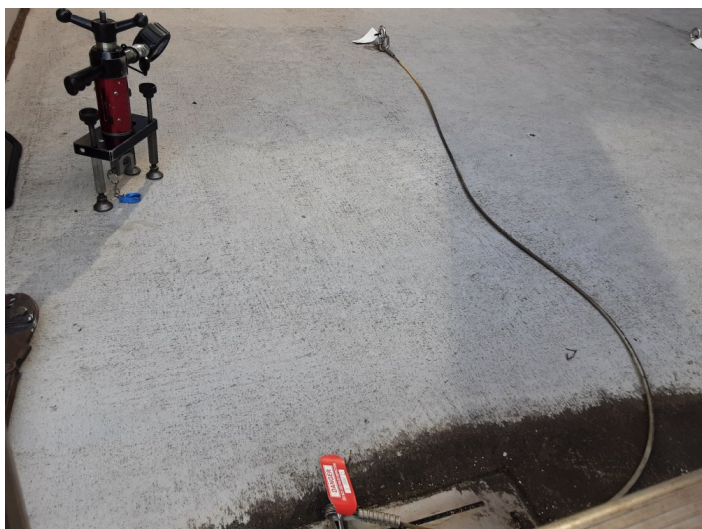
1 Example Photo

Identification #	SC1
Date of Certification	11/04/2025
Date of Next Certification	11/04/2026
Date Installed	Unknown
Who installed this system?	
Brand/Model	Safemaster Strop

Warning: Strop has failed due to having no manufacturer or kN ratings and also showing corrosion. There should be no access onto this roof until rectified. If access is required, additional controls must be put in place to reduce the risk of an incident

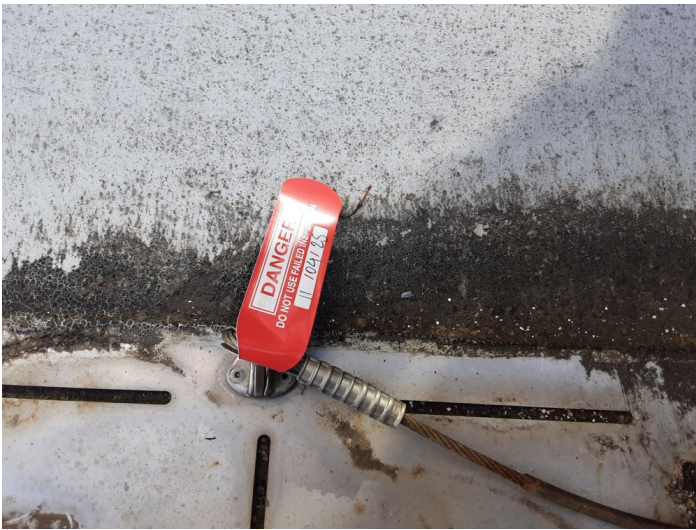
2 What is the diameter of the cable?	5.5m
3 What is the length of the cable? (in mm)	3000mm
4 When the cable is extended to the ladder bracket, it must not be more than 100mm past the front of the ladder bracket or more than 300mm back from the ladder rung which is inline with the ladder bracket. What is the measurement? Positive number for past the front of the ladder bracket, negative number for back in toward the roof	50mm
5 Do any fittings have a rating of 15kN or more clearly marked?	No
5.1 Does the fitting have a minimum diameter of 6mm?	No
5.1.1 Warning: Strop cable has failed	
Notes: No clear manufacturer or kN ratings

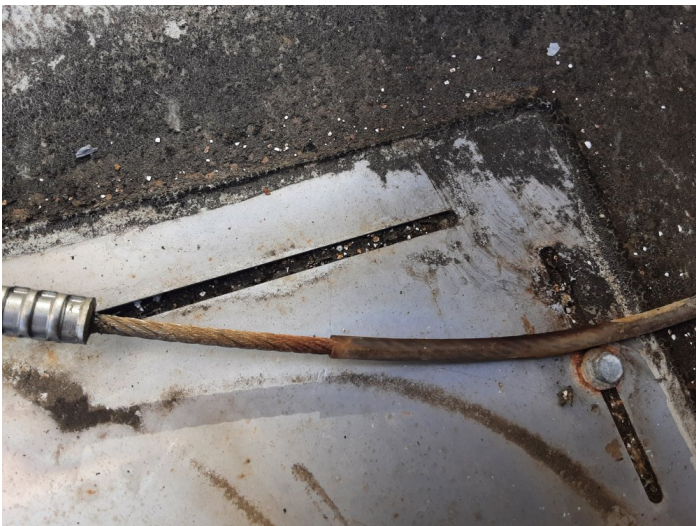
6 Is the strop cable in good condition and free from rust?	No
6.1 Provide description and take photos	
Notes: Rust showing on strop cable

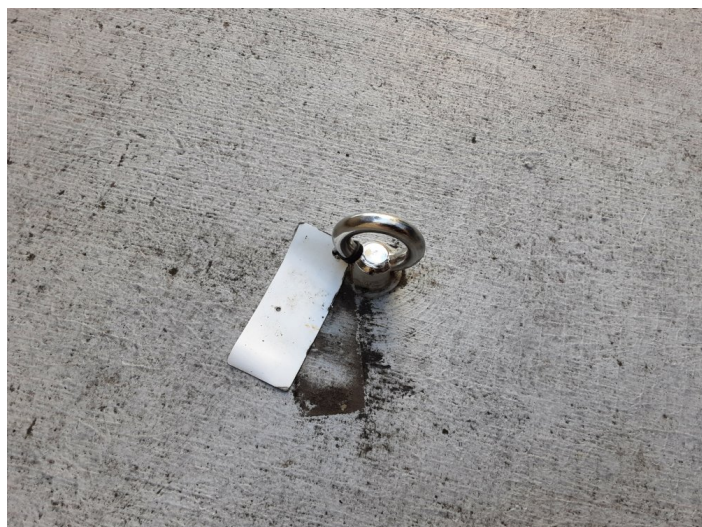
Identification #	AP1
Date of Certification	11/04/2025
Date of Next Certification	11/04/2026
Date Installed	-
Who installed this system?	
Brand/Model	Safemaster Concrete anchor
1 Example Photo

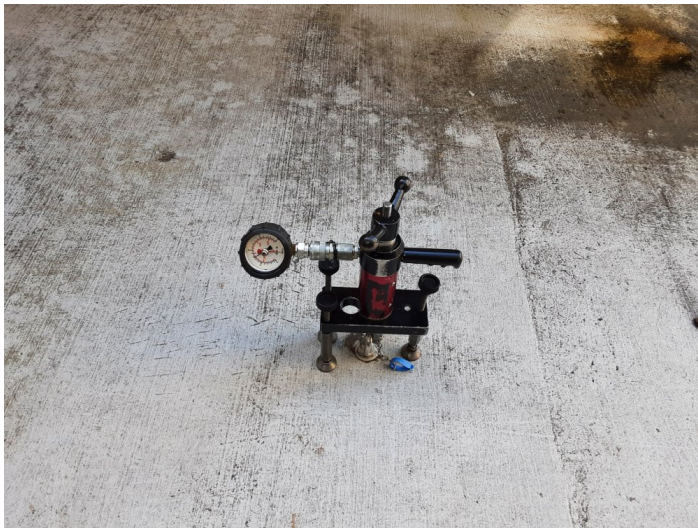
Anchor 1 pull tested at 7.5kN for 3 minutes

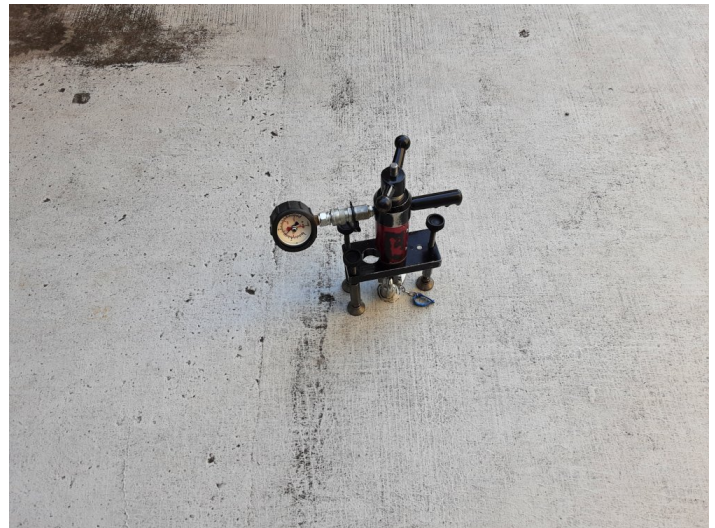
Anchor 2 pull tested at 7.5kN for 3 minutes

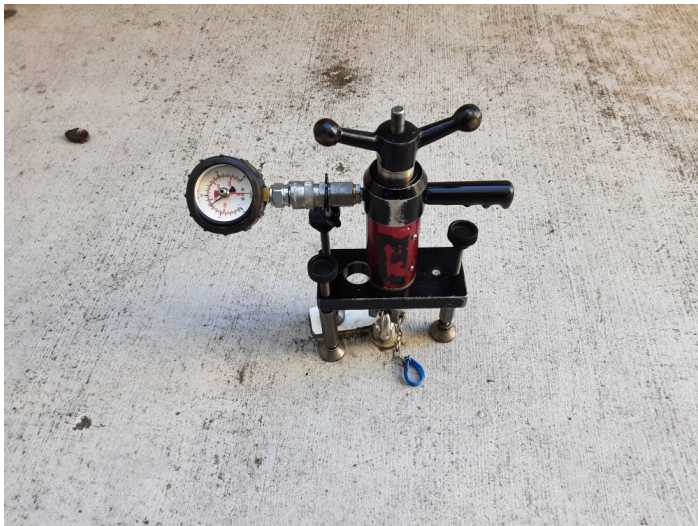
Anchor 3 pull tested at 7.5kN for 3 minutes

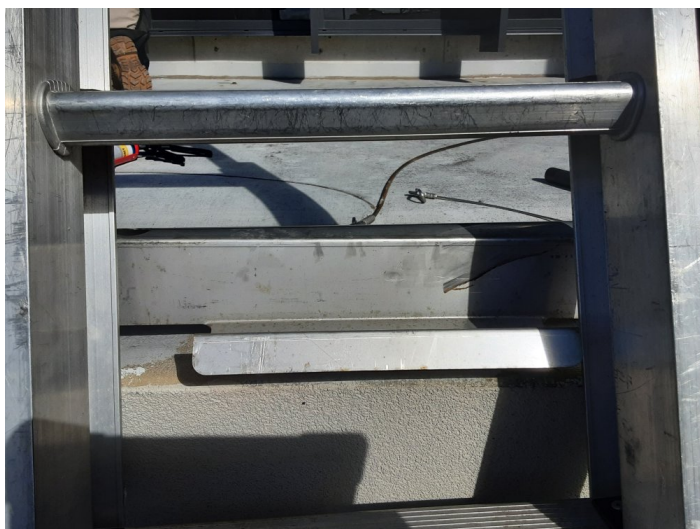
1 Example Photo

Identification #	LB1
Date of Certification	11/04/2025
Date of Next Certification	11/04/2026
Date Installed	Unknown
Who installed this system?	
Brand/Model	Safemaster Ladder Bracker

14 Is there a compliant anchor and strop in place?	No. There is an anchor and strop but it has failed. See next item
Warning: This is a failure	
Warning: Fail ladder bracket due to no strop	
Has the system Passed/Failed?	FAIL
Fail Reason?	Ladder bracket has been installed incorrectly. Ladder cannot be mounted correctly. There is also no ladder securing strop cable to tie the ladder off
Recommendations:	Warning: Ladder bracket has been installed incorrectly. Ladder cannot be mounted correctly. There is also no ladder securing strop cable to tie the ladder off. The fall arrest strop cable has also failed. Refer to next item

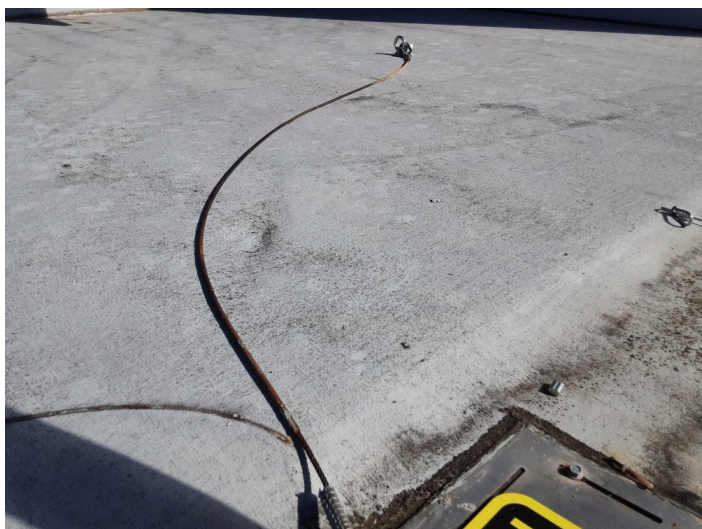
1 Example Photo

Identification #	SC1
Date of Certification	11/04/2025
Date of Next Certification	11/04/2026
Date Installed	Unknown
Who installed this system?	
Brand/Model	Safemaster Strop

9 While attached to the strop cable can you reach the first anchor, static line or rail system?	Yes
10 Anything else to be notes?	No
Has the system Passed/Failed?	FAIL
Fail Reason?	No manufacturer or kN ratings Corrosion showing Pendulum issue when attached to strop and getting on and off of roof
Recommendations:	Warning: Strop has failed due to having no manufacturer or kN ratings and also showing corrosion. There is also a pendulum risk when attaching to the strop from the ladder while climbing on and off of the roof. There should be no access onto this roof until rectified

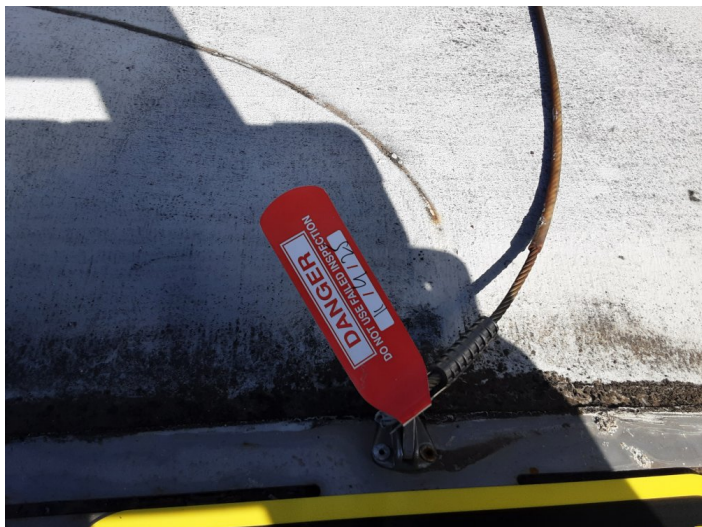
2 What is the diameter of the cable?	5.5m
3 What is the length of the cable? (in mm)	2300mm
4 When the cable is extended to the ladder bracket, it must not be more than 100mm past the front of the ladder bracket or more than 300mm back from the ladder rung which is inline with the ladder bracket. What is the measurement? Positive number for past the front of the ladder bracket, negative number for back in toward the roof	50mm
5 Do any fittings have a rating of 15kN or more clearly marked?	No
5.1 Does the fitting have a minimum diameter of 6mm?	No
5.1.1 Warning: Strop cable has failed	
Notes: No manufacturer or kN ratings

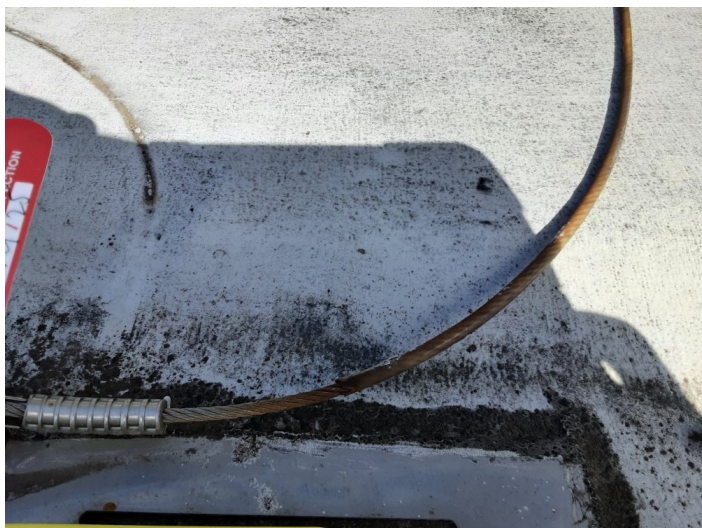
6 Is the strop cable in good condition and free from rust?	No
6.1 Provide description and take photos	
Notes: Rust showing on strop

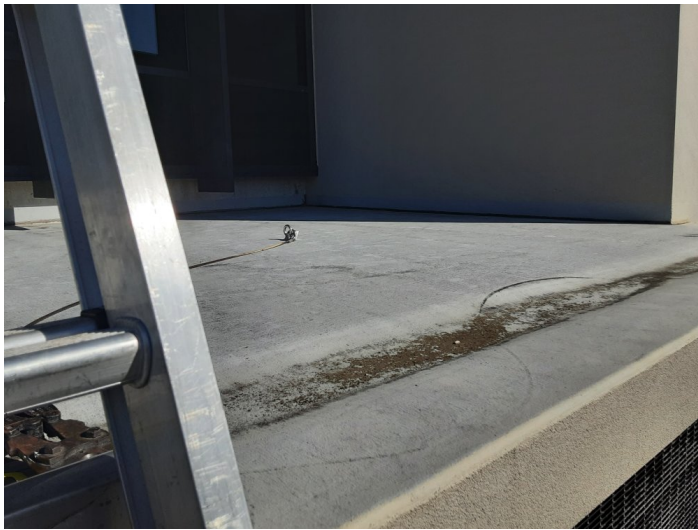
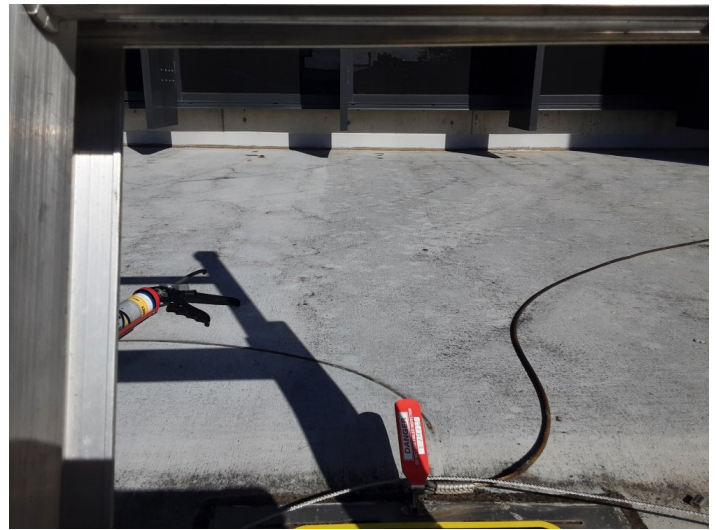
7 Is the strop cable attached to a compliant anchor point? Note: anchor details to be captured in their own item	Yes
8 When attached to the strop cable and move in a circle, is there a risk of falling off the roof?	Yes
8.1 Describe the issue and take photos. Contact office if unsure.	
Notes: Anchor point the strop is attached to is 1500mm to the right of the ladder bracket. A new concrete anchor needs to be installed directly in front of the ladder bracket to eliminate a pendulum effect

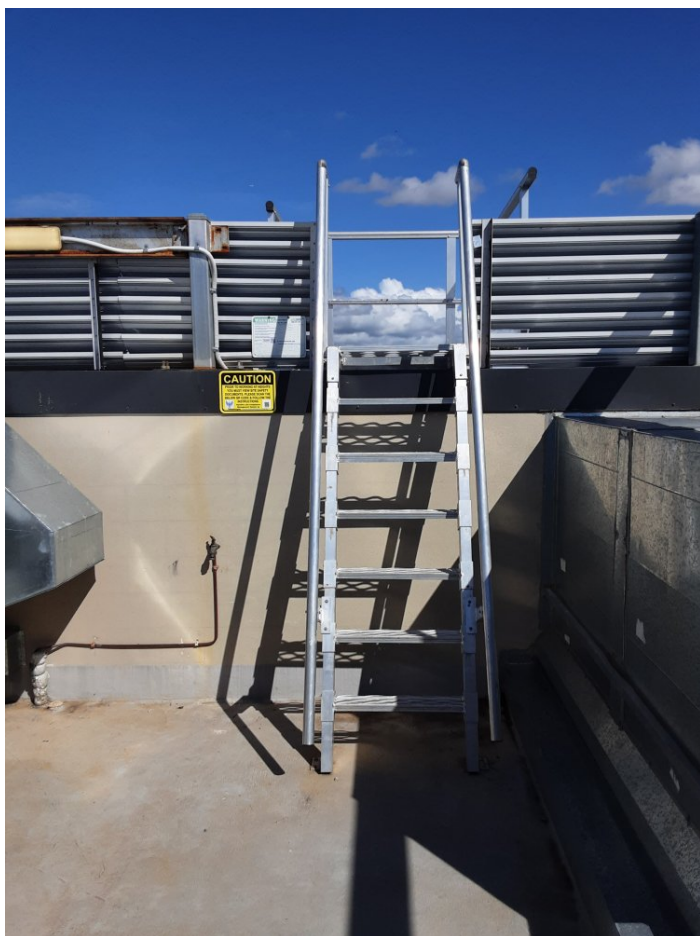
Identification #	STL1
Date of Certification	11/04/2025
Date of Next Certification	11/04/2026
Date Installed	Unknown
Who installed this system?	
Brand/Model	SafetyLink Step Tpre Ladder
1 Example Photo

2 What is the ladder made from?	Aluminium
3 Vertical height of ladder from top platform to bottom platform. (Must not exceed 6000mm)	2000mm
4 Bottom Platform	Does not require bottom platform
4.1 On concrete base or mesh base which has cross level & inline level under 7°	
4.1.1 Cross Level (degrees)	0°
4.1.2 Inline level (degrees)	0°

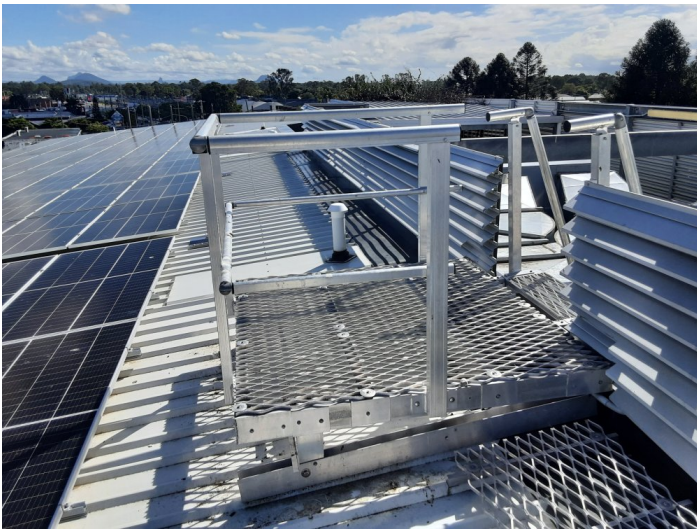
1 Example Photo

Identification #	PF1
Date of Certification	11/04/2025
Date of Next Certification	11/04/2026
Date Installed	Unknown
Who installed this system?	
Brand/Model	SafetyLink Platform

2 Is the system in good condition and all the fixings correctly installed and tight?	Yes
3 Has the system been installed as per manufacturer's instructions?	Yes
Has the system Passed/Failed?	PASS

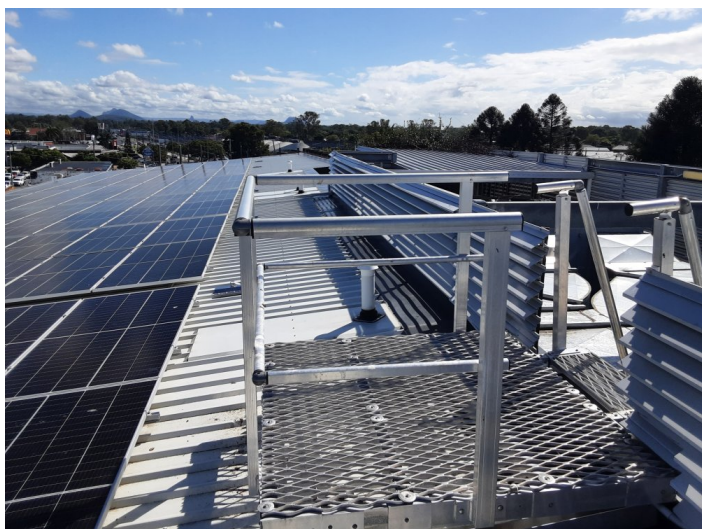
1 Example Photo

Identification #	GR1
Date of Certification	11/04/2025
Date of Next Certification	11/04/2026
Date Installed	Unknown
Who installed this system?	
Brand/Model	SafetyLink Guard rail

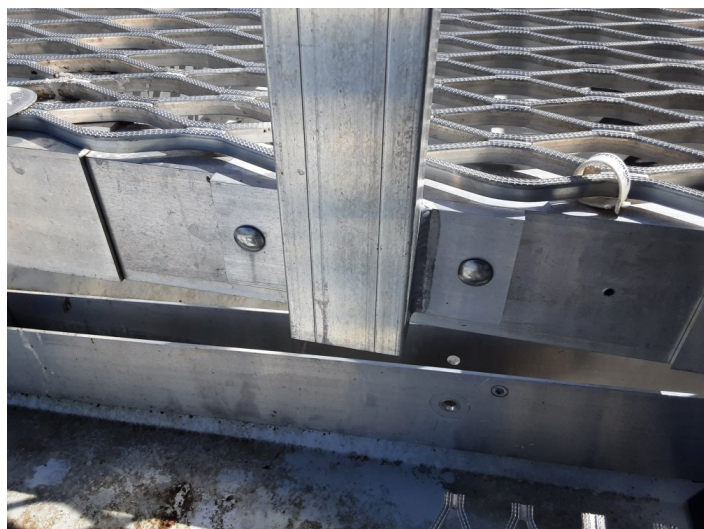
2 What is the guard railing made from?	Aluminium
3 How long is the section of guard railing in metres?	4m
4 How many corners?	2
4.1 All corners must have one post within 300mm one side and 2000mm the other if only a single post (1 x bay) construction or 400mm one side and 2200mm the other if more than two posts continuing in the run. Are all corners compliant?	Yes
5 What type of surface is the guard railing mounted to?	Other
5.1 Describe What fixings have been used and take photo	
Notes: Bolted to custom platform

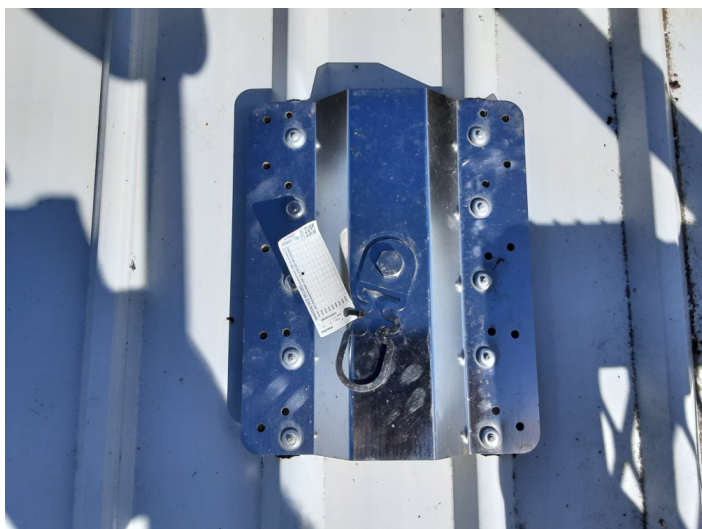
1 Example Photo

Identification #	AP1
Date of Certification	11/04/2025
Date of Next Certification	11/04/2026
Date Installed	-
Who installed this system?	
Brand/Model	Unknown/Not Marked Fall Arrest Anchor

Client Notes	Warning: Anchors have failed inspection due to non-compliance with AS1891.4. These anchors are missing manufacturer specifications and kN load ratings. We are unable to determine the anchors load capacity, installation method and structural integrity. The anchor points cannot be used		
For a list of failed anchors and the reason for failure, please see the attached table.

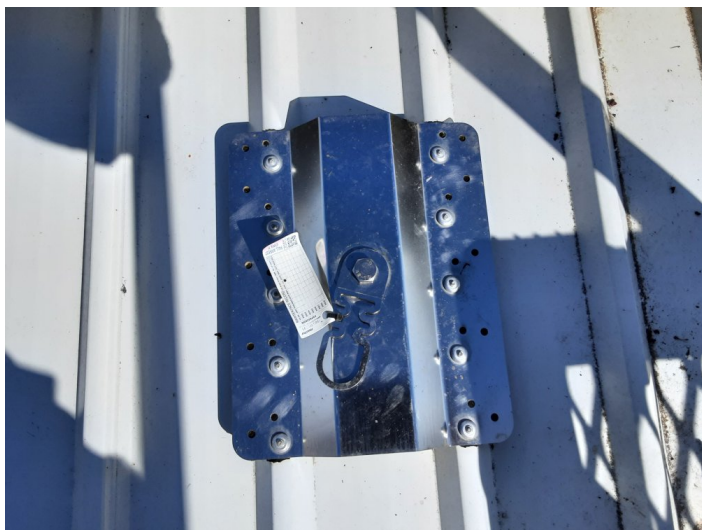
6.1 Take example photo of anchor missing label details
Notes: No manufacturer or kN ratings

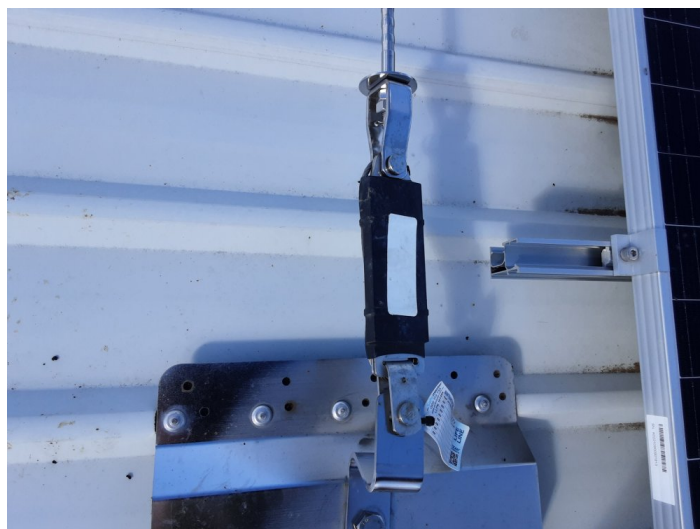
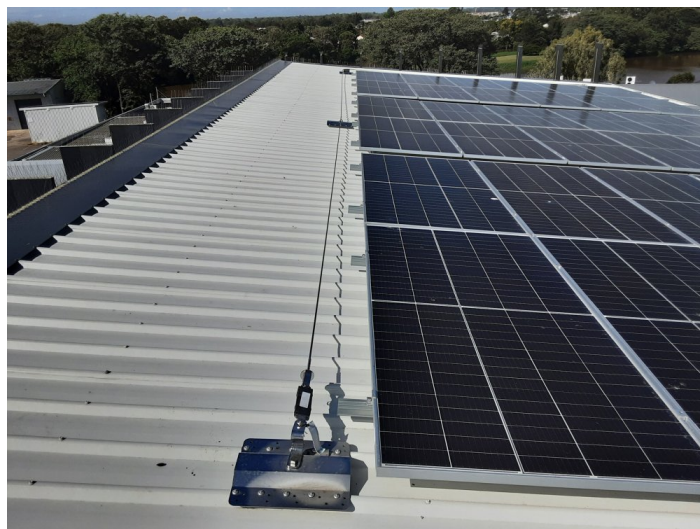
1 Example Photo

Identification #	HSL1
Date of Certification	11/04/2025
Date of Next Certification	11/04/2026
Date Installed	Unknown
Who installed this system?	
Brand/Model	Unknown/Not Marked Horizontal static line

Client Notes	Warning: Static Line has failed due to non-compliance issues with AS1891 Series. The system is an unknown brand, has no visible manufacturer or kN ratings and has more than 100mm of movement in the line. The end plate design would not withstand the required minimum rating of 20kN. The static line is dangerous and cannot be used under any circumstances.

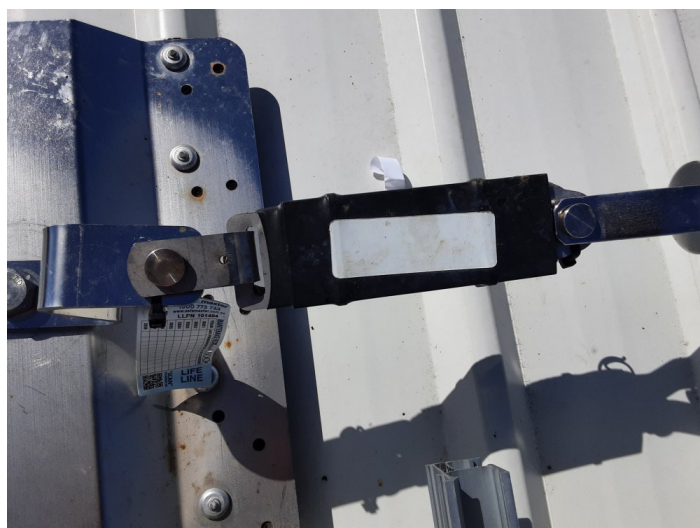
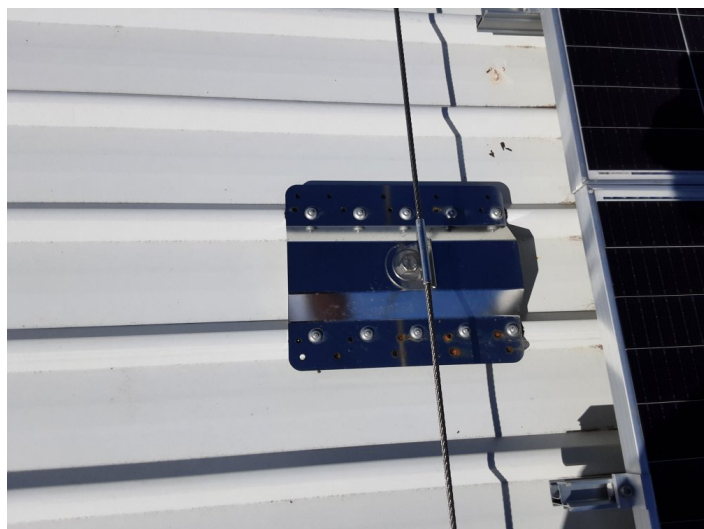
8.1 Take an example photo	
Notes: No clear manufacture or kn ratings

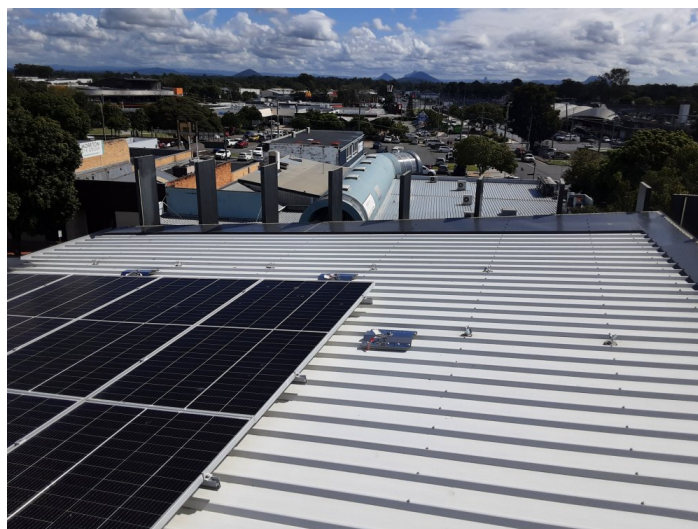
1 Example Photo

Identification #	AP2
Date of Certification	11/04/2025
Date of Next Certification	11/04/2026
Date Installed	Unknown
Who installed this system?	
Brand/Model	Sayfa Lowpro Anchor

Client Notes	Warning: Purlin Mounted Anchors have not undergone the required inspection and certification. We were unable to provide a structural verification of the purlin suitability and anchors may be incorrectly installed or loose. Do not use these anchors until they have been properly inspected. Recommend visual inspection using an internal camera		
For a list of failed anchors and the reason for failure, please see the attached table.
