HEIGHT SAFETY INSPECTION REPORT

Inspection No. 2286

Site No. 2416
The Lakes Centre - Block B - 8-22 King Street, Caboolture

Inspection - The Lakes Centre - Block B - 8-22 King Street, Caboolture - Block B

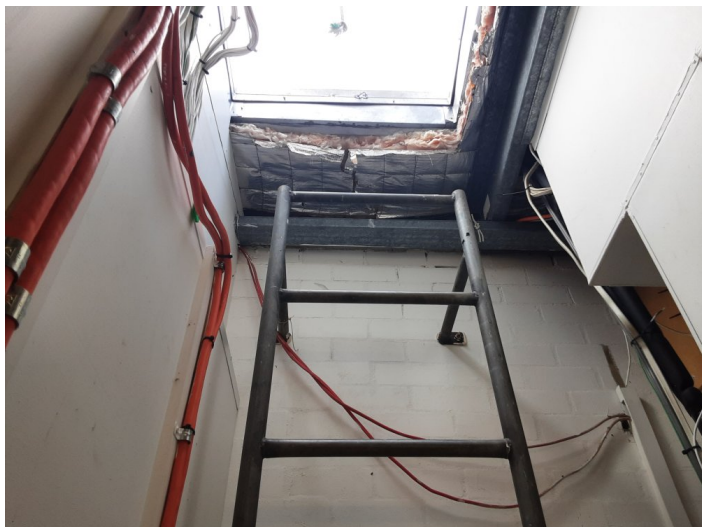
9 Is there a minimum distance of 200mm behind the back of each rung and any object?	Yes
10 Is the top rung level with the top platform?	No
10.1 Warning: ladder has failed.	
Notes: Ladder stops 600mm below hatch

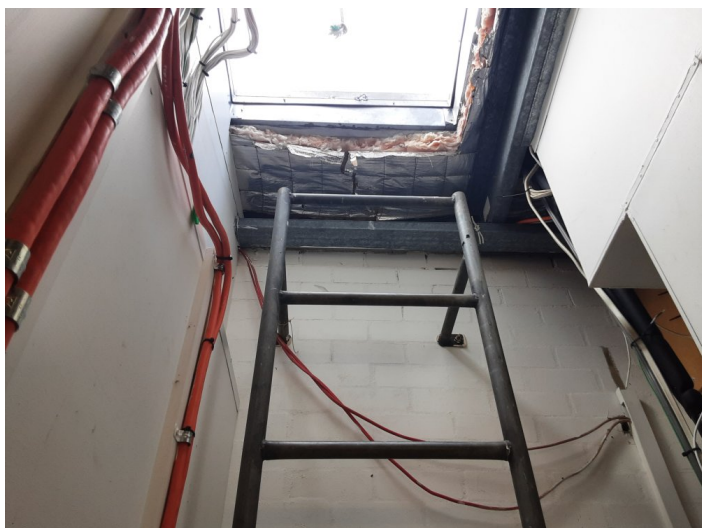
11 Is there an gap between the top rung and the platform?	No
12 What is the distance between the inside of the stiles of the main ladder body? Must be between 375mm and 525mm	500mm
13 What is the width between stiles at step off point? Must be between 525mm and 675mm.	0mm
13.1 Warning: ladder has failed.	
Notes: Ladder stops 600mm below hatch

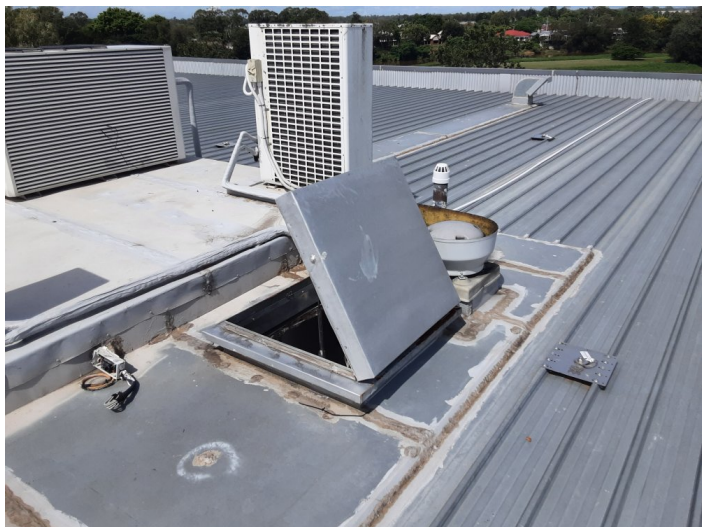
14 What are the dimensions of the stiles? Shape must fit within an 80mm circle.	
Stile Width (mm): 40	Stile Depth (mm): 40
15 Is there clear hand space of 50mm around the stiles?	Yes
16 Top Platform	No top platform but requires one
16.1 Warning: ladder may be non-compliant.	
Notes: There is no space directly in front of the hatch when exiting

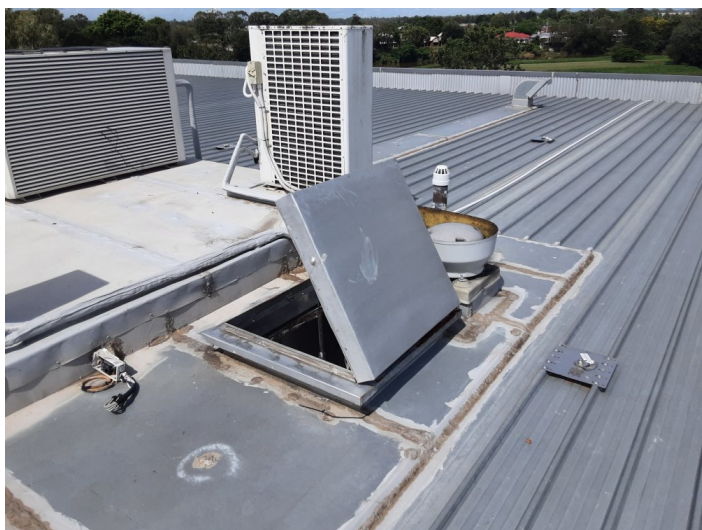
17 Actual angle of the ladder is:	90°
18 What type of grab rails does it have?	No P rails, none required
19 Does it have the required ladder support bracket at least every 3000mm or strengthening stiles?	Yes
20 Are all the fixings in good condition?	Yes
21 Does the ladder have a cage?	No
21.1 Is the ladder over 3500mm?	No
22 Is the side of the ladder within 500mm of a guard railing?	No
23 Is there guard railing within 900mm of the front of the ladder?	No
24 If the ladder is over 3.5m, is there a lead on kit or 2m of guard railing either side of the ladder?	No
24.1 Describe what would best suit this ladder for edge protection	
Notes: Hatch guard rail kit required

25 Is there anything else that needs to be addressed?	No
Has the system Passed/Failed?	FAIL
Fail Reason?	Multiple non-compliance issues to AS1657 No Fall arrest system Rung spacings over 300mm Top rung stops 600mm below top of hatch No top landing No guard railing safety system
Recommendations:	Warning: Vertical ladder has failed inspection and does not comply with AS1657:2018. Due to the multiple issues with this ladder, the hatch which it leads to and the area it is located, we recommend a full review

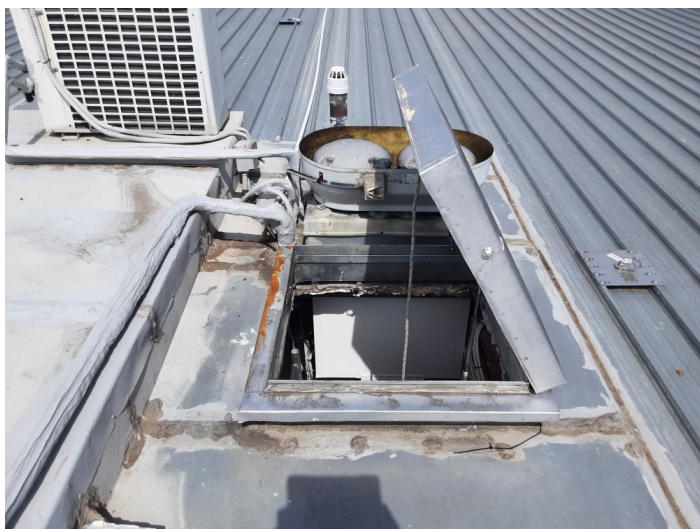
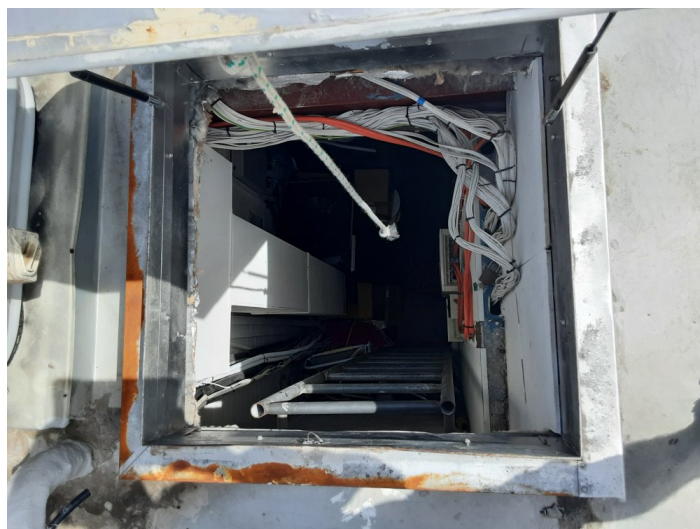
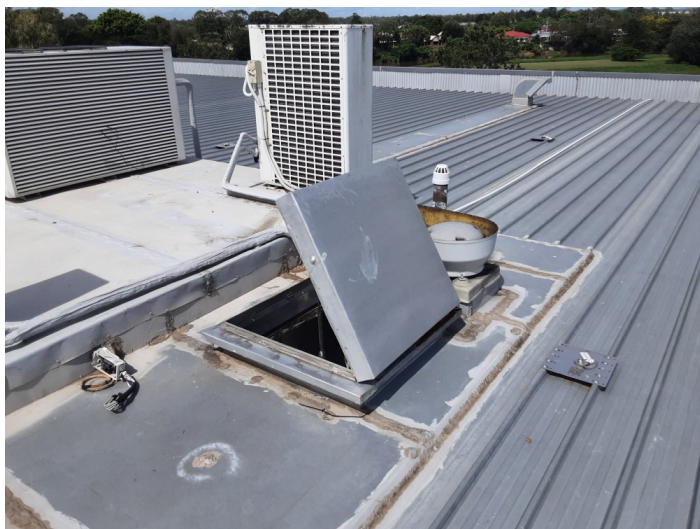
1 Example Photo

Identification #	HT1
Date of Certification	10/04/2025
Date of Next Certification	10/04/2026
Date Installed	Unknown
Who installed this system?	
Brand/Model	Unknown/Not Marked Hatch

2 What system leads to the hatch?	Vertical Ladder
2.1 Vertical ladders should not be used for accessing through a hatch. Inform client access is considered high risk and should not be used	
3 What type of hatch is installed?	Standard Access Hatch

4 What are the opening measurements?		
Length (mm): 800mm	Width (mm): 800mm	
5 Does the hatch have gas struts to help it open?		Yes
5.1 Are they in good working condition?		Yes
6 Is the opening size sufficient to allow a minimum of 750mm from front of ladder access rung to back edge of hatch? Record measurement in mm		800mm
7 How do you step out of the hatch?		Directly Forward
Has the system Passed/Failed?	FAIL	
Fail Reason?	Non-compliant ladder to hatch No guard rail hatch kit installed Unsafe entry/exit from hatch	
Recommendations:	Warning: Hatch has failed inspection and does not comply with AS1657:2018. If access through this hatch is required, additional controls must be first implimented to reduce the risk of an incident. We recommend a review of this entry point as there are multiple safety issues with the access ladder, position of hatch, direction of exit/entry, lack of fall controls and complications with other plant/equipment/services

Client Notes	Warning: Hatch has failed inspection and does not comply with AS1657:2018. If access through this hatch is required, additional controls must be first implimented to reduce the risk of an incident. We recommend a review of this entry point as there are multiple safety issues with the access ladder, position of hatch, direction of exit/entry, lack of fall controls and complications with other plant/equipment/services

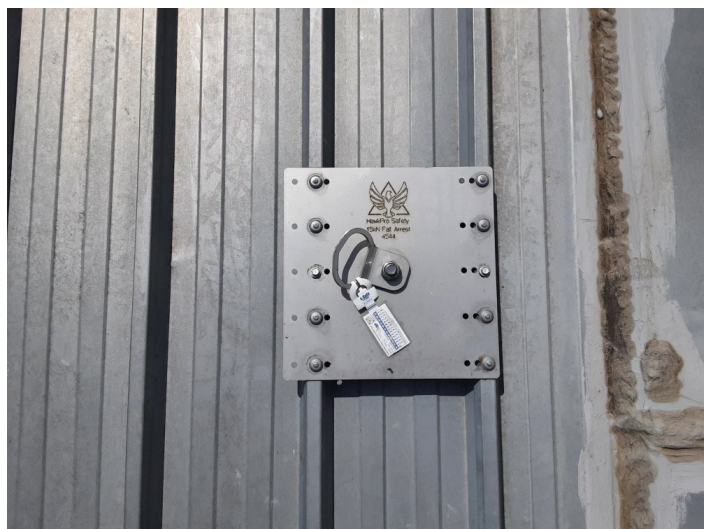
Identification #	AP1
Date of Certification	10/04/2025
Date of Next Certification	10/04/2026
Date Installed	01/04/2022
Who installed this system?	
Brand/Model	HawkPro Safety Fall arrest anchor
1 Example Photo

2 Is the system for:	Fall Arrest
3 What is the type of anchor?	Surface mounted
4 Surface type?	Metal Roof
4.1 Roof type	Kliploc 700
4.2 Is the system surface mounted or into a purlin with screws?	Purlin Mounted
4.3 Is there a minimum of 3 x purlins under each sheet where an anchor is installed?	Yes
4.4 Is the roof sheeting in good condition and free from rust?	Yes
4.5 Are there any penetrations in the same roof sheet that has the anchor installed that is within 2000mm?	No
4.6 Are all the fixings installed correctly and in good condition?	Yes
4.7 Are the anchors installed on the correct lap?	Yes
4.8 Is there anything else that must be noted?	No
4.9 For Kliploc: Is there the required additional screws in the sheets?	No
4.9.1 Warning: Anchors have failed

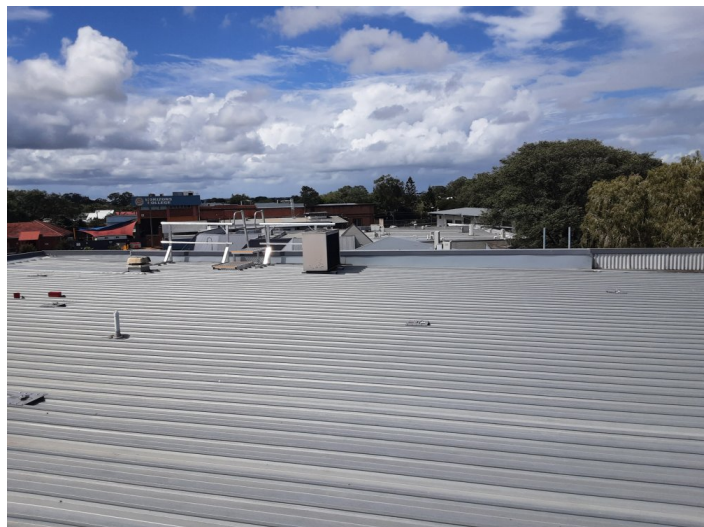
Notes: Roof has more than 10 purlins. Additional screws not required

5 Pitch of roof (in degrees)	3°
6 Does each anchor have clear labels stating manufacturer and rating?	Yes
7 Is the design of the system compliant, allowing 100% connection?	Yes
8 Are there any pendulum risks? You must measure each anchor and ensure that: <ul style="list-style-type: none"> 1. The distance the anchor is from the closest fall edge is the same or LESS than to the next anchor 2. The distance between each anchor is no MORE than 6m 3. If any pendulum issues are found that the EXACT measurements are written clearly on the roof plan 	No
9 Is there a parapet wall?	Yes
Affected Anchors Numbers	3,8
What is the distance in mm from the anchor eye to base of wall?	3050mm
What is the height of wall?	650mm
What is the distance in millimetres from the anchor eye to the top of wall?	3100mm
Calculated Angle	12.1°
Has the system Passed/Failed?	PASS

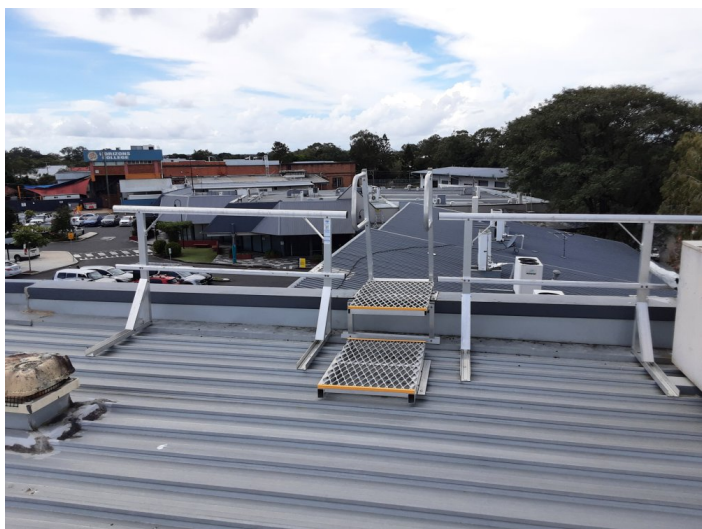
Identification #	GR1
Date of Certification	10/04/2025
Date of Next Certification	10/04/2026
Date Installed	01/04/2022
Who installed this system?	
Brand/Model	HawkPro Safety Guard rail wing kit
1 Example Photo

2 What is the guard railing made from?	Aluminium
3 How long is the section of guard railing in metres?	4m
4 How many corners?	0
5 What type of surface is the guard railing mounted to?	Metal Roof
5.1 Metal Roof type	Kliploc 700
5.2 Are the bases a minimum of 800mm long or have an approved short base design and installed using either 3 x 7.7mm rivets or 4 x 5.2mm rivets?	Yes
5.3 Does each base and post have a compliant brace at approximately 45°?	Yes
5.4 Does each straight length of guard railing have a brace at each end post?	Yes
6 When applying pressure to the guard railing posts, is there more than 100mm of movement?	No
7 What is the height from surface to top of top rail? (must be between 900mm and 1100mm)	1000mm
8 What is the height from the under side of the top rail to the top side of the mid rail? (must be below 450mm)	440mm
9 Is there a toe board installed?	No

9.1 What is the height from surface to bottom of mid rail? (must not exceed 560mm)	540mm
10 Is the guard railing installed along the edge of the roof and the roof pitch is greater than 12°?	No
11 The distance between guard railing posts must not exceed 2m when a single bay (i.e. 2 posts only or 2200mm where there is more than 3 posts in a single line. Do any post lengths exceed this?	No
12 Is the mid rail positioned on the inside of the posts to the fall zone?	Yes
13 Is there a minimum of 2 screws in each mid rail?	Yes
14 Is there a minimum of 1 x 20mm tek screw either side of top rail into each post?	Yes
15 All rail overhangs must not exceed 300mm if only two posts in a line or 400mm if more than 2 posts in a single line. Are all overhangs under this measurement?	Yes
Has the system Passed/Failed?	PASS

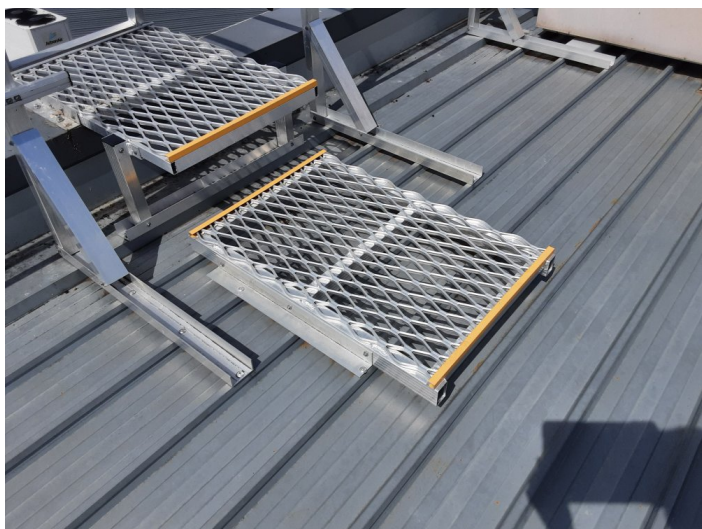
1 Example Photo

Identification #	PF1
Date of Certification	10/04/2025
Date of Next Certification	10/04/2026
Date Installed	01/04/2022
Who installed this system?	
Brand/Model	HawkPro Safety Platform

2 Is the system in good condition and all the fixings correctly installed and tight?	Yes
3 Has the system been installed as per manufacturer's instructions?	Yes
Has the system Passed/Failed?	PASS

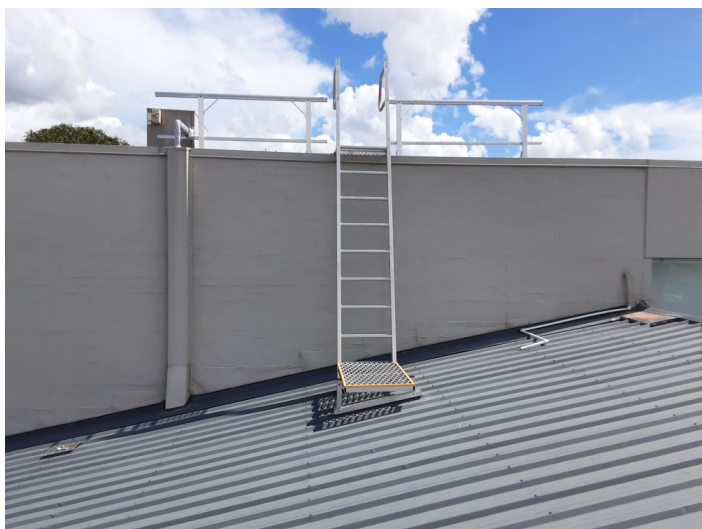
1 Example Photo

Identification #	AL1
Date of Certification	10/04/2025
Date of Next Certification	10/04/2026
Date Installed	01/04/2022
Who installed this system?	
Brand/Model	HawkPro Safety Angled ladder

2 What is the ladder made from?			Aluminium
3 Vertical height of ladder from top platform to bottom platform. (Must not exceed 6000mm)			2400mm
4 Bottom Platform			Has a bottom platform
4.1 Platform size at least 900mm long, 600mm wide, and levelled to within 7°			
Length (mm): 900mm	Width (mm): 600mm	Level (degrees): 0°	
4.2 Height from platform to roof (must not exceed 300mm)			200mm
5 Excluding the bottom rung, are all the rungs no less than 250mm and no more than 300mm and the same space apart, within +/-5mm?			Yes
5.1 Rung Spacings (mm)			300mm
5.2 Height from top of bottom platform to top of first rung (mm). Must be within 10% of rung spacing.			300mm
6 The rung width must not be less than 20mm and not more than 50mm. Rung width:			45mm
7 Do the rungs have a knurled or anti-slip surface?			Yes
8 Is there a minimum distance of 200mm behind the back of each rung and any object?			Yes

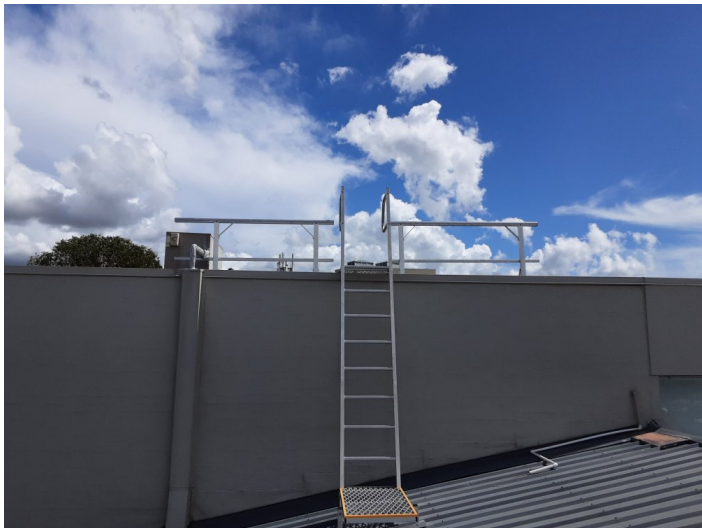
23.1 Describe what is installed and take photo		
Notes: Guard rail wing kit

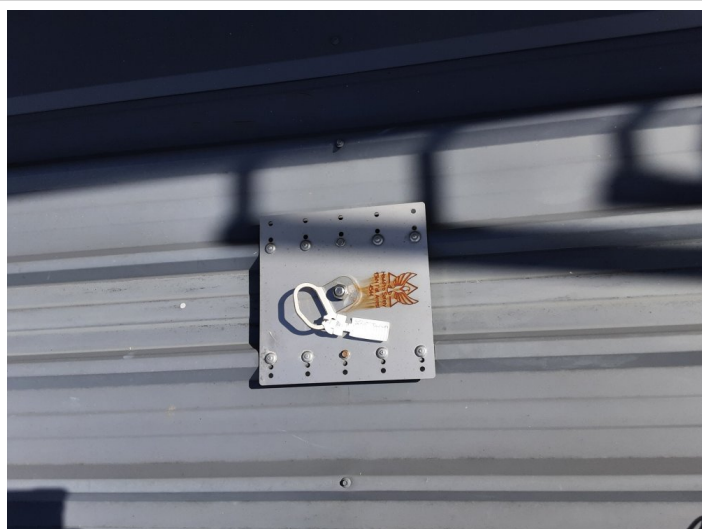
Identification #	AP1
Date of Certification	10/04/2025
Date of Next Certification	10/04/2026
Date Installed	01/04/2022
Who installed this system?	
Brand/Model	HawkPro Safety Fall arrest anchor
1 Example Photo

2 Is the system for:	Fall Arrest
3 What is the type of anchor?	Surface mounted
4 Surface type?	Metal Roof
4.1 Roof type	Trimdek
4.2 Is the system surface mounted or into a purlin with screws?	Purlin Mounted
4.3 Is there a minimum of 3 x purlins under each sheet where an anchor is installed?	Yes
4.4 Is the roof sheeting in good condition and free from rust?	Yes
4.5 Are there any penetrations in the same roof sheet that has the anchor installed that is within 2000mm?	No
4.6 Are all the fixings installed correctly and in good condition?	Yes
4.7 Are the anchors installed on the correct lap?	Yes
4.8 Is there anything else that must be noted?	No
5 Pitch of roof (in degrees)	12°
6 Does each anchor have clear labels stating manufacturer and rating?	Yes

7 Is the design of the system compliant, allowing 100% connection?	Yes
8 Are there any pendulum risks? You must measure each anchor and ensure that: <ul style="list-style-type: none"> 1. The distance the anchor is from the closest fall edge is the same or LESS than to the next anchor 2. The distance between each anchor is no MORE than 6m 3. If any pendulum issues are found that the EXACT measurements are written clearly on the roof plan 	No
9 Is there a parapet wall?	No
Has the system Passed/Failed?	PASS

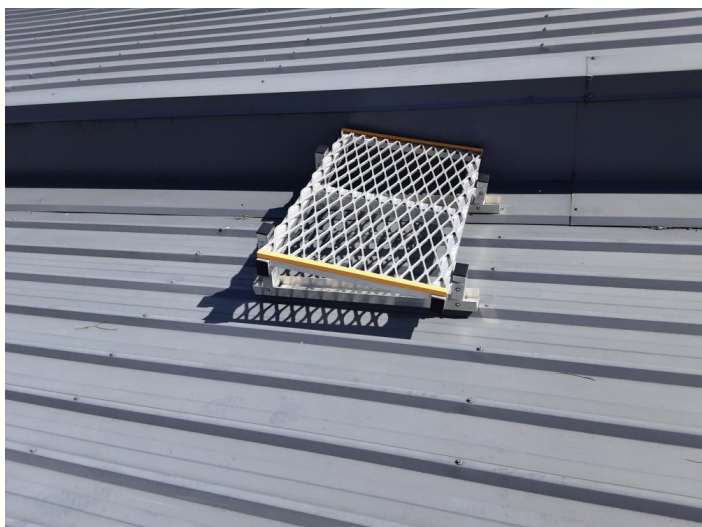
Identification #	PF1
Date of Certification	10/04/2025
Date of Next Certification	10/04/2026
Date Installed	01/04/2022
Who installed this system?	
Brand/Model	HawkPro Safety Platform step
1 Example Photo

2 Is the system in good condition and all the fixings correctly installed and tight?	Yes
3 Has the system been installed as per manufacturer's instructions?	Yes
Has the system Passed/Failed?	PASS
