HEIGHT SAFETY INSPECTION REPORT

Inspection No. 2190

Site No. 2414
15 Astor Terrace, Spring Hill

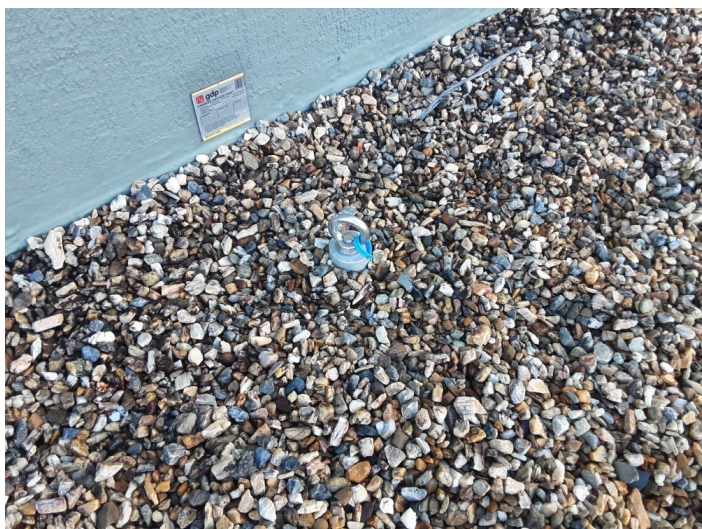
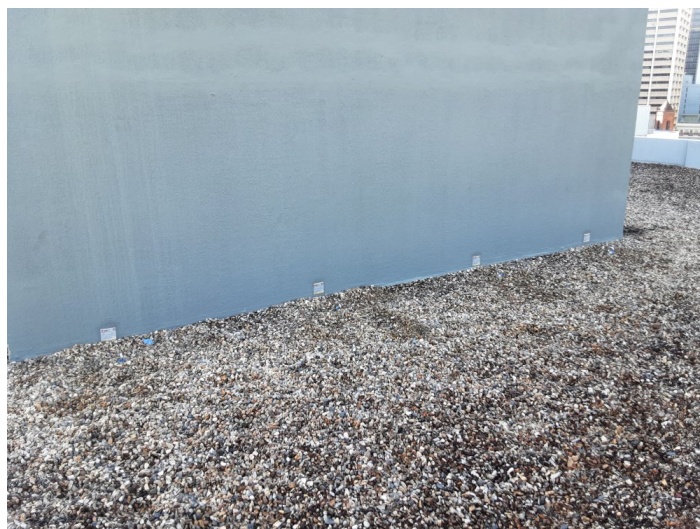
1 Example Photo

Identification #	AP3
Date of Certification	21/03/2025
Date of Next Certification	21/03/2026
Date Installed	08/09/2014
Who installed this system?	
Brand/Model	PEHQ (Safetylyne) Concrete Anchor

2 Is the system for:	Abseil
3 What is the type of anchor?	Concrete mounted
4 Surface type?	Concrete
4.1 How is the system mounted?	Horizontal Floor Mounted
4.2 Take wide image of structure	
4.3 What is the thickness of the concrete? Must be minimum 150mm	200mm
4.4 Are the anchors a minimum of 200mm from edge of slab?	No
4.5 Are there any holes within 200mm of the anchors?	No
4.6 Are all anchors tested to 7.5kN for 3 minutes with no sign of movement?	Yes
4.7 Is the concrete in good condition without any structural cracks or issues?	Yes
4.8 Is there anything else that must be noted?	No
5 Pitch of roof (in degrees)	0°
6 Does each anchor have clear labels stating manufacturer and rating?	Yes
7 Is the design of the system compliant, allowing 100% connection?	NA
7.1 Describe Purpose of System?

For abseil use	
8 Are there any pendulum risks? You must measure each anchor and ensure that: <ul style="list-style-type: none"> 1. The distance the anchor is from the closest fall edge is the same or LESS than to the next anchor 2. The distance between each anchor is no MORE than 6m 3. If any pendulum issues are found that the EXACT measurements are written clearly on the roof plan 	No
9 Is there a parapet wall?	Yes
Affected Anchors Numbers	All
What is the distance in mm from the anchor eye to base of wall?	6000mm
What is the height of wall?	600mm
What is the distance in millimetres from the anchor eye to the top of wall?	6100mm
Calculated Angle	5.6°
Has the system Passed/Failed?	PASS

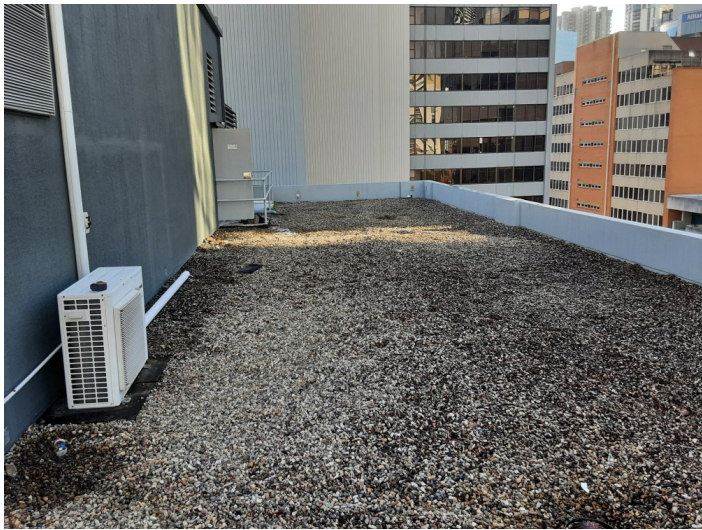
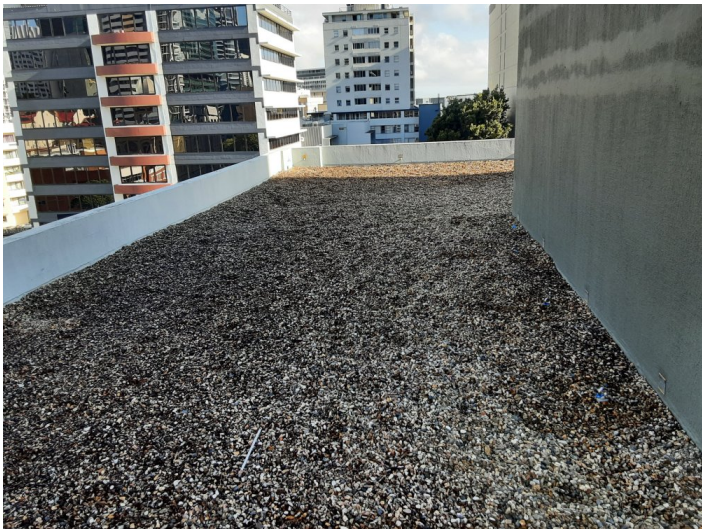
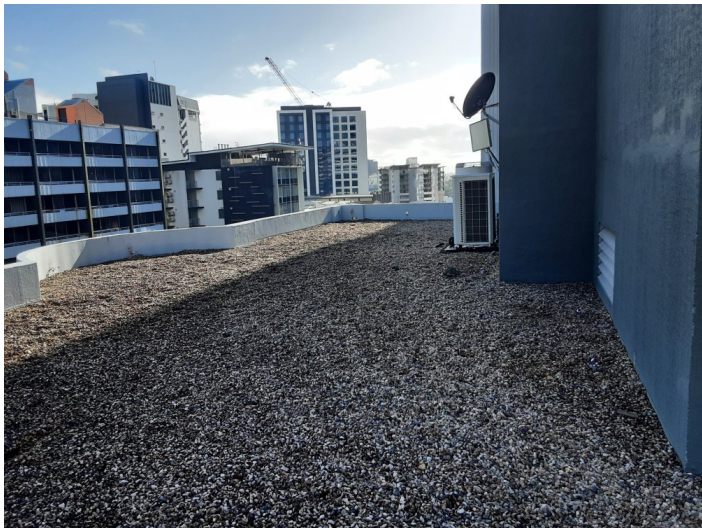
LEVEL 6 ROOF - Item #4: Loose Object Observation

Identification #	LOO1
Date of Observation	01/07/2025
1 Example Photo	
Notes: No lose objects on roof

2 Were any Loose Objects Identified?

No

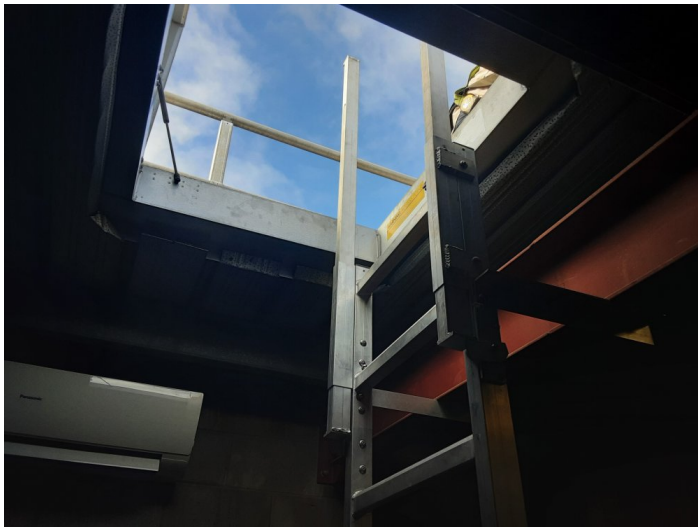
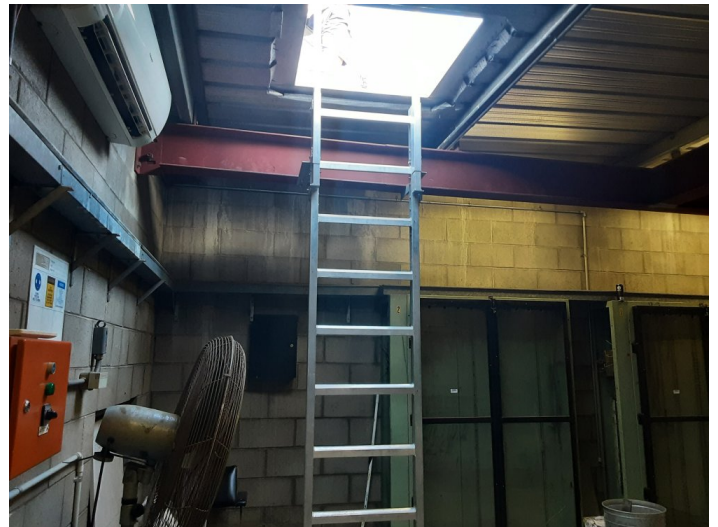
1 Example Photo

Identification #	VL1
Date of Certification	21/03/2025
Date of Next Certification	21/03/2026
Date Installed	Unknown
Who installed this system?	
Brand/Model	PEHQ (Safetylyne) Vertical ladder

10.1 Warning: ladder has failed.	
Notes: Top rung is 300mm below step off point onto roof

Has the system Passed/Failed?	FAIL
Fail Reason?	Ladder has multiple non compliant issues
Recommendations:	Warning: Vertical ladder has failed due to multiple non-compliance issues with AS1657. This was identified in an audit conducted in March 2022. We recommend that the ladder is removed and replaced with a aluminium angled ladder between 70° and 75° in accordance with AS1657:2018 and Managing the Risk of Falls at Workplaces Code of Practice. As part of this rectification works, the hatch will require a guard railing safety system installed, which will provide safe transition from the new ladder to the roof

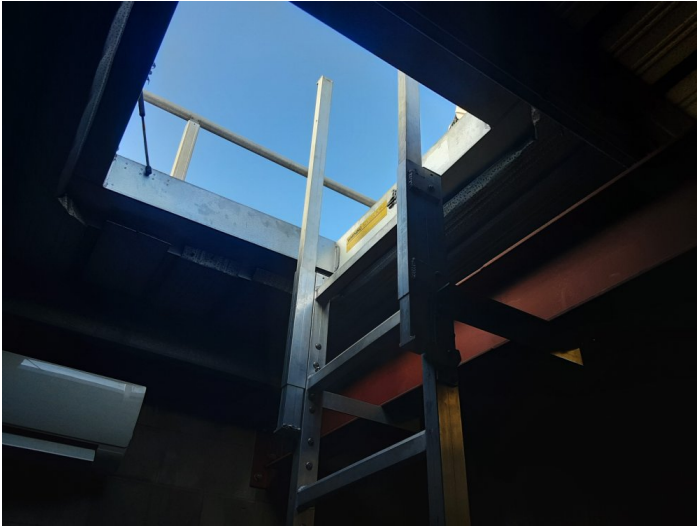
21.1 Is the ladder over 3500mm?		No
22 Is the side of the ladder within 500mm of a guard railing?		No
23 Is there guard railing within 900mm of the front of the ladder?		No
24 If the ladder is over 3.5m, is there a lead on kit or 2m of guard railing either side of the ladder?		No

24.1 Describe what would best suit this ladder for edge protection		
Notes: Ladder leads to hatch

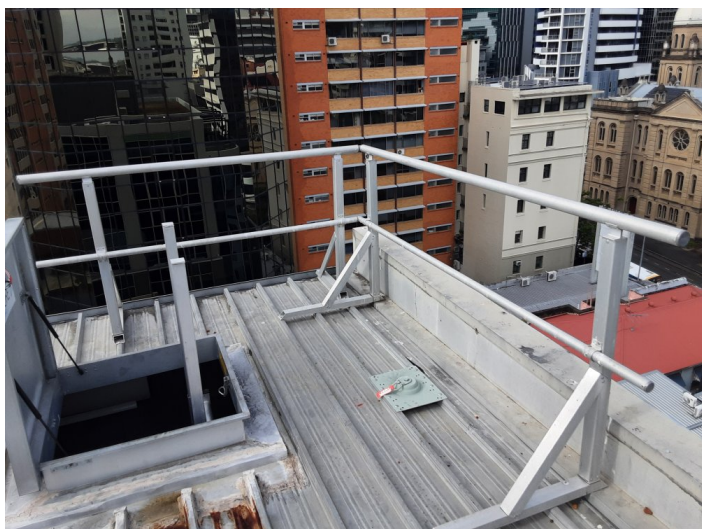
1 Example Photo

Identification #	GR1
Date of Certification	21/03/2025
Date of Next Certification	21/03/2026
Date Installed	Unknown
Who installed this system?	
Brand/Model	ABRA Guard rail

2 What is the guard railing made from?	Aluminium
3 How long is the section of guard railing in metres?	4m
4 How many corners?	1
4.1 All corners must have one post within 300mm one side and 2000mm the other if only a single post (1 x bay) construction or 400mm one side and 2200mm the other if more than two posts continuing in the run. Are all corners compliant?	Yes
5 What type of surface is the guard railing mounted to?	Metal Roof
5.1 Metal Roof type	Kliploc 700
5.2 Are the bases a minimum of 800mm long or have an approved short base design and installed using either 3 x 7.7mm rivets or 4 x 5.2mm rivets?	Yes
5.3 Does each base and post have a compliant brace at approximately 45°?	Yes
5.4 Does each straight length of guard railing have a brace at each end post?	No
5.4.1 Note down how many are missing and take a photo	
Notes: Guard rail is riveted - no movement

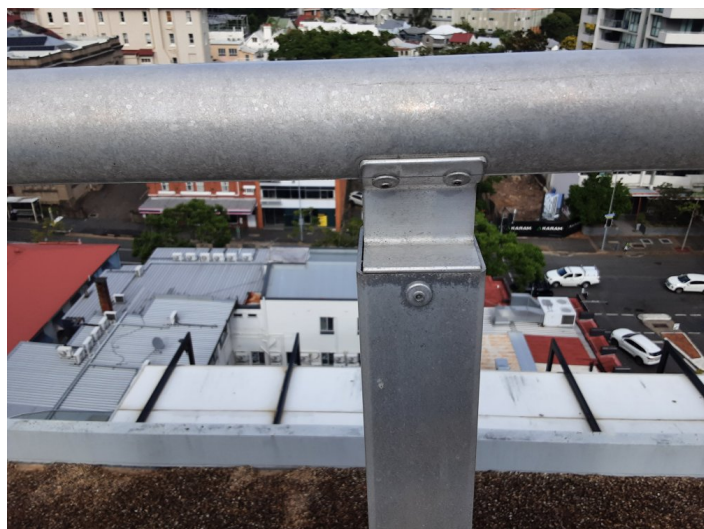
6 When applying pressure to the guard railing posts, is there more than 100mm of movement?	No
7 What is the height from surface to top of top rail? (must be between 900mm and 1100mm)	1090mm
8 What is the height from the under side of the top rail to the top side of the mid rail? (must be below 450mm)	440mm
9 Is there a toe board installed?	No

9.1 What is the height from surface to bottom of mid rail? (must not exceed 560mm)	560mm
10 Is the guard railing installed along the edge of the roof and the roof pitch is greater than 12°?	No
11 The distance between guard railing posts must not exceed 2m when a single bay (i.e. 2 posts only or 2200mm where there is more than 3 posts in a single line. Do any post lengths exceed this?	No
12 Is the mid rail positioned on the inside of the posts to the fall zone?	Yes
13 Is there a minimum of 2 screws in each mid rail?	No

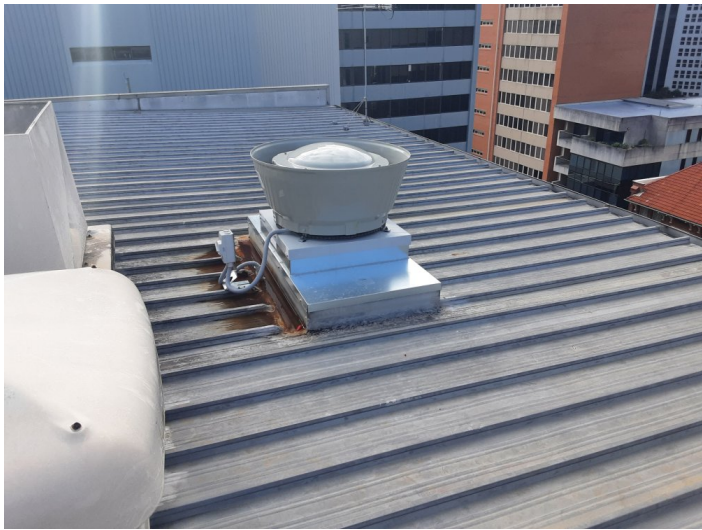
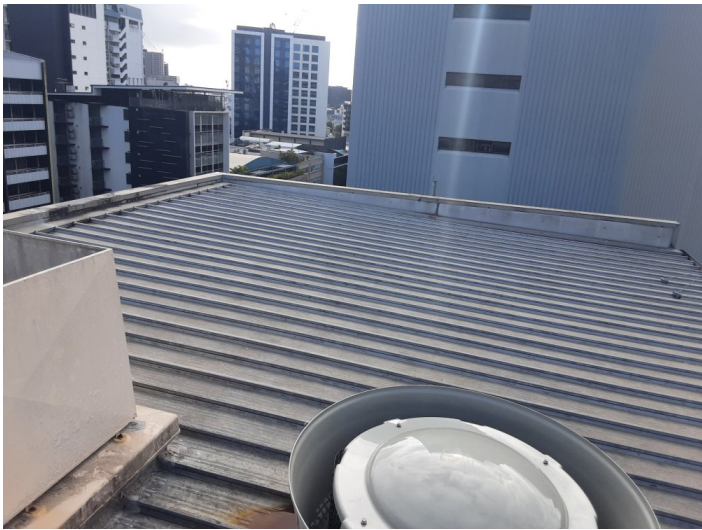
LEVEL 6 UPPER ROOF - Item #6: Loose Object Observation

Identification #	LOO1
Date of Observation	01/07/2025
1 Example Photo	
Notes: No loose objects on inspection 21/3/25

2 Were any Loose Objects Identified?	No
--------------------------------------	----
