HEIGHT SAFETY INSPECTION REPORT

Inspection No. 2214

Site No. 2419
Anglicare - 12 King Street, Caboolture

Inspection - Anglicare - 12 King Street, Caboolture

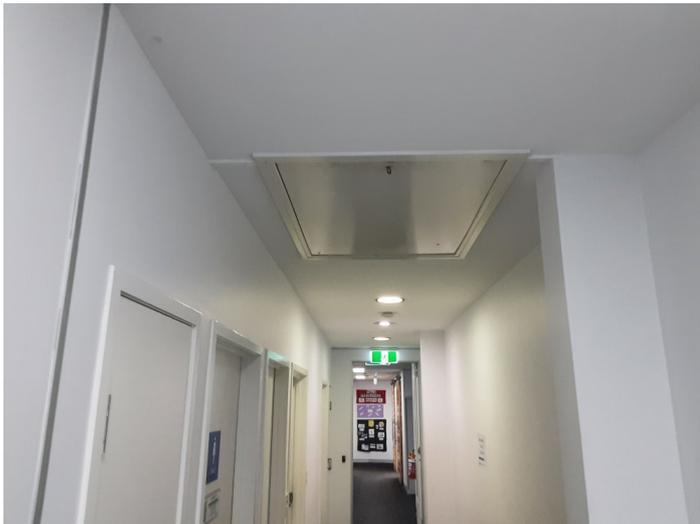
2 Type of fold down ladder	Other
2.1 Other	
3 What is the vertical height from ceiling to floor?	3000mm
4 What is the width of the ladder between the stiles?	465mm
5 What angle in degrees is the ladder when extended?	69°
6 What is the width of the ladder rungs?	80mm
7 How is the ladder installed?	Fixed into solid frame
7.3 Take a photo and describe how it has been fixed to the frame and if there are any issues	
Notes: Tek screws into steel frame

Has the system Passed/Failed?	PWC
PWC Condition:	Minor noncompliance/Low risk. Additional care required during use/access. Prior to use/access person/s must be provided with this report and understand the issue. Only authorised person/s can access
PWC Details:	125mm foot clearance from front of ladder rung to the Fold Down Ladder lid Top step is 210mm from top of ladder rung to top of Fold Down Ladder User to be aware when climbing the lader
Recommendations:	Warning: Fold Down Ladder has Passed With Conditions (PWC) and approved for limited use. The non-compliances identified include: Minimal foot clearance between ladder rungs and the lid surface with also a smaller top step which may affect footing and stability when transitioning to the next ladder. Be sure to maintain 3 points of contact at all times when using the system. We recommend that the ladder is replaced to improve safety and reduce overall risk

Recommendations:	Warning: Fold Down Ladder has Passed With Conditions (PWC) and approved for limited use. The non-compliances identified include: Minimal foot clearance between ladder rungs and the lid surface with also a smaller top step which may affect footing and stability when transitioning to the next ladder. Be sure to maintain 3 points of contact at all times when using the system. We recommend that the ladder is replaced to improve safety and reduce overall risk		
Client Notes	Warning: Fold Down Ladder has Passed With Conditions (PWC) and approved for limited use. The non-compliances identified include: Minimal foot clearance between ladder rungs and the lid surface with also a smaller top step which may affect footing and stability when transitioning to the next ladder. Be sure to maintain 3 points of contact at all times when using the system. We recommend that the ladder is replaced to improve safety and reduce overall risk

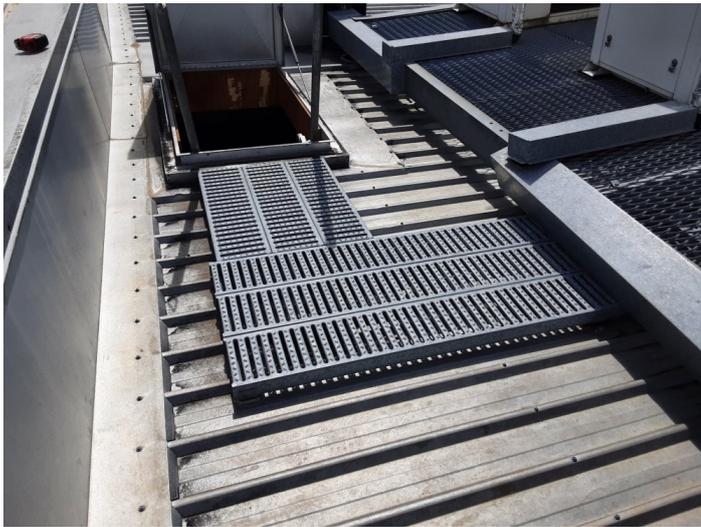
Item #4: Walkway Compliance Report

Identification #	WW1
Date of Certification	11/04/2025
Date of Next Certification	11/04/2026
Date Installed	Unknown
Who installed this system?	
Brand/Model	Steel Walkway
1 Example Photo

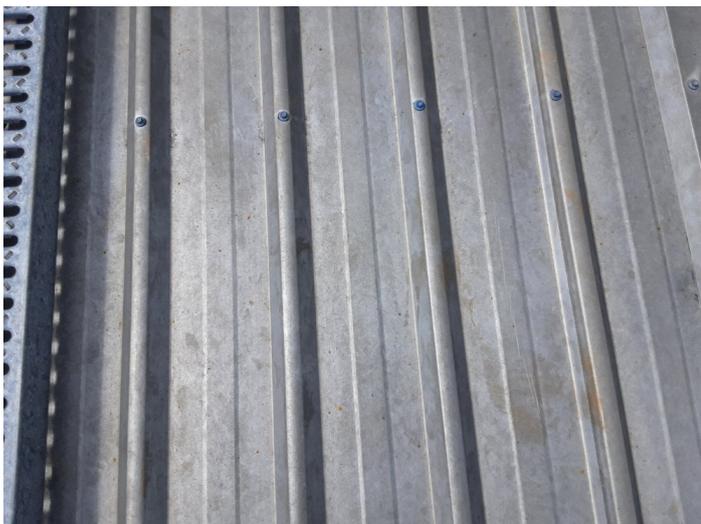
2 What is the walkway made from?	Steel
3 Type of surface it is mounted to	Trimdek
4 Take a photo of the roof profile

5 How long is the section of walkway in metres?	3m
6 Walkway must be a minimum of 600mm wide. The width of the walkway is:	670mm
7 What is the pitch of the roof in degrees?	5°
8 Does the walkway run across the roof pitch?	Yes
9 Does the walkway run up the roof pitch?	Yes
10 Are all the joiner and end bars correctly installed and with require fixings?	Yes
11 Are all the fixings in good condition and installed correctly?	Yes
12 Anything else needs to be noted?	No
Has the system Passed/Failed?	PASS

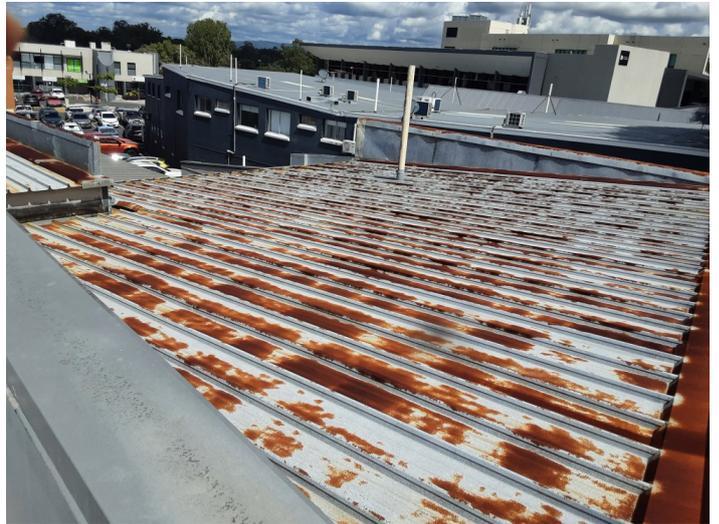
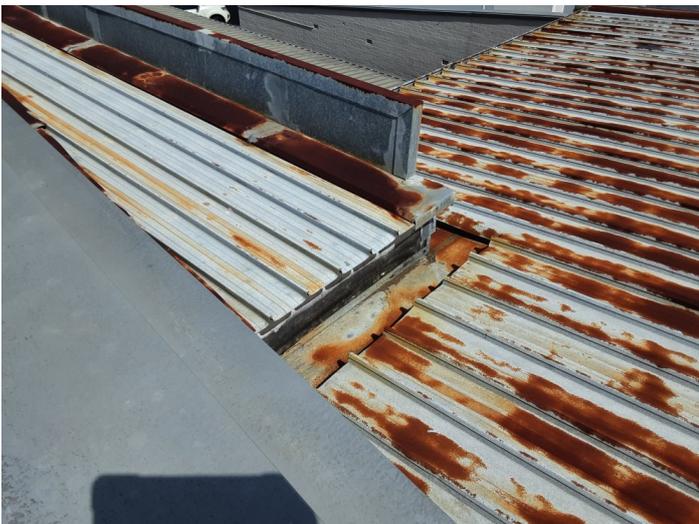
1200mm walkway space

3 Describe the issue with as much detail as required

Observation Status:	High Risk - Identified hazard
Recommendations:	Warning: DO NOT ENTER this lower roof area. Roof sheets have been identified as severely rusted and structurally compromised. This area is non-compliant without safe access and structural requirements under AS1657 and must not be accessed under any circumstances. Access should be prohibited until the roof is repaired and certified safe by a competent person. At the same time, fall prevention systems should be considered for accessing plant or having the plant removed and installed in a safe location
