# HEIGHT SAFETY INSPECTION REPORT

**Inspection No. 2294**

**Site No. 2415**  
490 Upper Edward Street, Spring Hill

## Inspection - 490 Upper Edward Street, Spring Hill - 490 Upper Edward

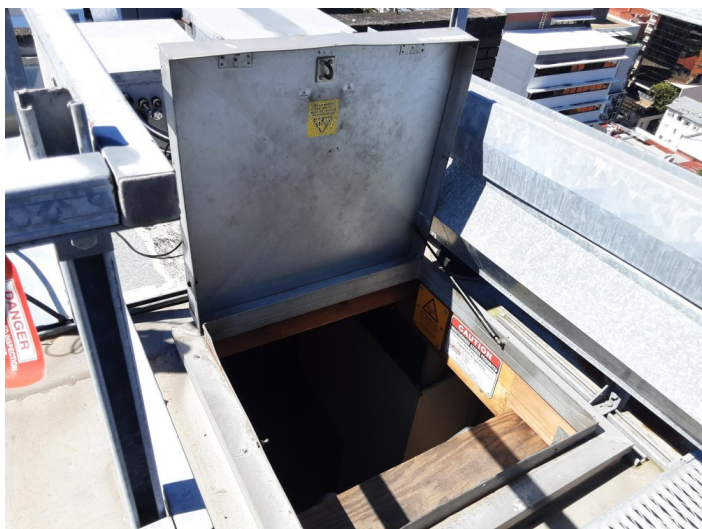
1 Example Photo

2 What system leads to the hatch?	Angled Ladder
3 What type of hatch is installed?	Standard Access Hatch
4 What are the opening measurements?	
Length (mm): 800mm	Width (mm): 800mm
5 Does the hatch have gas struts to help it open?	Yes
5.1 Are they in good working condition?	No
5.1.1 Record sizes and ratings of the struts	
<b>Notes:</b> 1 x gas strut is missing - hatch still opens and closes safely 250mm long x 20mm thick

6 Is the opening size sufficient to allow a minimum of 750mm from front of ladder access rung to back edge of hatch? Record measurement in mm	500mm
7 How do you step out of the hatch?	Directly Forward
Has the system Passed/Failed?	PASS
Recommendations:	Warning: The hatch lid only has one working gas strut installed to help with opening and closing the hatch lid. Recommend that a new strut be installed

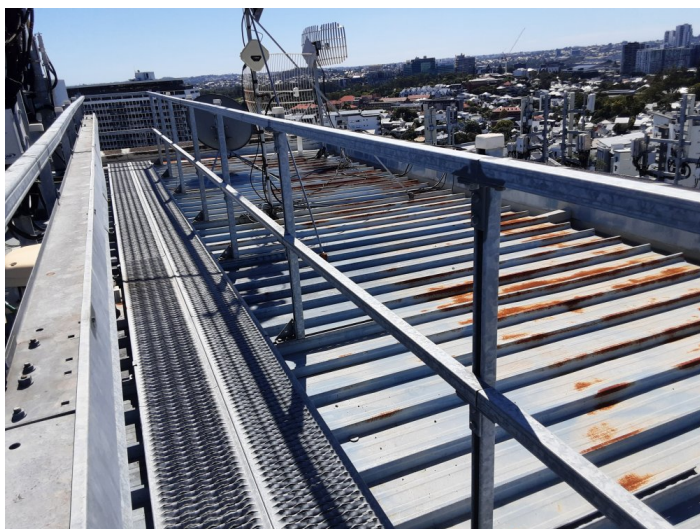
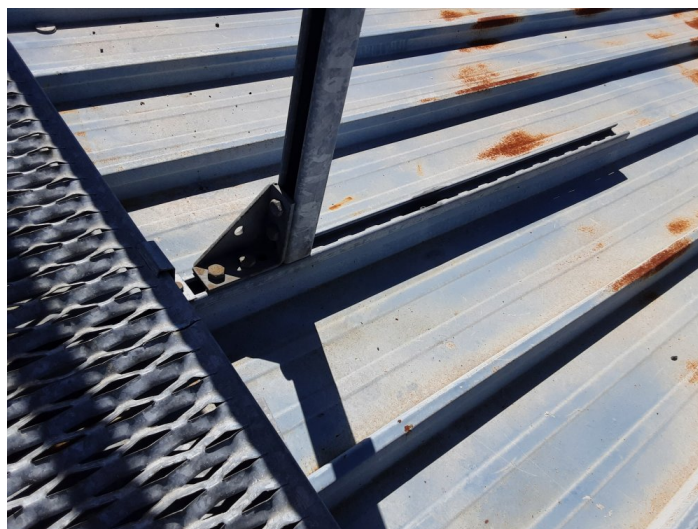
#### 1 Example Photo

2 What is the guard railing made from?	Steel
3 How long is the section of guard railing in metres?	30m
4 How many corners?	6
4.1 All corners must have one post within 300mm one side and 2000mm the other if only a single post (1 x bay) construction or 400mm one side and 2200mm the other if more than two posts continuing in the run. Are all corners compliant?	Yes
5 What type of surface is the guard railing mounted to?	Metal Roof
5.1 Metal Roof type	Kliploc 700
5.2 Are the bases a minimum of 800mm long or have an approved short base design and installed using either 3 x 7.7mm rivets or 4 x 5.2mm rivets?	No
5.2.1 Are the bases considered compliant?	No
5.2.2 Describe the issues and list how many	
<b>Notes:</b> Only 1 screw in bases

Has the system Passed/Failed?	FAIL
Fail Reason?	The bases only have one screw installed causing the guard railing to rock back and forth over the 100mm allowed in AS1657 The maximum gap between the top and mid rail must not exceed 450mm. The gap ranges from 460mm to over 480mm
Recommendations:	Refer to Quote dated March 2022

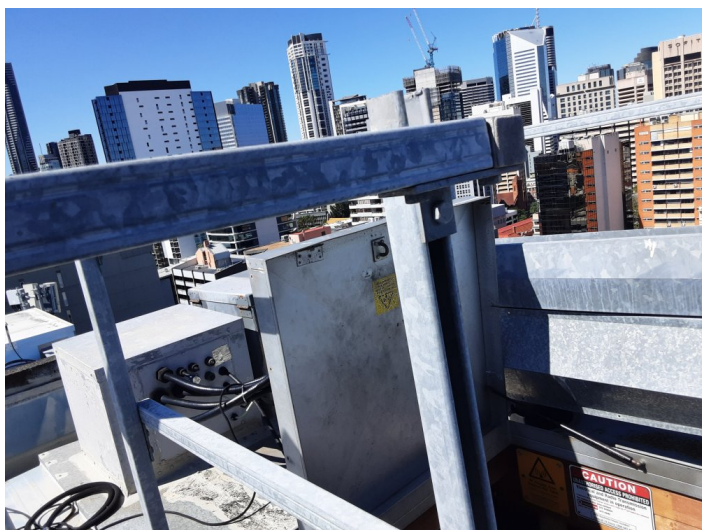
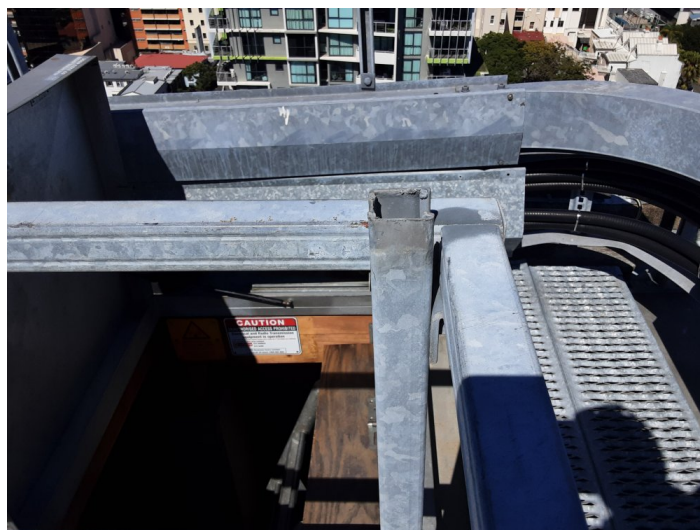
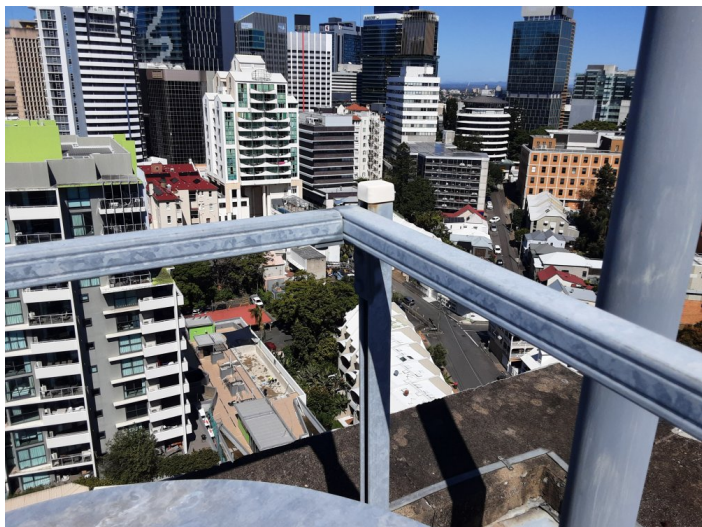
5.3 Does each base and post have a compliant brace at approximately 45°?	Yes
5.4 Does each straight length of guard railing have a brace at each end post?	No
5.4.1 Note down how many are missing and take a photo	
<b>Notes:</b> Guard rail is old square steel guard rail and is bolted into post at corners using L shape brackets

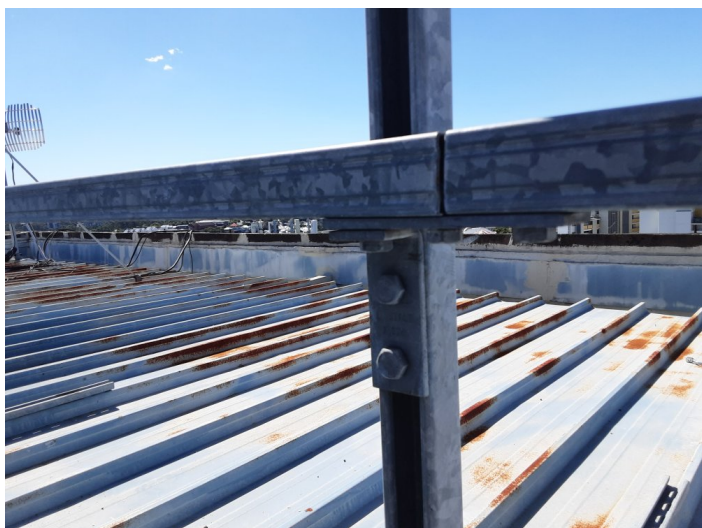
11 The distance between guard railing posts must not exceed 2m when a single bay (i.e. 2 posts only or 2200mm where there is more than 3 posts in a single line. Do any post lengths exceed this?	No
12 Is the mid rail positioned on the inside of the posts to the fall zone?	Yes
13 Is there a minimum of 2 screws in each mid rail?	No
13.1 Note how many posts are missing screws and take photo	
<b>Notes:</b> Guard rail has been bolted to post using L shape brackets

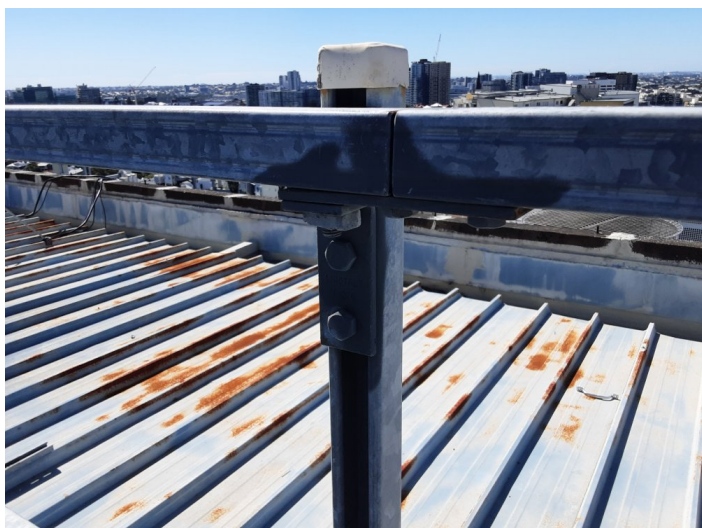
14 Is there a minimum of 1 x 20mm tek screw either side of top rail into each post?	No
14.1 Note how many posts are missing screws and take photo	
<b>Notes:</b> Guard rail has been bolted to post using L shape bracket

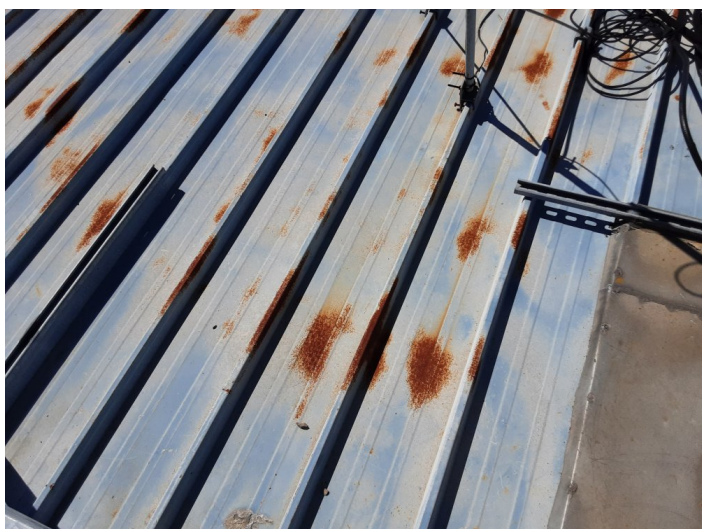
2 What is the walkway made from?	Steel
3 Type of surface it is mounted to	Kliploc 700
4 Take a photo of the roof profile

5 How long is the section of walkway in metres?	13m
6 Walkway must be a minimum of 600mm wide. The width of the walkway is:	600mm
7 What is the pitch of the roof in degrees?	3°
8 Does the walkway run across the roof pitch?	Yes
9 Does the walkway run up the roof pitch?	No
10 Are all the joiner and end bars correctly installed and with require fixings?	Yes
11 Are all the fixings in good condition and installed correctly?	Yes
12 Anything else needs to be noted?	Yes
12.1 Describe the issues	
<b>Notes:</b> Roof is showing signs of rust

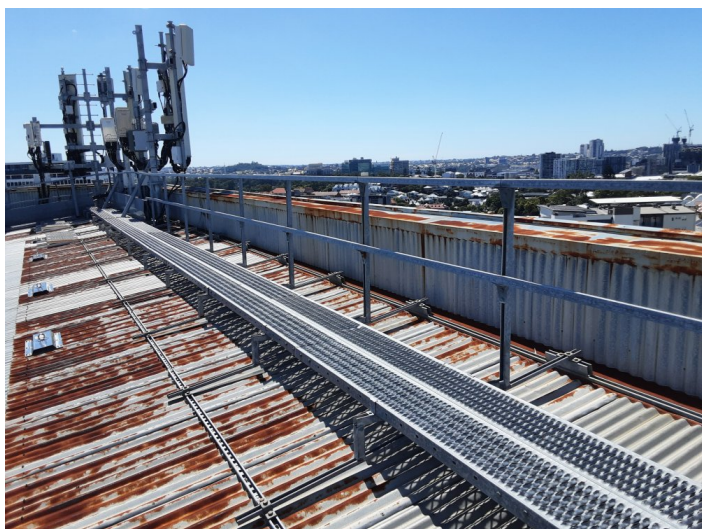
1 Example Photo

<b>Inspection Date</b>	22/04/2025	<b>Job Number</b>	1352
<b>Company Name</b>	DeMartini Fletcher Property	<b>Site Address</b>	490 Upper Edward Street, Spring Hill
<b>Contact Name</b>	Clare Burton	<b>Site Contact Name</b>	
<b>Contact Phone</b>		<b>Site Contact Phone</b>	
<b>Identification #:</b>	GR1		
<b>Type of System:</b>	GUARD RAIL		
<b>Brand/Model</b>	Steel Guard rail		
<b>System Location:</b>	LOWER ROOF		
<b>Date of Installation:</b>	Unknown		
<b>Date of Next Service:</b>	22/04/2026		
<b>Technician:</b>	SAFE @ HEIGHTS PTY LTD (Damien Hewitt (Supervisor), Aaron Parr)		
<b>Status:</b>	<b>FAIL</b>		
<b>Fail Reason?</b>	Multiple non-compliant issues The maximum gap between the top and mid rail must not exceed 450mm - The gap ranges from 455mm to over 480mm The maximum overall height of the guardrail must be between 900mm and 1100mm - The height is 1150mm The height from surface to bottom of mid rail must not exceed 560mm - the height is 600mm

<b>Recommendations:</b>	Refer to Quote dated March 2022

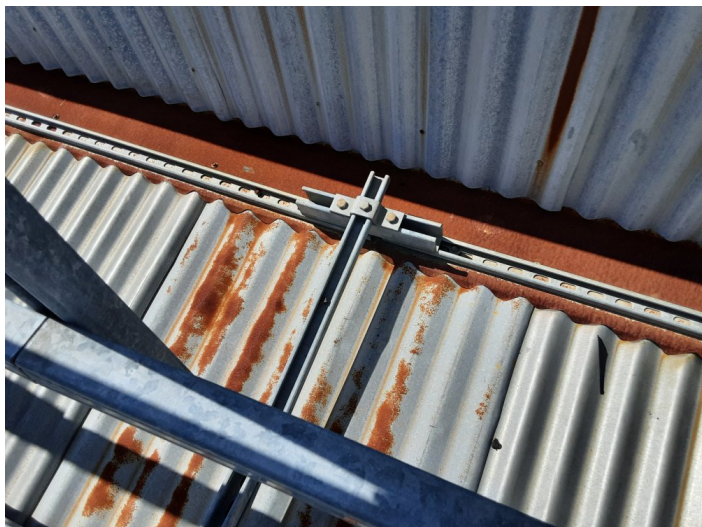
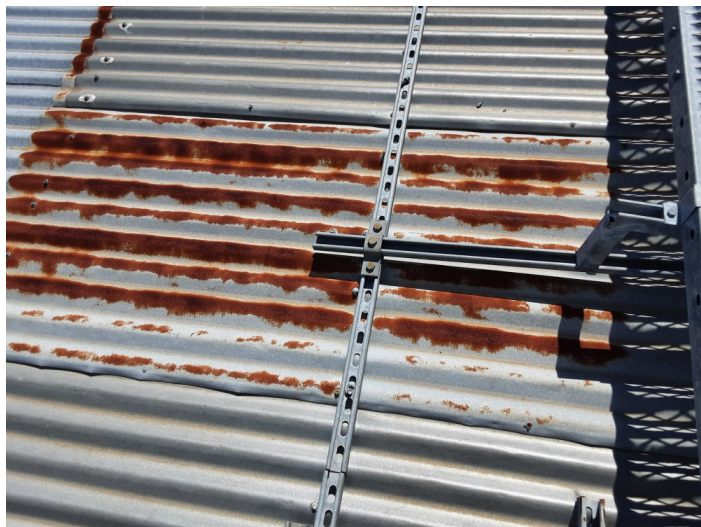
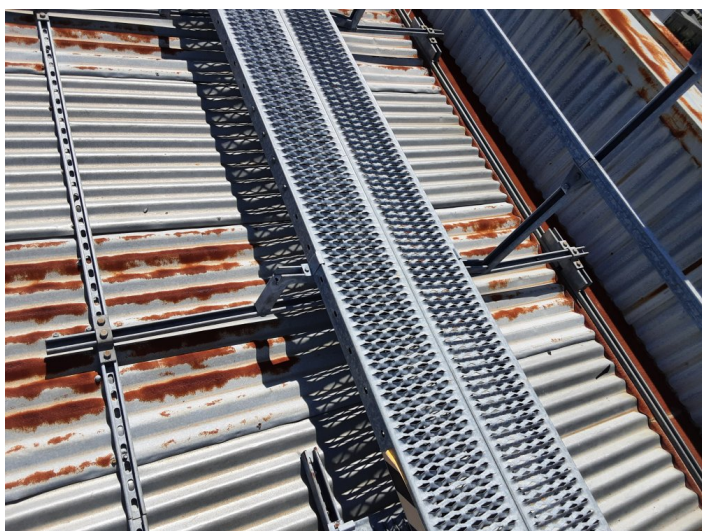
<b>2</b> What is the guard railing made from?	Steel
<b>3</b> How long is the section of guard railing in metres?	35m
<b>4</b> How many corners?	2
<b>4.1</b> All corners must have one post within 300mm one side and 2000mm the other if only a single post (1 x bay) construction or 400mm one side and 2200mm the other if more than two posts continuing in the run. Are all corners compliant?	Yes
<b>5</b> What type of surface is the guard railing mounted to?	Metal Roof
<b>5.1</b> Metal Roof type	Corrugated
<b>5.2</b> Are the bases a minimum of 800mm long or have an approved short base design and installed using either 3 x 7.7mm rivets or 4 x 5.2mm rivets?	No
<b>5.2.1</b> Are the bases considered compliant?	No
<b>5.2.2</b> Describe the issues and list how many	
<b>Notes:</b> Only fixed at each end of steel Chanel

5.3 Does each base and post have a compliant brace at approximately 45°?	No
5.3.1 Describe the issues and how many are non-compliant	
Notes: No braces at any post

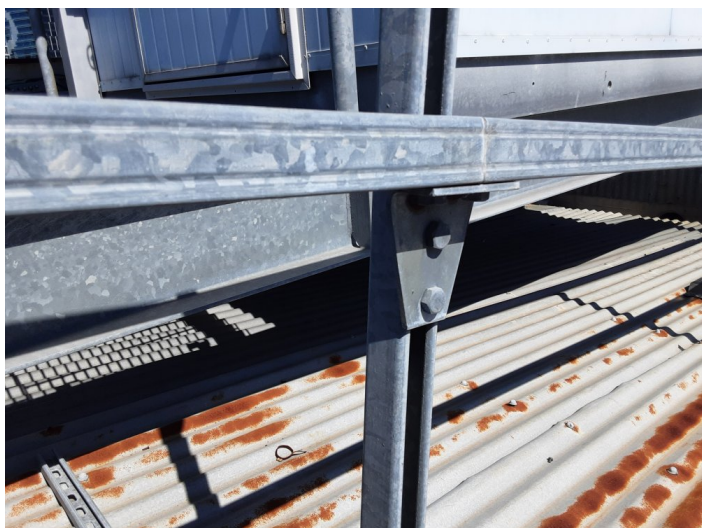
<b>10</b> Is the guard railing installed along the edge of the roof and the roof pitch is greater than 12°?	No
<b>11</b> The distance between guard railing posts must not exceed 2m when a single bay (i.e. 2 posts only or 2200mm where there is more than 3 posts in a single line. Do any post lengths exceed this?	No
<b>12</b> Is the mid rail positioned on the inside of the posts to the fall zone?	Yes
<b>13</b> Is there a minimum of 2 screws in each mid rail?	No
<b>13.1</b> Note how many posts are missing screws and take photo	
<b>Notes:</b> Mid rail joined to post with bolts and L bracket

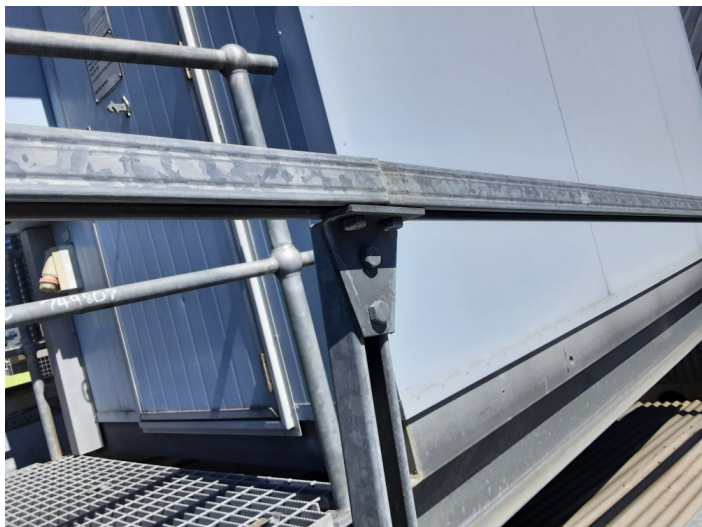
<b>14</b> Is there a minimum of 1 x 20mm tek screw either side of top rail into each post?	No
<b>14.1</b> Note how many posts are missing screws and take photo	
<b>Notes:</b> Top rail joined to posts using bolts and L bracket

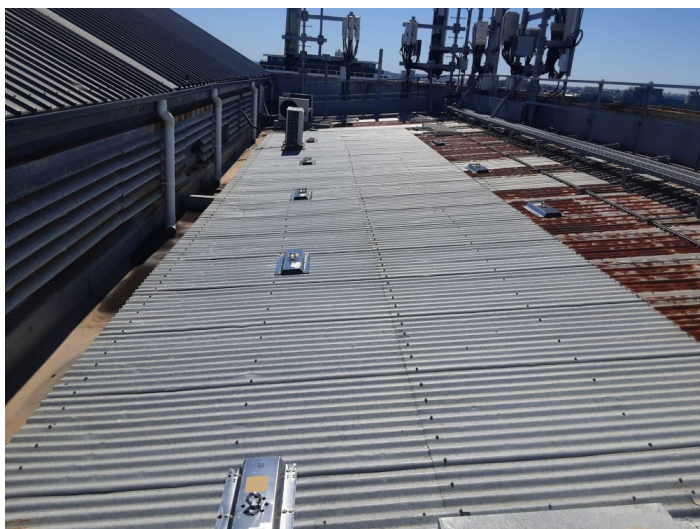
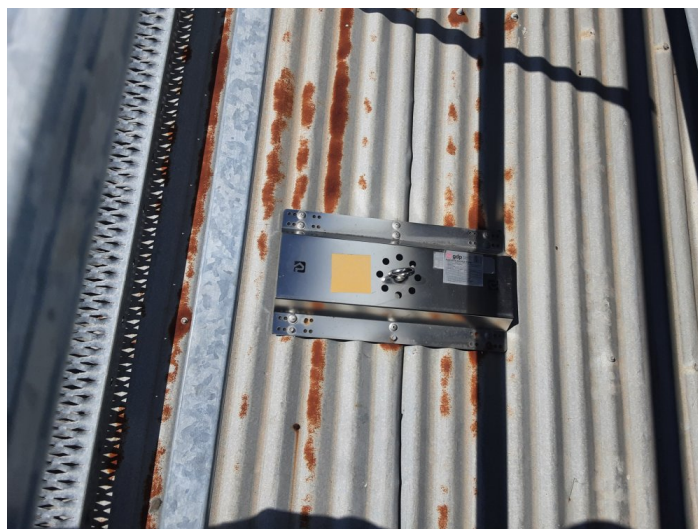
### 1 Example Photo

2 Is the system for:	Abseil
3 What is the type of anchor?	Surface mounted
4 Surface type?	Metal Roof
4.1 Roof type	Corrugated
4.2 Is the system surface mounted or into a purlin with screws?	Purlin Mounted
4.3 Is there a minimum of 3 x purlins under each sheet where an anchor is installed?	Yes
4.4 Is the roof sheeting in good condition and free from rust?	No

**Notes:** 4 x anchors installed on rusted sheets

<b>9</b> Is there a parapet wall?	Yes
Affected Anchors Numbers	1-4
What is the distance in mm from the anchor eye to base of wall?	2900mm
What is the height of wall?	710mm
What is the distance in millimetres from the anchor eye to the top of wall?	3000mm
Calculated Angle	13.7°
<b>Has the system Passed/Failed?</b>	<b>FAIL</b>
<b>Fail Reason?</b>	The roof sheeting is in very poor condition, Issues include: Roof sheets are extremely rusted Roof sheets are missing screws Roof sheets have nails
<b>Recommendations:</b>	Refer to Quote dated March 2022

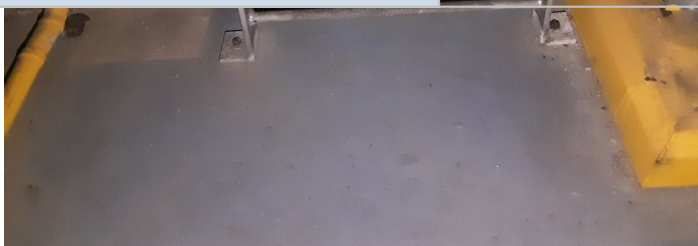
Bottom rung is not within 10%  
 The rungs do not have a non slip surface  
 The top rung is not within the specified tolerance of not less than 50mm and not more than 100mm. It is at 105mm  
 Distance between top stiles is 465mm. AS1657 states the minimum distance is 525mm  
 Upon reaching the top of the ladder, there is a beam directly at head height. If a worker was not watching when they stepped off the ladder they would immediately hit their head on this beam. As it is right on the edge of the platform, this is most likely going to cause them to fall backwards off the ladder  
 Bottom of the ladder does not have the minimum required 600mm clearance

This ladder is not able to be rectified due to the location of the beam. We would recommend that we remove the ladder, extend the platform and install a new ladder at 90°. This will allow workers to be fully on the platform and away from the edge when they are required to duck under the beam. Remove and dispose of the current noncompliant ladder Installation of a custom platform 600mm wide by 900mm with guard railing and self supporting legs (vertical height from top of platform to slab 2660mm) Installation of custom made aluminium angled ladder Note, may require a lower levelled platform to bridge across services Low head room sign for beam
