# HEIGHT SAFETY INSPECTION REPORT

**Inspection No. 1691**

**Site No. 853**  
2 King Street, Caboolture QLD 4510

## Inspection - 2 King Street, Caboolture QLD 4510 - Business Building

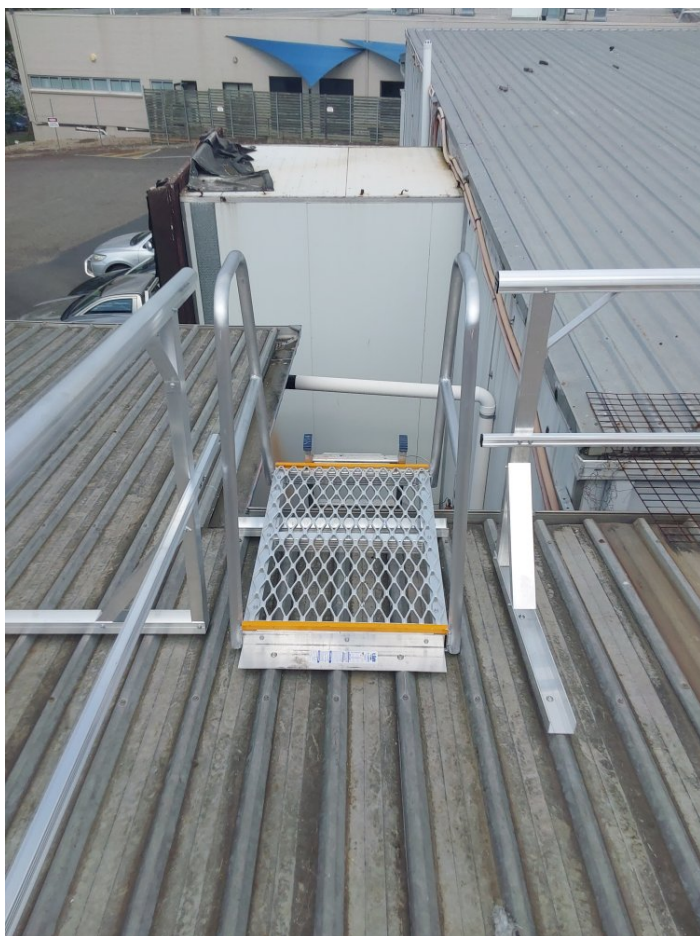
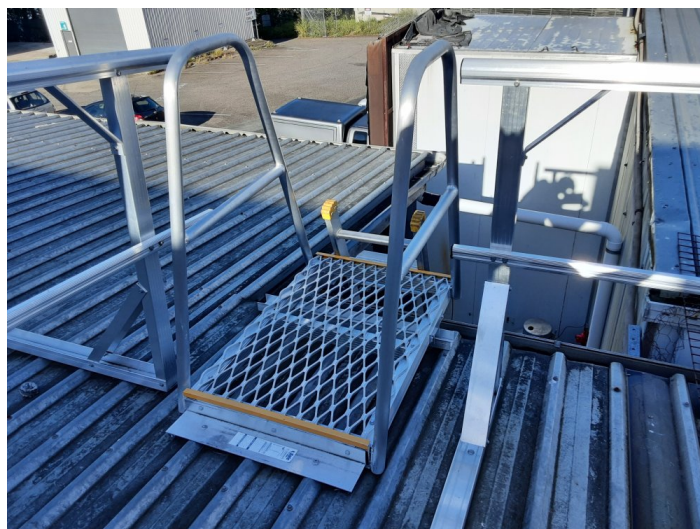
#### 1 Example Photo

| 2 What is the vertical height from ground to top of the ladder dock platform? (in mm) | 4800mm |
| 3 Choose height level category | Over 3.4m but under 5m |
| 7 How is the ladder dock installed? | roof sheeting |

| <b>9</b> Does the ladder dock have a levelled platform at least 525mm wide and 600mm long and levelled to within 3°? | Yes |
| <b>10</b> Is the ladder dock correctly & securely installed? | Yes |
| <b>13</b> What is the type of roof? | Trimdek |
| <b>14</b> Pitch of roof (in degrees) | 5° |
| <b>Has the system Passed/Failed?</b> | <b>PASS</b> |

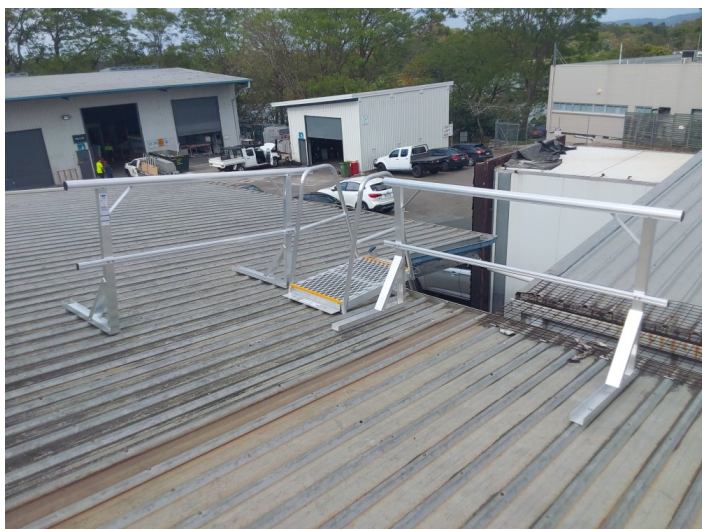
| 1 Example Photo | |

| 2 Is the system in good condition and all the fixings correctly installed and tight? | Yes |
| 3 Has the system been installed as per manufacturer's instructions? | Yes |
| Has the system Passed/Failed? | PASS |

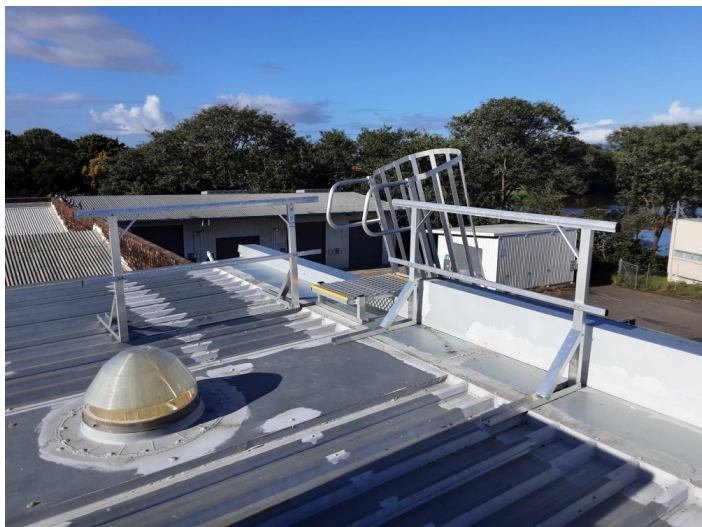
| <b>23.1</b> Describe what is installed and take photo | |

**Notes:** Guard rail 2m wing kit

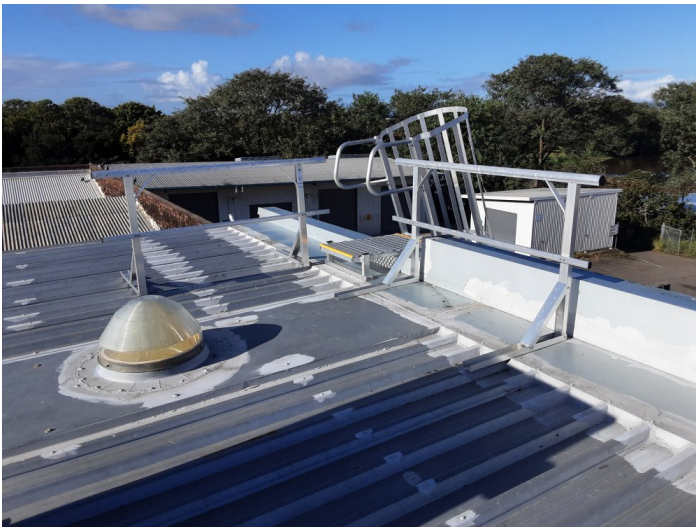
| 1 Example Photo | |

| 2 Is the system in good condition and all the fixings correctly installed and tight? | Yes |
| 3 Has the system been installed as per manufacturer's instructions? | Yes |
| Has the system Passed/Failed? | PASS |

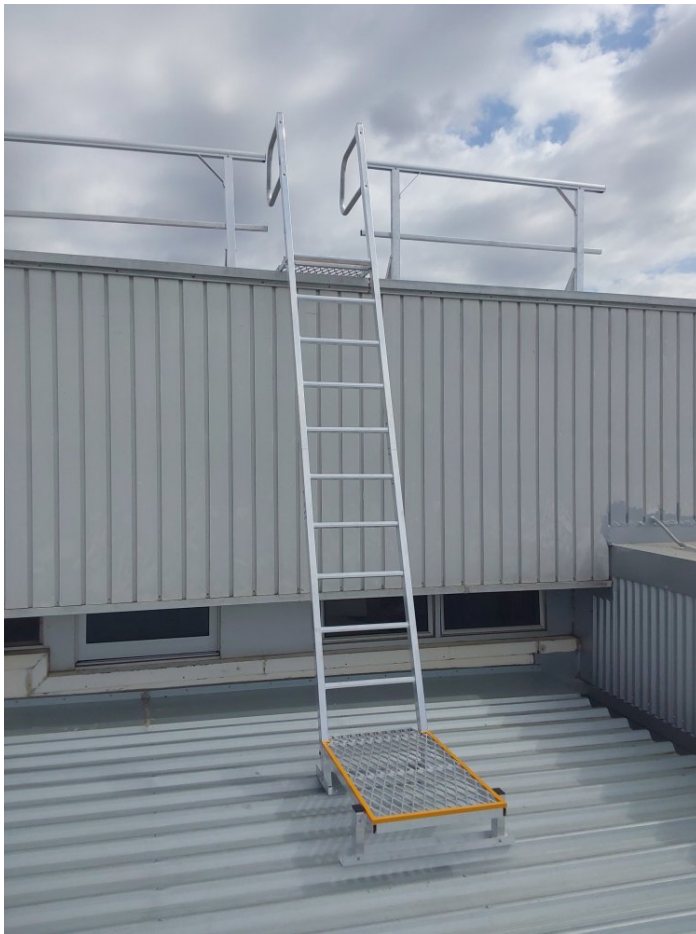
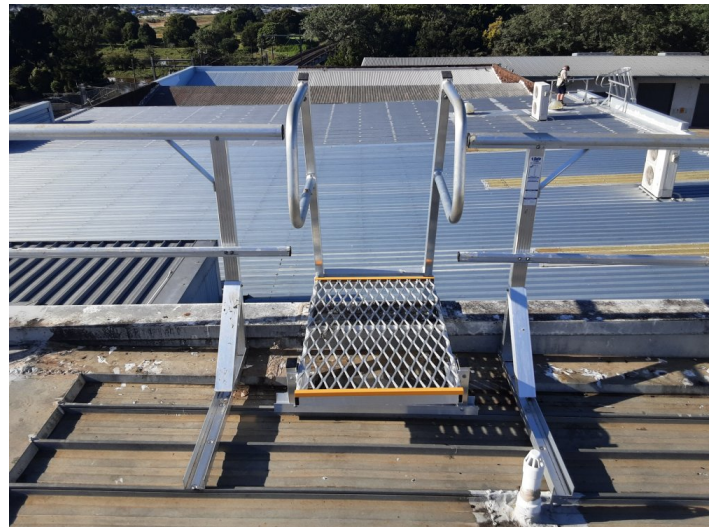
### 1 Example Photo

| 2 What is the ladder made from? | | | Aluminium |
| 3 Vertical height of ladder from top platform to bottom platform. (Must not exceed 6000mm) | | | 3000mm |
| 4.2 Height from platform to roof (must not exceed 300mm) | | | 280mm |

| <b>5.2</b> Height from top of bottom platform to top of first rung (mm). Must be within 10% of rung spacing. | | | 280mm |
| <b>6</b> The rung width must not be less than 20mm and not more than 50mm. Rung width: | | | 42mm |
| <b>Has the system Passed/Failed?</b> | | <b>PASS</b> | |

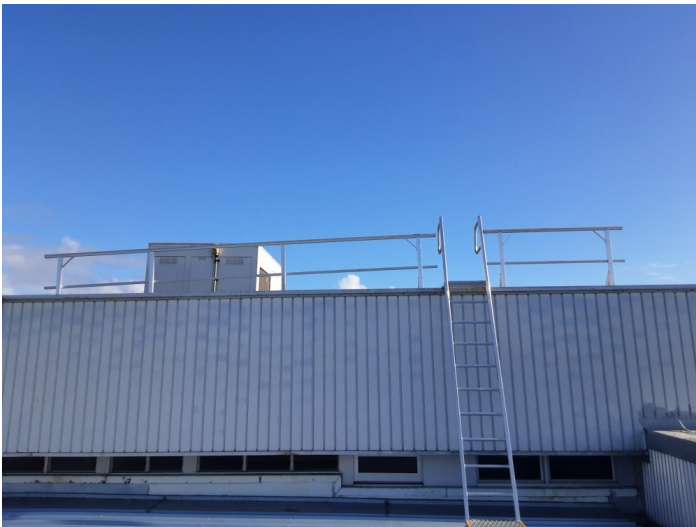
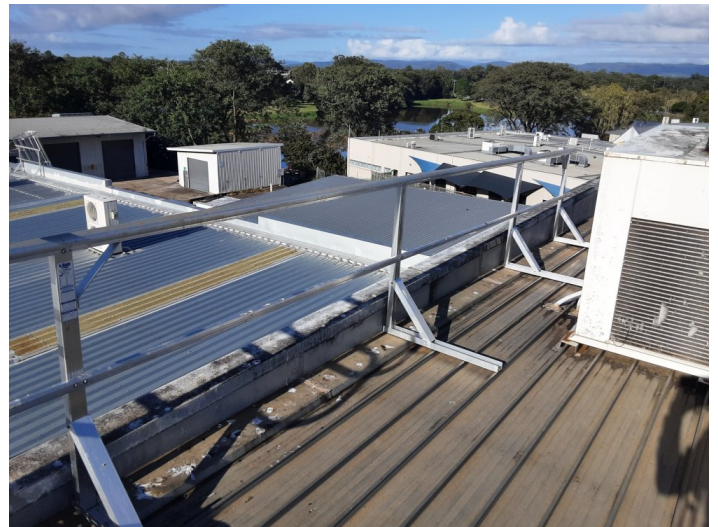
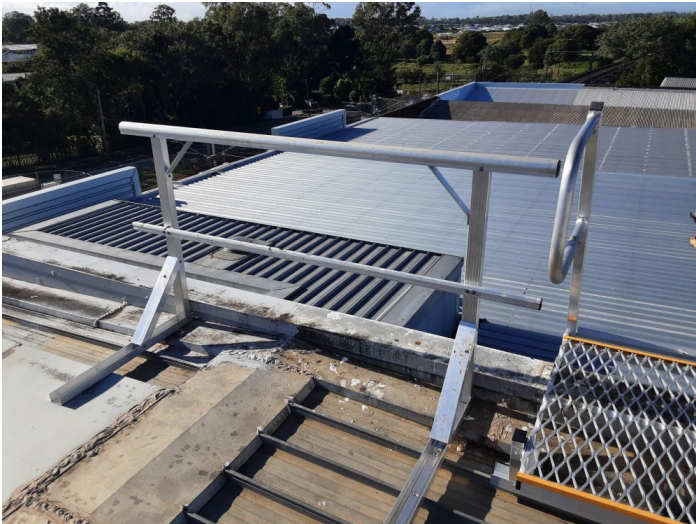
| 1 Example Photo | |

| 2 Is the system in good condition and all the fixings correctly installed and tight? | Yes |
| 3 Has the system been installed as per manufacturer's instructions? | Yes |
| Has the system Passed/Failed? | PASS |
