HEIGHT SAFETY INSPECTION REPORT

Inspection No. 2285

Site No. 2505
The Lakes Centre - Block C - 8-22 King Street, Caboolture

Inspection - The Lakes Centre - Block C - 8-22 King Street, Caboolture - Block C

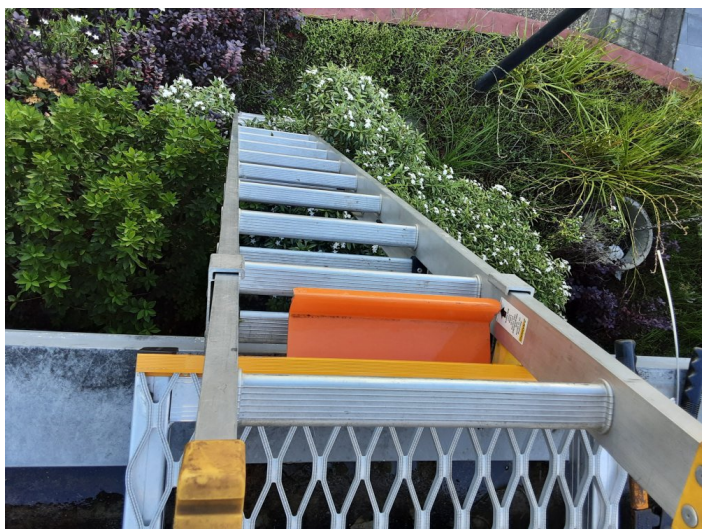
1 Example Photo

Identification #	LB1
Date of Certification	10/04/2025
Date of Next Certification	10/04/2026
Date Installed	08/02/2022
Who installed this system?	
Brand/Model	Sayfa Ladder bracket

2 What is the vertical height from ground to top of roof profile? (in mm)	3300mm
3 What is the height level category?	Up to 4m
4 Type of surface for base of ladder?	Garden Bed
5 Is the surface level, free from trip hazards and fit for purpose?	Yes
6 Mounting Type	Roof Mounted
7 Is the ladder bracket correctly & securely installed?	Yes
8 Is there a ladder safety attachment stop?	No
8.1 Warning: Ladder bracket is missing ladder securing safety stop. We highly recommend that a stop is installed	
Notes: No safety stop attached - no where to attach

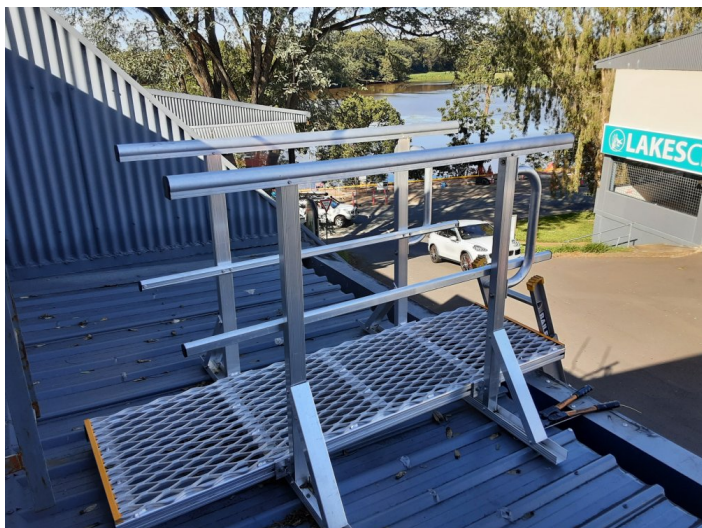
9 Is there a parapet wall with a step down over 100mm?	No
10 What is the type of roof?	Trimdek
11 Pitch of roof (in degrees)	3°
12 Direction of the slope	Towards the ladder bracket
13 Are there any trip hazards such as a gutter or cable tray within 900mm of the ladder bracket?	No
14 Is there a compliant anchor and stop in place?	N/A
14.1 Please describe why it is not required. Take Image	
Notes: Guard rail lead on kit installed

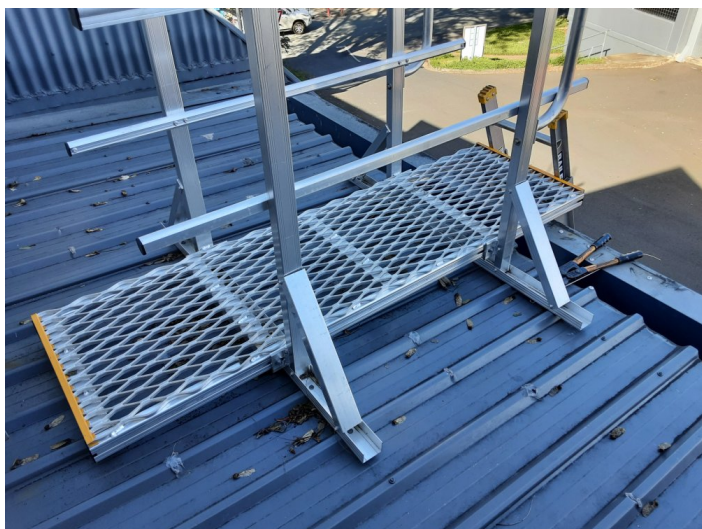
1 Example Photo

Identification #	PF1
Date of Certification	10/04/2025
Date of Next Certification	10/04/2026
Date Installed	08/02/2022
Who installed this system?	
Brand/Model	Sayfa Platform

2 Is the system in good condition and all the fixings correctly installed and tight?	Yes
3 Has the system been installed as per manufacturer's instructions?	Yes
Has the system Passed/Failed?	PASS

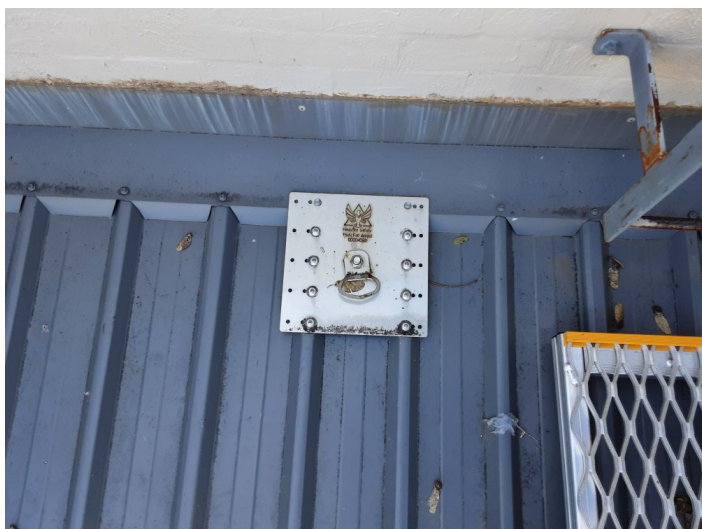
1 Example Photo

Identification #	AP1
Date of Certification	10/04/2025
Date of Next Certification	10/04/2026
Date Installed	08/02/2022
Who installed this system?	
Brand/Model	HawkPro Safety Fall arrest anchor

2 Is the system for:	Fall Arrest
3 What is the type of anchor?	Surface mounted
4 Surface type?	Metal Roof
4.1 Roof type	Trimdek
4.2 Is the system surface mounted or into a purlin with screws?	Purlin Mounted
4.3 Is there a minimum of 3 x purlins under each sheet where an anchor is installed?	Yes
4.4 Is the roof sheeting in good condition and free from rust?	Yes
4.5 Are there any penetrations in the same roof sheet that has the anchor installed that is within 2000mm?	No
4.6 Are all the fixings installed correctly and in good condition?	Yes
4.7 Are the anchors installed on the correct lap?	Yes
4.8 Is there anything else that must be noted?	No
5 Pitch of roof (in degrees)	3°
6 Does each anchor have clear labels stating manufacturer and rating?	Yes

7 Is the design of the system compliant, allowing 100% connection?	Yes
8 Are there any pendulum risks? You must measure each anchor and ensure that: <ul style="list-style-type: none"> 1. The distance the anchor is from the closest fall edge is the same or LESS than to the next anchor 2. The distance between each anchor is no MORE than 6m 3. If any pendulum issues are found that the EXACT measurements are written clearly on the roof plan 	No
9 Is there a parapet wall?	No
Has the system Passed/Failed?	PASS

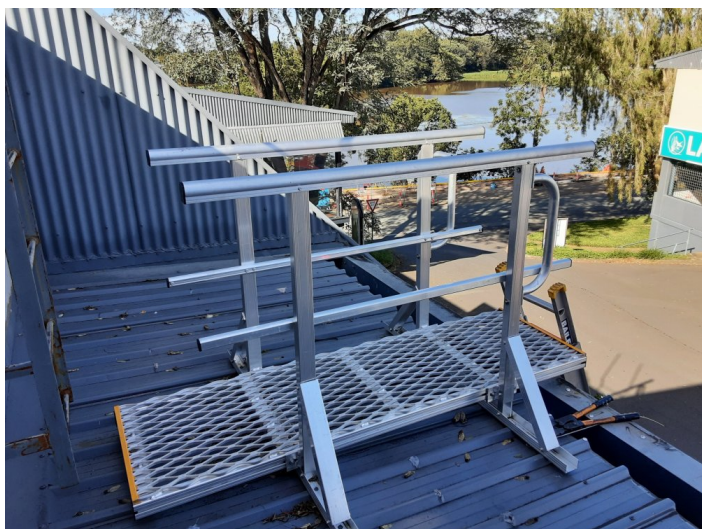
1 Example Photo

Identification #	GR1
Date of Certification	10/04/2025
Date of Next Certification	10/04/2026
Date Installed	08/02/2022
Who installed this system?	
Brand/Model	Sayfa Guard rail

2 What is the guard railing made from?	Aluminium
3 How long is the section of guard railing in metres?	3m
4 How many corners?	0
5 What type of surface is the guard railing mounted to?	Other
5.1 Describe What fixings have been used and take photo	
Notes: Bolted to side of platform

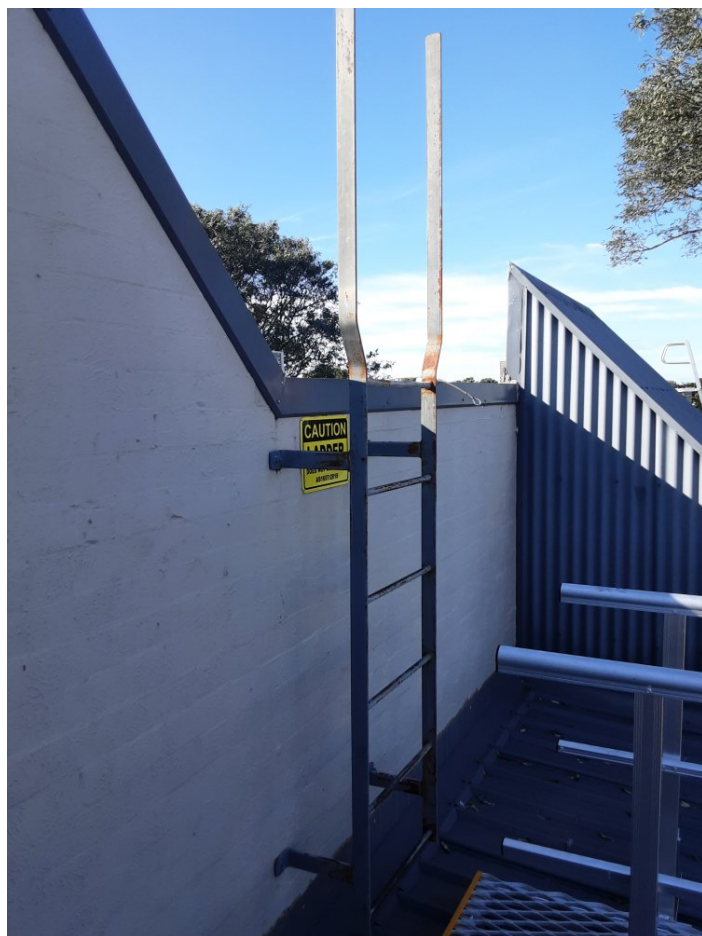
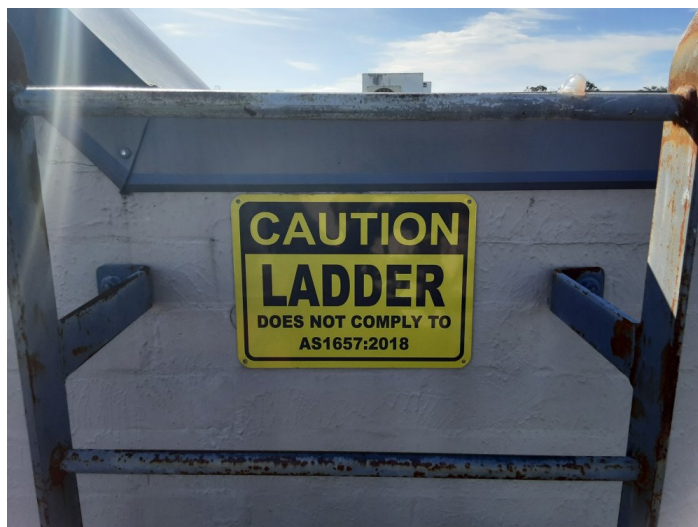
1 Example Photo

WARNING: Vertical ladder from front awning accessing the main roof has failed. It does not comply with AS1657 and we have recommended that it is replaced. Please review the report in full

Identification #	VL1
Date of Certification	10/04/2025
Date of Next Certification	10/04/2026
Date Installed	Unknown
Who installed this system?	
Brand/Model	Steel Vertical ladder

2 Does the ladder have any form of fall arrest system installed?	No
Warning: Ladder does not comply with Managing the Risks of Falls at Workplaces Code of Practice. Provide further guidance to client	
3 What is the ladder made from?	Steel
4 Vertical height of ladder from top platform to bottom platform. (Must not exceed 6000mm)	1700mm
5 Bottom Platform	Does not require bottom platform

System Type	Item Status	Recommendation
FRONT AWNING ACCESS - Item #5 - Vertical Ladder - VL1	FAIL	Warning: Ladder has failed due to multiple non-compliance issues, a sign has been installed stating that the ladder does not comply with AS1657:2018. We recommend that the ladder is removed and a new angled ladder in compliance with AS1657:2018 is installed

Client Notes	Warning: Ladder has failed due to multiple non-compliance issues, a sign has been installed stating that the ladder does not comply with AS1657:2018. We recommend that the ladder is removed and a new angled ladder in compliance with AS1657:2018 is installed

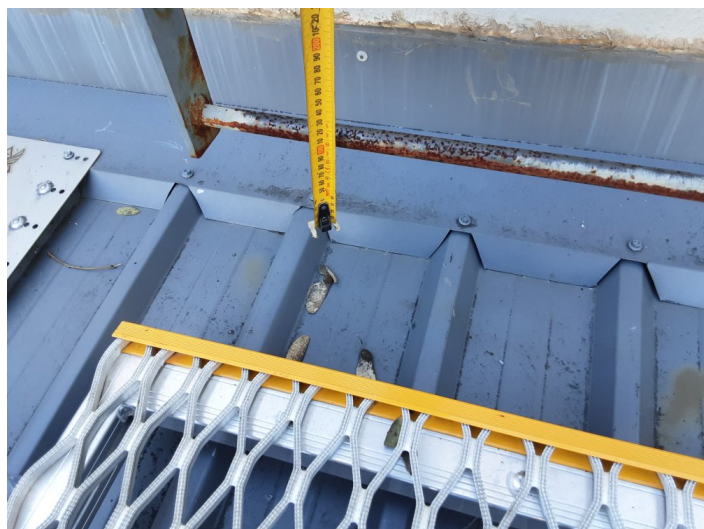
5.1 On concrete base or mesh base which has cross level & inline level under 7°	
5.1.1 Cross Level (degrees)	0°
5.1.2 Inline level (degrees)	0°
6 Excluding the bottom rung, are all the rungs no less than 250mm and no more than 300mm and the same space apart, within ± 5 mm?	Yes
6.1 Rung Spacings (mm)	300mm
6.2 Height from top of bottom platform to top of first rung (mm). Must be within 10% of rung spacing.	120mm
6.3 Warning: ladder has failed.

24.1 Describe what would best suit this ladder for edge protection	
25 Is there anything else that needs to be addressed?	No
Has the system Passed/Failed?	FAIL
Fail Reason?	Multiple non-compliance issues to AS1657 No fall arrest system No anti slip on ladder rungs No top landing
Recommendations:	Warning: Ladder has failed due to multiple non-compliance issues, a sign has been installed stating that the ladder does not comply with AS1657:2018. We recommend that the ladder is removed and a new angled ladder in compliance with AS1657:2018 is installed

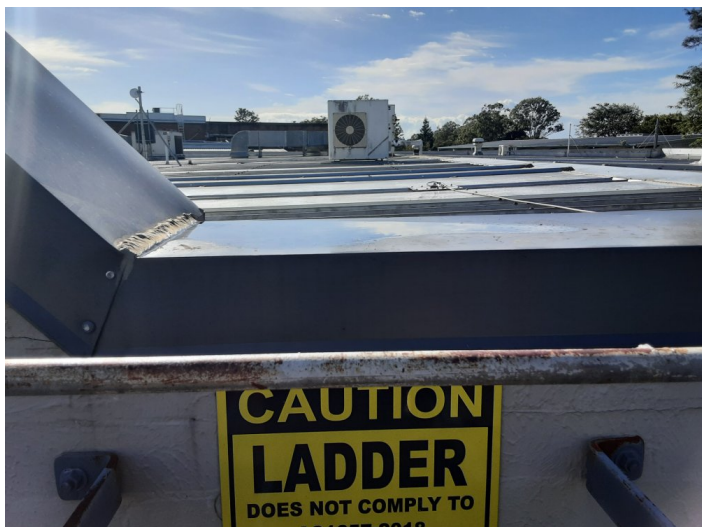
9 Is there a minimum distance of 200mm behind the back of each rung and any object?	Yes
10 Is the top rung level with the top platform?	No
10.1 Warning: ladder has failed.	
Notes: No top platform

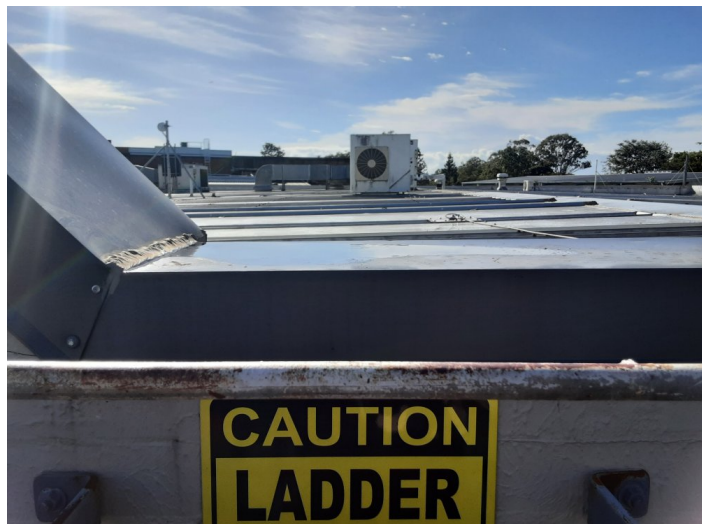
16 Top Platform	No top platform but requires one
16.1 Warning: ladder may be non-compliant.	
Notes: No top platform

17 Actual angle of the ladder is:	90°
18 What type of grab rails does it have?	No P rails, but are required
18.1 Warning: ladder has failed.	
19 Does it have the required ladder support bracket at least every 3000mm or strengthening stiles?	Yes
20 Are all the fixings in good condition?	Yes
21 Does the ladder have a cage?	No

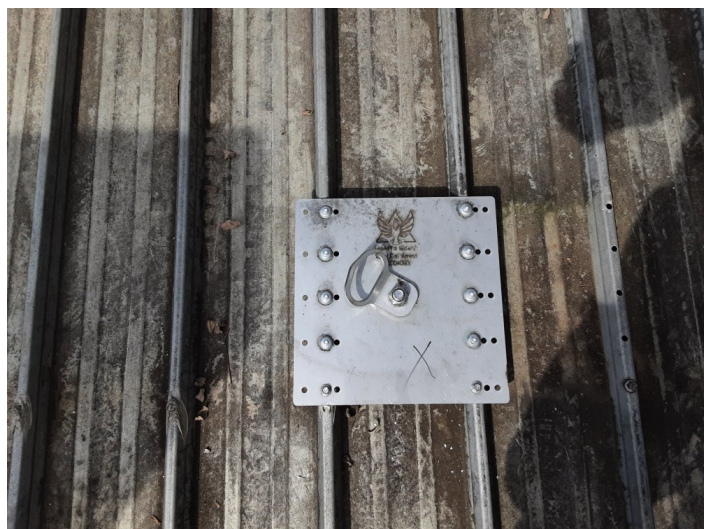
Identification #	AP1
Date of Certification	10/04/2025
Date of Next Certification	10/04/2026
Date Installed	08/02/2022
Who installed this system?	
Brand/Model	HawkPro Safety Fall Arrest Anchor
1 Example Photo

2 Is the system for:	Fall Arrest
3 What is the type of anchor?	Surface mounted
4 Surface type?	Metal Roof
4.1 Roof type	Kliploc 700
4.2 Is the system surface mounted or into a purlin with screws?	Purlin Mounted
4.3 Is there a minimum of 3 x purlins under each sheet where an anchor is installed?	Yes
4.4 Is the roof sheeting in good condition and free from rust?	Yes
4.5 Are there any penetrations in the same roof sheet that has the anchor installed that is within 2000mm?	No
4.6 Are all the fixings installed correctly and in good condition?	Yes
4.7 Are the anchors installed on the correct lap?	Yes
4.8 Is there anything else that must be noted?	No
4.9 For Kliploc: Is there the required additional screws in the sheets?	Yes
5 Pitch of roof (in degrees)	3°

6 Does each anchor have clear labels stating manufacturer and rating?	Yes
7 Is the design of the system compliant, allowing 100% connection?	Yes
8 Are there any pendulum risks? You must measure each anchor and ensure that: <ul style="list-style-type: none"> 1. The distance the anchor is from the closest fall edge is the same or LESS than to the next anchor 2. The distance between each anchor is no MORE than 6m 3. If any pendulum issues are found that the EXACT measurements are written clearly on the roof plan 	No
9 Is there a parapet wall?	Yes
Affected Anchors Numbers	2,10
What is the distance in mm from the anchor eye to base of wall?	1800mm
What is the height of wall?	400mm
What is the distance in millimetres from the anchor eye to the top of wall?	1900mm
Calculated Angle	12.0°
Has the system Passed/Failed?	PASS

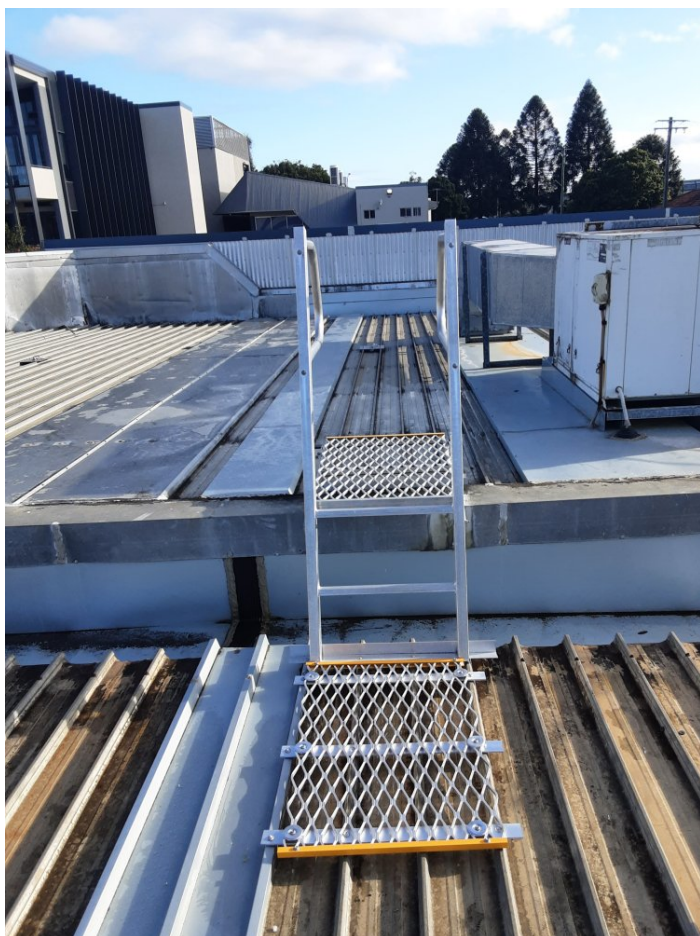
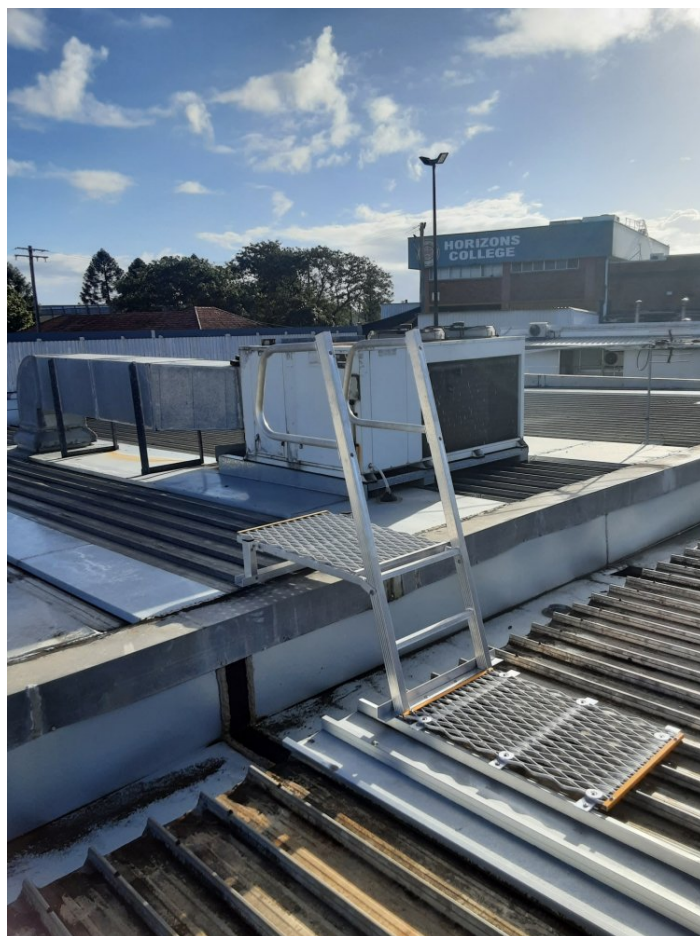
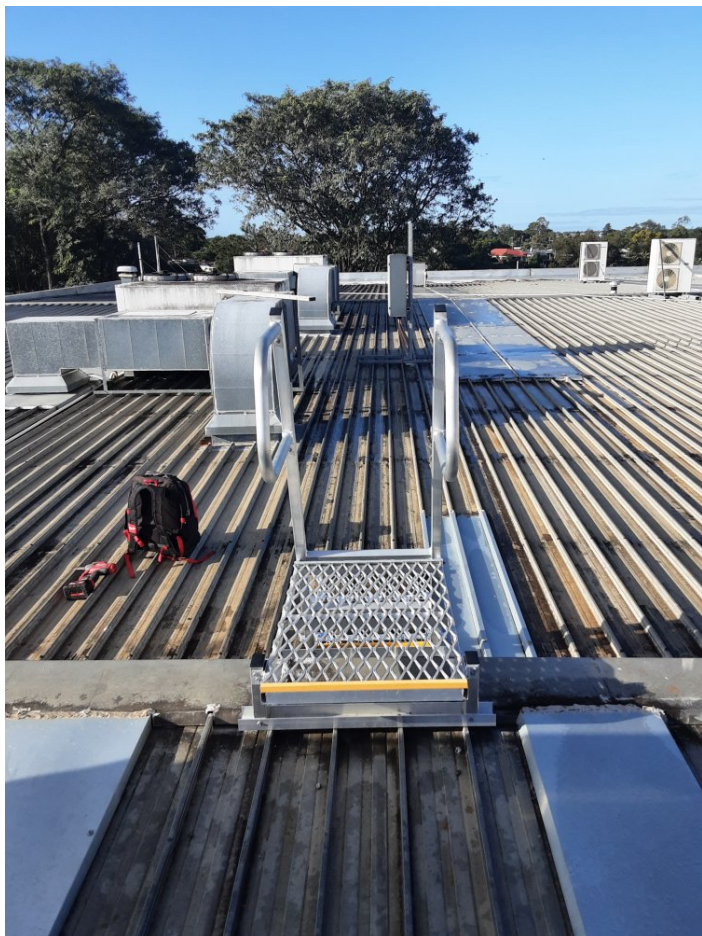
Identification #	AL1
Date of Certification	10/04/2025
Date of Next Certification	10/04/2026
Date Installed	08/02/2022
Who installed this system?	
Brand/Model	HawkPro Safety Angled ladder
1 Example Photo

2 What is the ladder made from?			Aluminium
3 Vertical height of ladder from top platform to bottom platform. (Must not exceed 6000mm)			600mm
4 Bottom Platform			Has a bottom platform
4.1 Platform size at least 900mm long, 600mm wide, and levelled to within 7°			
Length (mm): 900mm	Width (mm): 600mm	Level (degrees): 3°	
4.2 Height from platform to roof (must not exceed 300mm)			20mm
5 Excluding the bottom rung, are all the rungs no less than 250mm and no more than 300mm and the same space apart, within +/-5mm?			Yes
5.1 Rung Spacings (mm)			300mm
5.2 Height from top of bottom platform to top of first rung (mm). Must be within 10% of rung spacing.			300mm
6 The rung width must not be less than 20mm and not more than 50mm. Rung width:			45mm
7 Do the rungs have a knurled or anti-slip surface?			Yes
8 Is there a minimum distance of 200mm behind the back of each rung and any object?			Yes

9 Is the top rung level with the top platform?		Yes
10 Is there an gap between the top rung and the platform?		Yes
10.1 The gap between the back of the rung and the platform must be not less than 50mm and not more than 100mm. Actual gap in mm is?		70mm
11 What is the distance between the inside of the stiles of the main ladder body? Must be between 375mm and 525mm		525mm
12 What is the width between stiles at step off point? Must be between 525mm and 675mm.		525mm
13 What are the dimensions of the stiles? Shape must fit within an 80mm circle.		
Stile Width (mm): 40	Stile Depth (mm): 60	
14 Is there clear hand space of 50mm around the stiles?		Yes
15 Top Platform		Has a top platform

15.1 Platform size at least 900mm long, 600mm wide, and levelled to within 3°		
Length (mm): 900mm	Width (mm): 600mm	Level (degrees): 0°
15.2 Unprotected height from platform to roof in mm is? (Note: if guard railed or no fall risk record as 0)		0mm
16 Angled ladders should be between 70° and 75°. Actual angle is:		73°
17 What type of grab rails does it have?		Rear facing
18 Does it have the required ladder support bracket at least every 3000mm or strengthening stiles?		Yes
19 Are all the fixings in good condition?		Yes
20 Does the ladder have a cage?		No

20.1 Is the ladder over 3500mm?		No
21 Is the side of the ladder within 500mm of a guard railing?		No
22 Is there guard railing within 900mm of the front of the ladder?		No
23 If the ladder is over 3.5m, is there a lead on kit or 2m of guard railing either side of the ladder?		NA
Has the system Passed/Failed?		PASS
Fail Reason?		No bottom landing

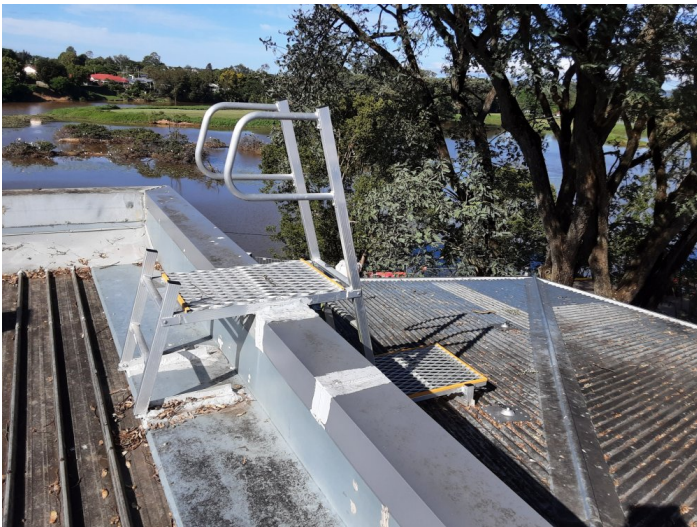
1 Example Photo

Identification #	CL1
Date of Certification	10/04/2025
Date of Next Certification	10/04/2026
Date Installed	08/02/2022
Who installed this system?	
Brand/Model	HawkPro Safety Crossover ladder

PASS

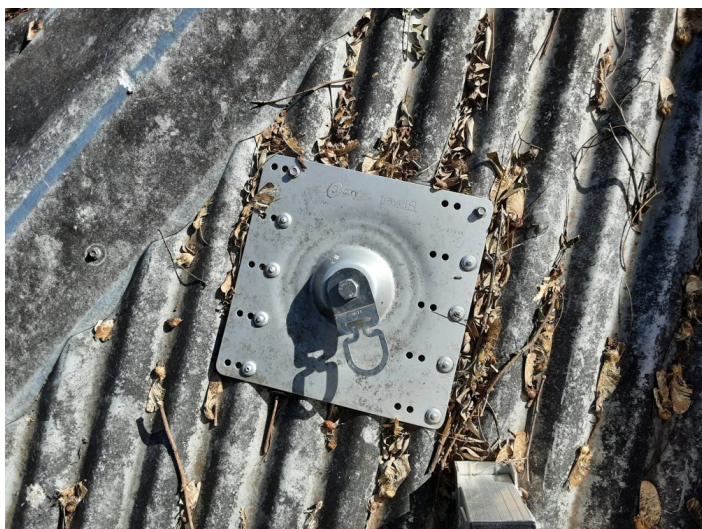
Identification #	AP1
Date of Certification	10/04/2025
Date of Next Certification	10/04/2026
Date Installed	08/02/2022
Who installed this system?	
Brand/Model	Sayfa 360 top hat anchor
1 Example Photo

2 Is the system for:	Fall Arrest
3 What is the type of anchor?	Surface mounted
4 Surface type?	Metal Roof
4.1 Roof type	Corrugated
4.2 Is the system surface mounted or into a purlin with screws?	Purlin Mounted
4.3 Is there a minimum of 3 x purlins under each sheet where an anchor is installed?	Yes
4.4 Is the roof sheeting in good condition and free from rust?	Yes
4.5 Are there any penetrations in the same roof sheet that has the anchor installed that is within 2000mm?	No
4.6 Are all the fixings installed correctly and in good condition?	Yes
4.7 Are the anchors installed on the correct lap?	Yes
4.8 Is there anything else that must be noted?	No
5 Pitch of roof (in degrees)	5°
6 Does each anchor have clear labels stating manufacturer and rating?	Yes

7 Is the design of the system compliant, allowing 100% connection?	Yes
8 Are there any pendulum risks? You must measure each anchor and ensure that: <ul style="list-style-type: none"> 1. The distance the anchor is from the closest fall edge is the same or LESS than to the next anchor 2. The distance between each anchor is no MORE than 6m 3. If any pendulum issues are found that the EXACT measurements are written clearly on the roof plan 	No
9 Is there a parapet wall?	No
Has the system Passed/Failed?	PASS

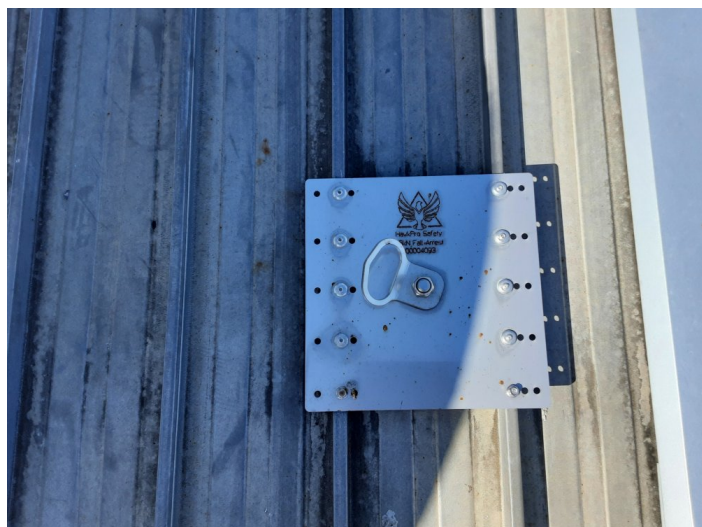
Identification #	AP1
Date of Certification	10/04/2025
Date of Next Certification	10/04/2026
Date Installed	08/02/2022
Who installed this system?	
Brand/Model	HawkPro Safety Fall Arrest Anchor
1 Example Photo

2 Is the system for:	Fall Arrest
3 What is the type of anchor?	Surface mounted
4 Surface type?	Metal Roof
4.1 Roof type	Kliploc 700
4.2 Is the system surface mounted or into a purlin with screws?	Purlin Mounted
4.3 Is there a minimum of 3 x purlins under each sheet where an anchor is installed?	Yes
4.4 Is the roof sheeting in good condition and free from rust?	Yes
4.5 Are there any penetrations in the same roof sheet that has the anchor installed that is within 2000mm?	No
4.6 Are all the fixings installed correctly and in good condition?	Yes
4.7 Are the anchors installed on the correct lap?	Yes
4.8 Is there anything else that must be noted?	No
5 Pitch of roof (in degrees)	3°
6 Does each anchor have clear labels stating manufacturer and rating?	Yes

7 Is the design of the system compliant, allowing 100% connection?	Yes
9 Is there a parapet wall?	Yes
Affected Anchors Numbers	5
What is the distance in mm from the anchor eye to base of wall?	1750mm
What is the height of wall?	330mm
What is the distance in millimetres from the anchor eye to the top of wall?	1800mm
Calculated Angle	10.5°
Has the system Passed/Failed?	PASS
